PHASE II SITE APPRAISAL
WHINNEY HILL, GUIDE POST, NORTHUMBERLAND
for
DYSART DEVELOPMENTS LTD

July 2016

N16055	Phase II Site Appraisal, Whinney Hill, Guide Post, Northumberland
---------------	--

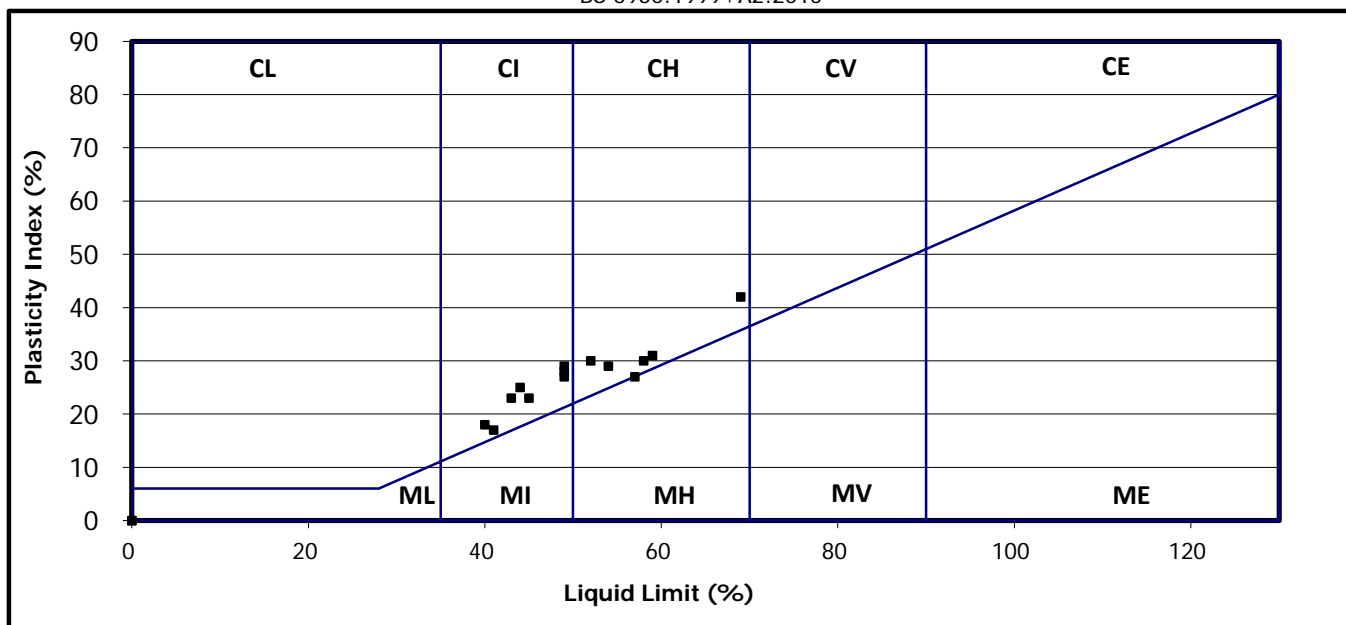
PLASTICITY CHART FOR CASAGRANDE CLASSIFICATION.

Hole/ Sample Number	Sample Type	Depth m	Moisture Content % Cl. 3.2	Liquid Limit % Cl. 4.3/4.4	Plastic Limit % Cl. 5.	Plasticity Index % Cl. 6.	% Passing .425mm	Remarks
TP101	D	3.20	30	41	24	17	100	CI Intermediate Plasticity
TP102	D	2.50	32	43	20	23	100	CI Intermediate Plasticity
TP105	D	0.50	23	49	22	27	100	CI Intermediate Plasticity
TP105	D	1.85	30	44	19	25	100	CI Intermediate Plasticity
TP109	D	0.50	36	45	22	23	100	CI Intermediate Plasticity
TP112	D	2.75	25	40	22	18	100	CI Intermediate Plasticity
TP205	D	1.25	36	57	30	27	100	MH High Plasticity
TP206	D	3.40	30		NP		87	
TP213	D	1.00	29	59	28	31	100	CH High Plasticity
TP225	D	0.50	25	69	27	42	100	CH High Plasticity
TP226	D	0.60	28	58	28	30	100	CH High Plasticity
TP504	D	1.80	30	54	25	29	100	CH High Plasticity
TP506	D	1.75	31	52	22	30	100	CH High Plasticity
TP508	D	1.00	25	49	21	28	100	CI Intermediate Plasticity
TP512	D	1.70	28	49	20	29	100	CI Intermediate Plasticity

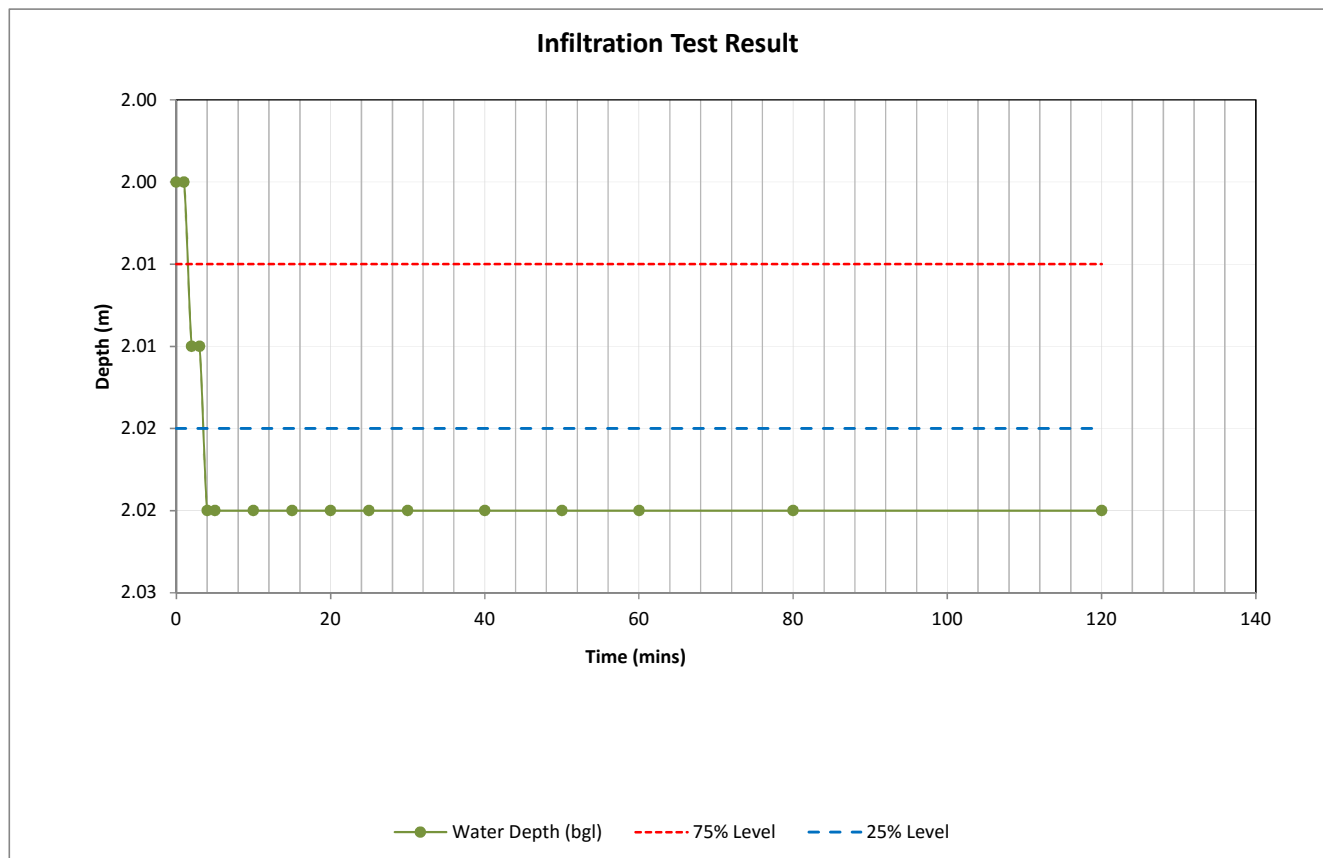
PROJECT: Whinney Hill, Guide Post, Northumberland
JOB REF: N16055
DATE: 24/06/2016
TEST REF: TP513

SOAKAWAY TEST - BRE DIGEST 365

75% Level (m)	1.008
25% Level (m)	1.023
Effective Range 75% - 25% (m)	0.015

Time to fall to 75% Depth (mins)	4
Time to fall to 25% Depth (mins)	10
Time from 75% to 25% Depth (mins)	6
