## **Preliminary Bat Roost Assessment (inc. Birds) Survey Report.**

**Grid Ref: SX43200 61449**

Torbay Development Agency (TDA) wishes to demolish two 'portacabin' style school buildings and construct a replacement new building at Paignton Community & Sports Academy, Borough Road, Paignton TQ4 7DH. The purpose is to build a modern school unit to serve the needs of the school. The new build, once constructed, will be in the same location and within the original building's development 'foot-print'. A bat and bird inspection survey has been requested by Torbay Council as part of a planning application.

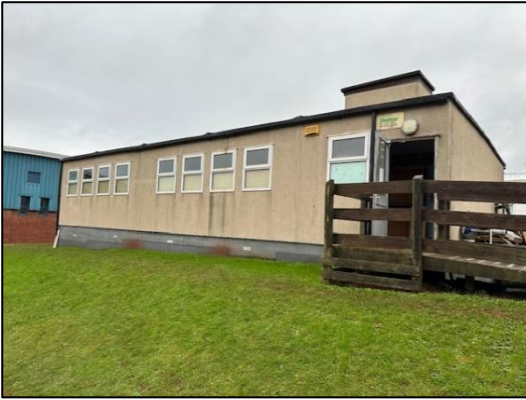
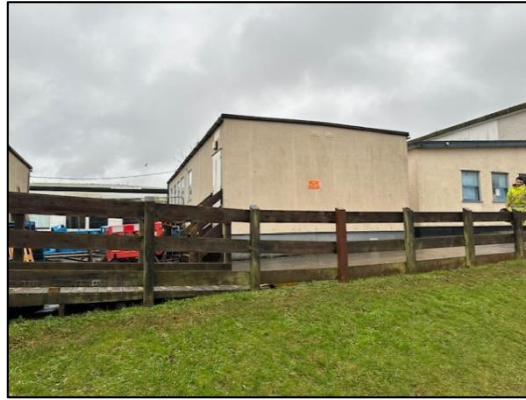
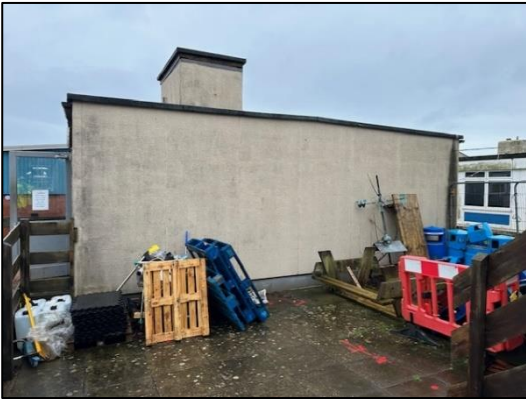
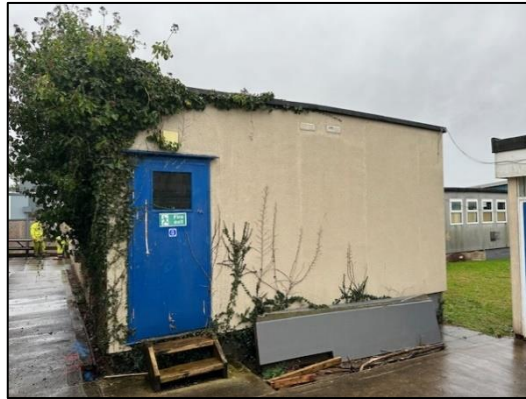
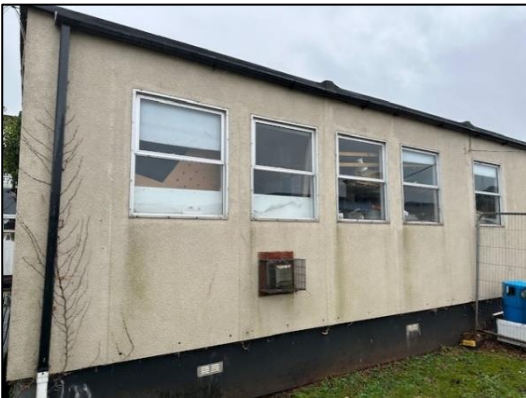
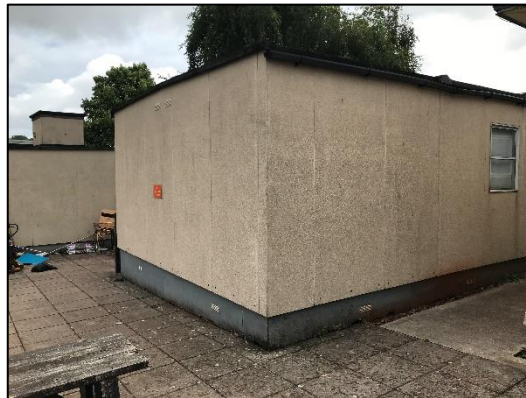
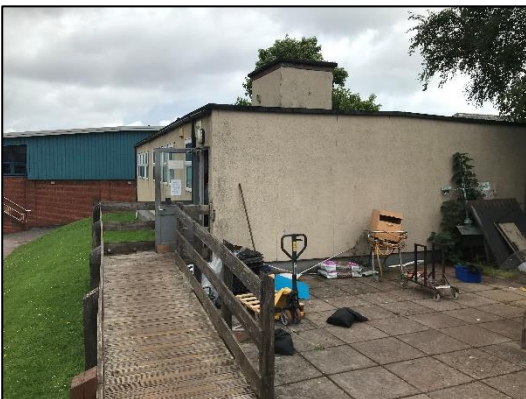
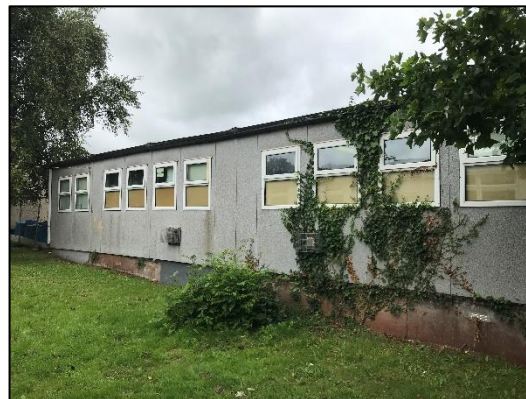
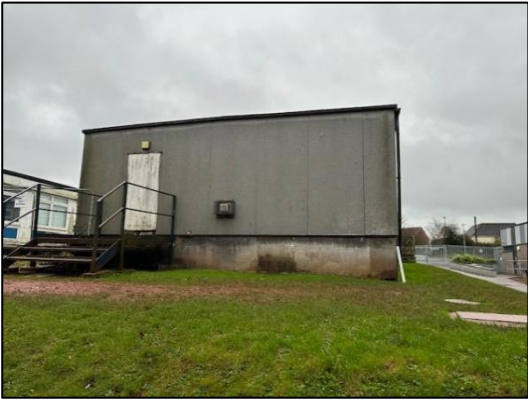
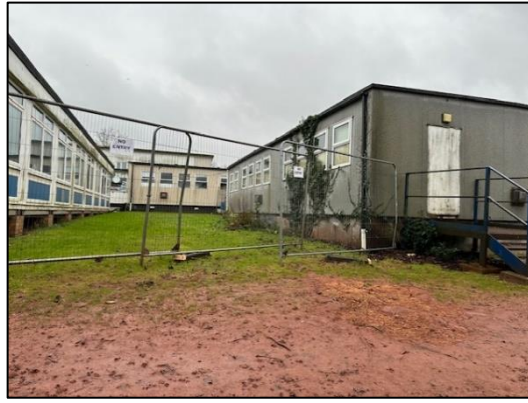
The two 'portacabin' style school buildings both had 'bitumen' felted flat roofs. The approximately 1960/70s buildings, were of breeze block construction with composite external panelling and rendered finish. Soffits and fascias were absent and all windows and doors intact. Both buildings were intact and in reasonable condition and appeared to be 'completely' sealed in relation to access/egress to bats and birds (Images 1 to 10). Internally the buildings supported composite ceiling panels with no roof voids and are currently used for storage (Images11 to 13).

No evidence of roosting bats, such as signs of bat occupancy, presence, droppings, scratch marks, staining and feeding remains were observed internally within the building. External features such as crevices, fissures and gaps within structures that could be potentially used by roosting bats were absent on the building. The building was deemed to be of negligible value to bats.

During the time of inspection, no birds were observed nesting internally or externally of the building. The building is deemed to be of negligible value to birds.

1. Portacabin northeast elevation.

2. Portacabin northeast elevation.

3. Portacabin southeast elevation.

4 Portacabin southeast elevation.

5. Portacabin northwest elevation.

6. Portacabin southwest elevation.

7. Portacabin northeast elevation.

8. Portacabin northwest elevation.

9. Portacabin southwest elevation.

10. Portacabin northwest elevation.

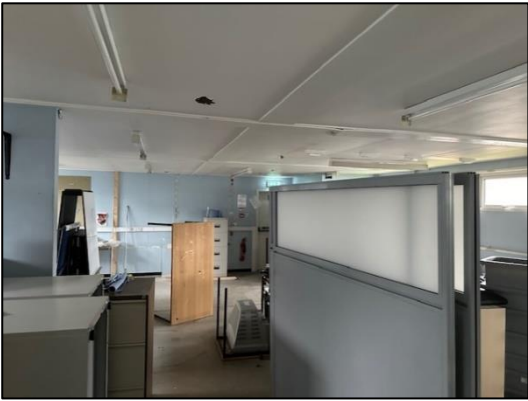
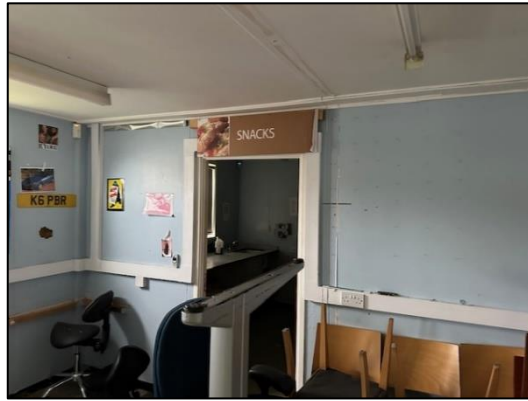
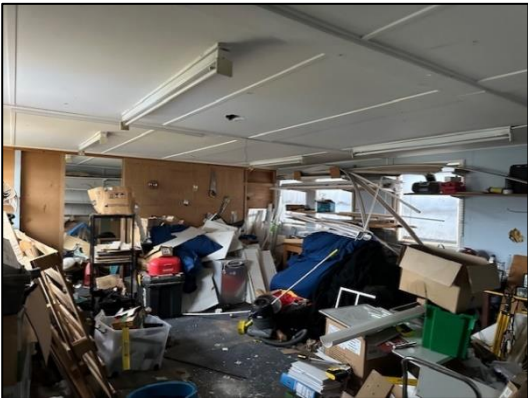
11. Portacabin building internal.

12. Portacabin building internal.

13. Portacabin building internal.
