Newcastle University  
**Newcastle LTC**  
Ground Risk Report

LTC-ARP-SI-XX-RP-GEO-0001

P1 | 5 August 2016

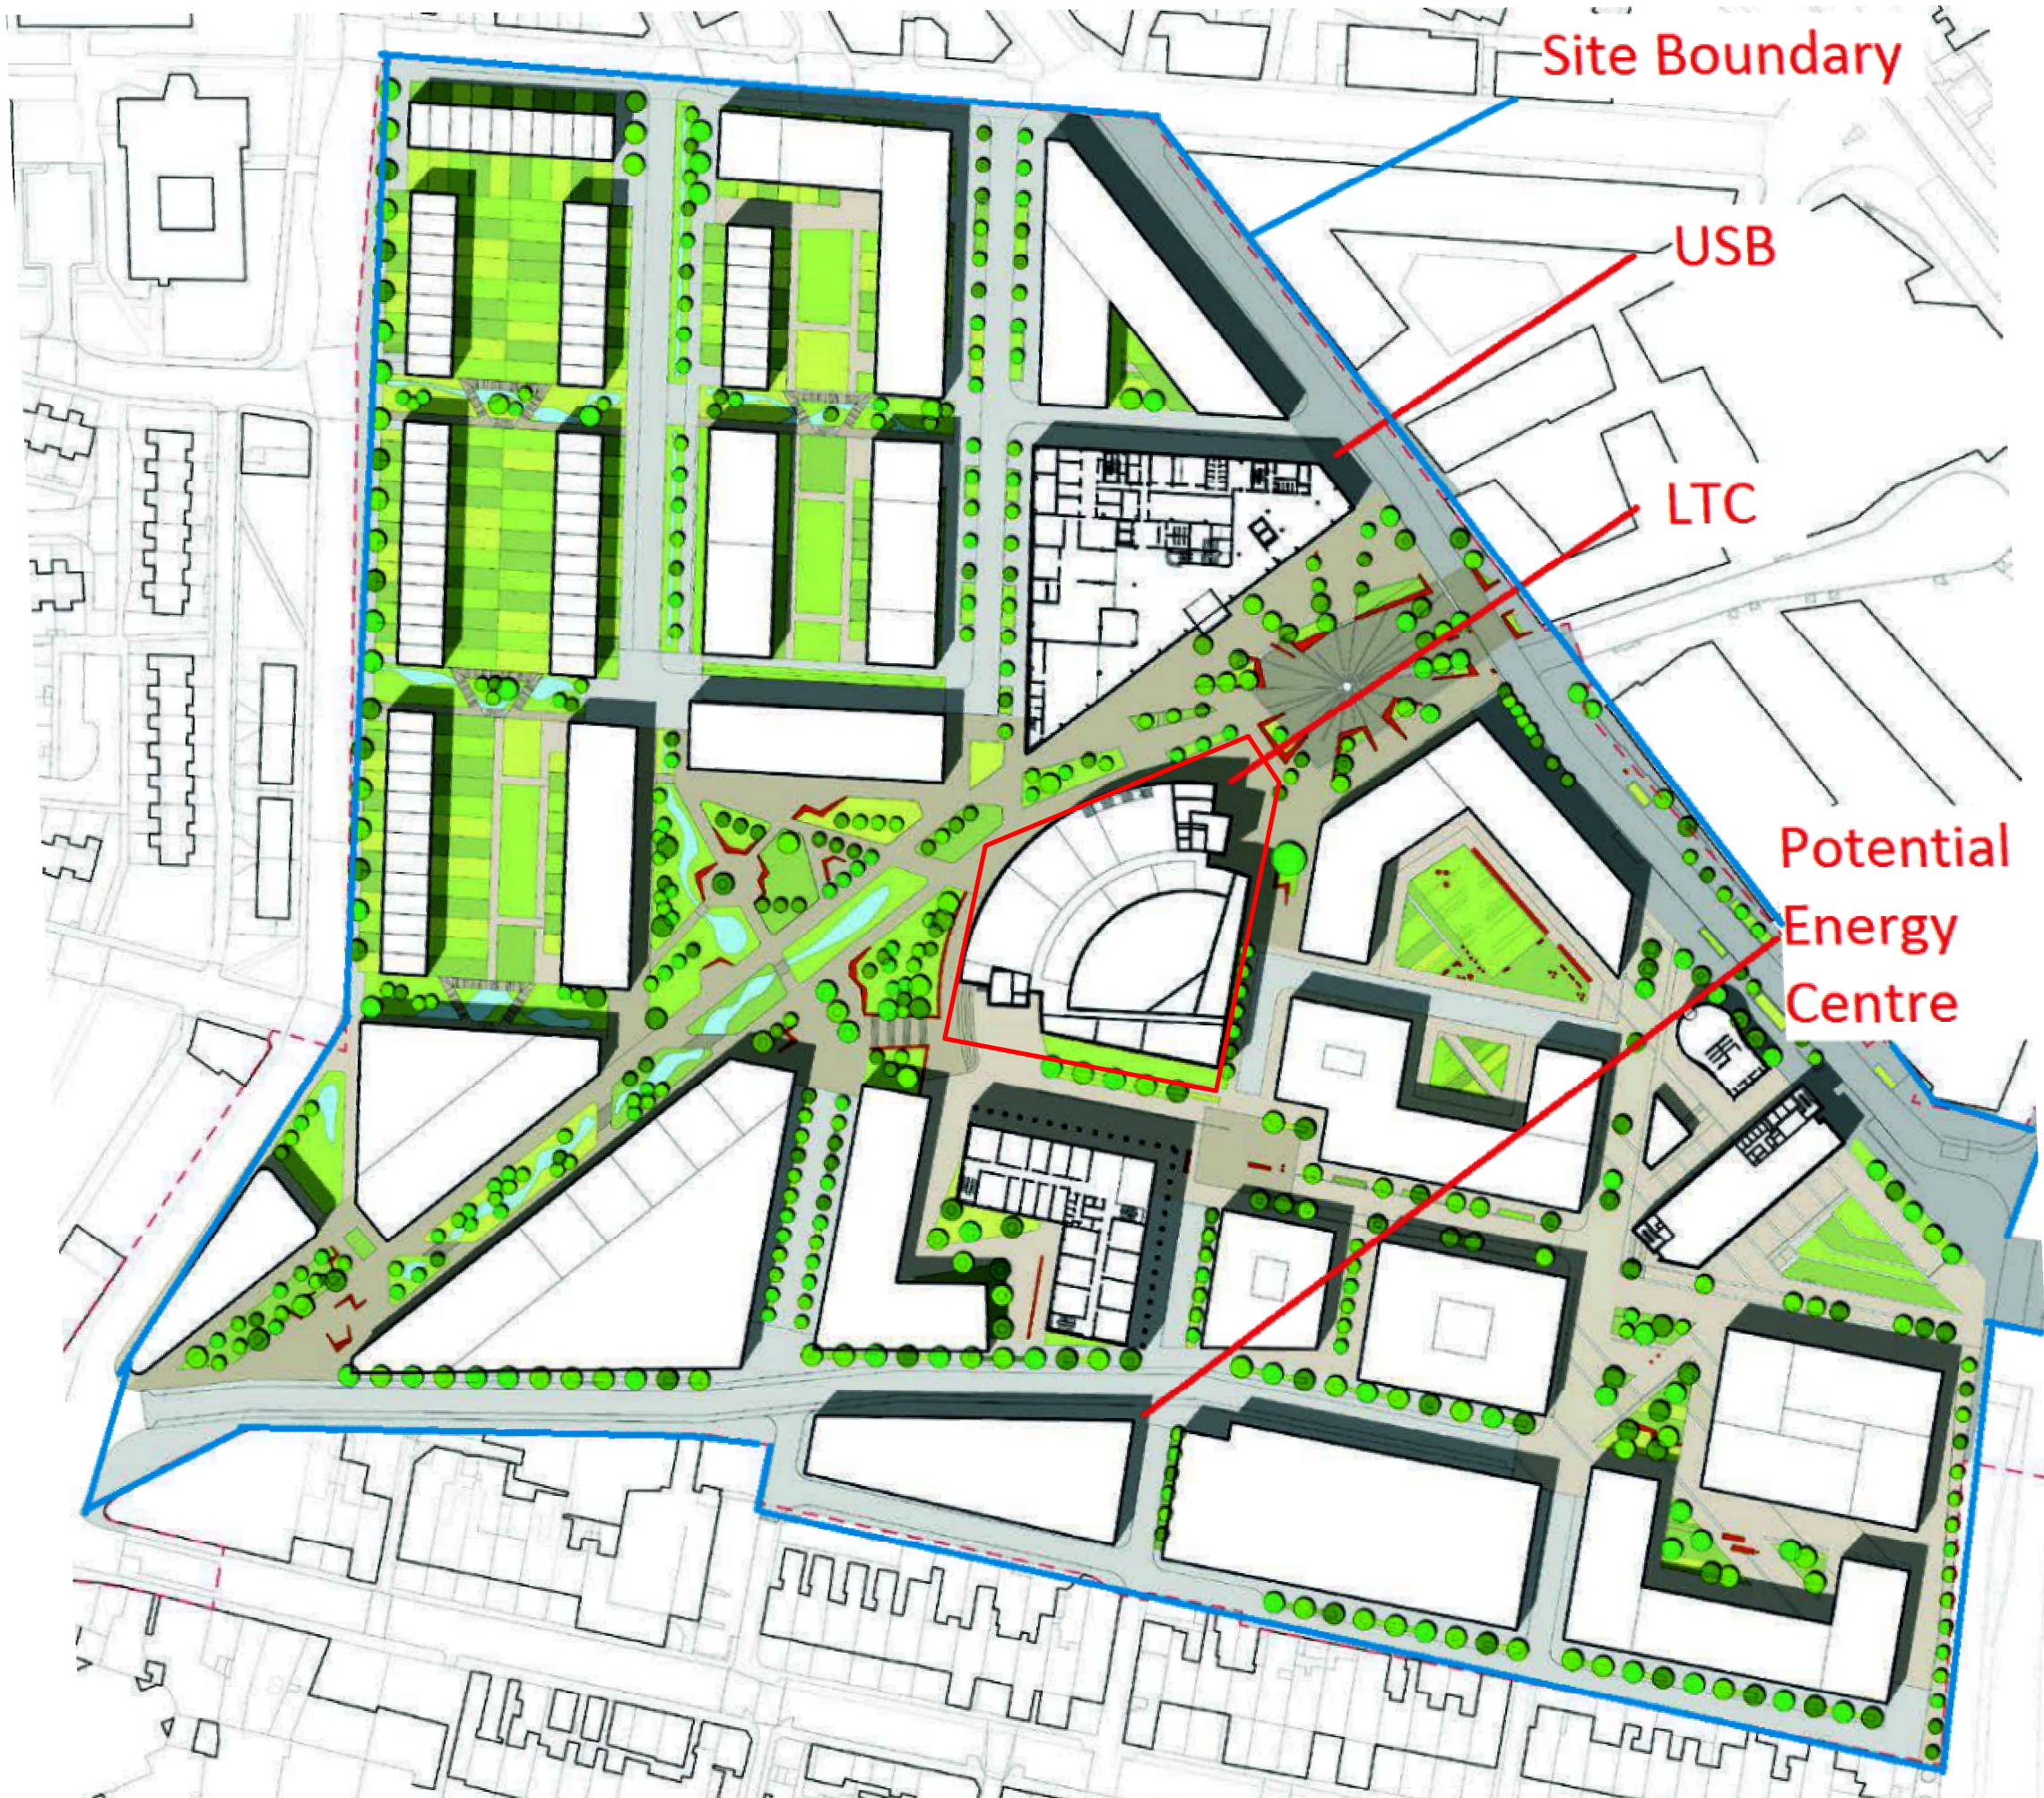
FIGURE 2

- Learning and Teaching Centre
- Science Central Site

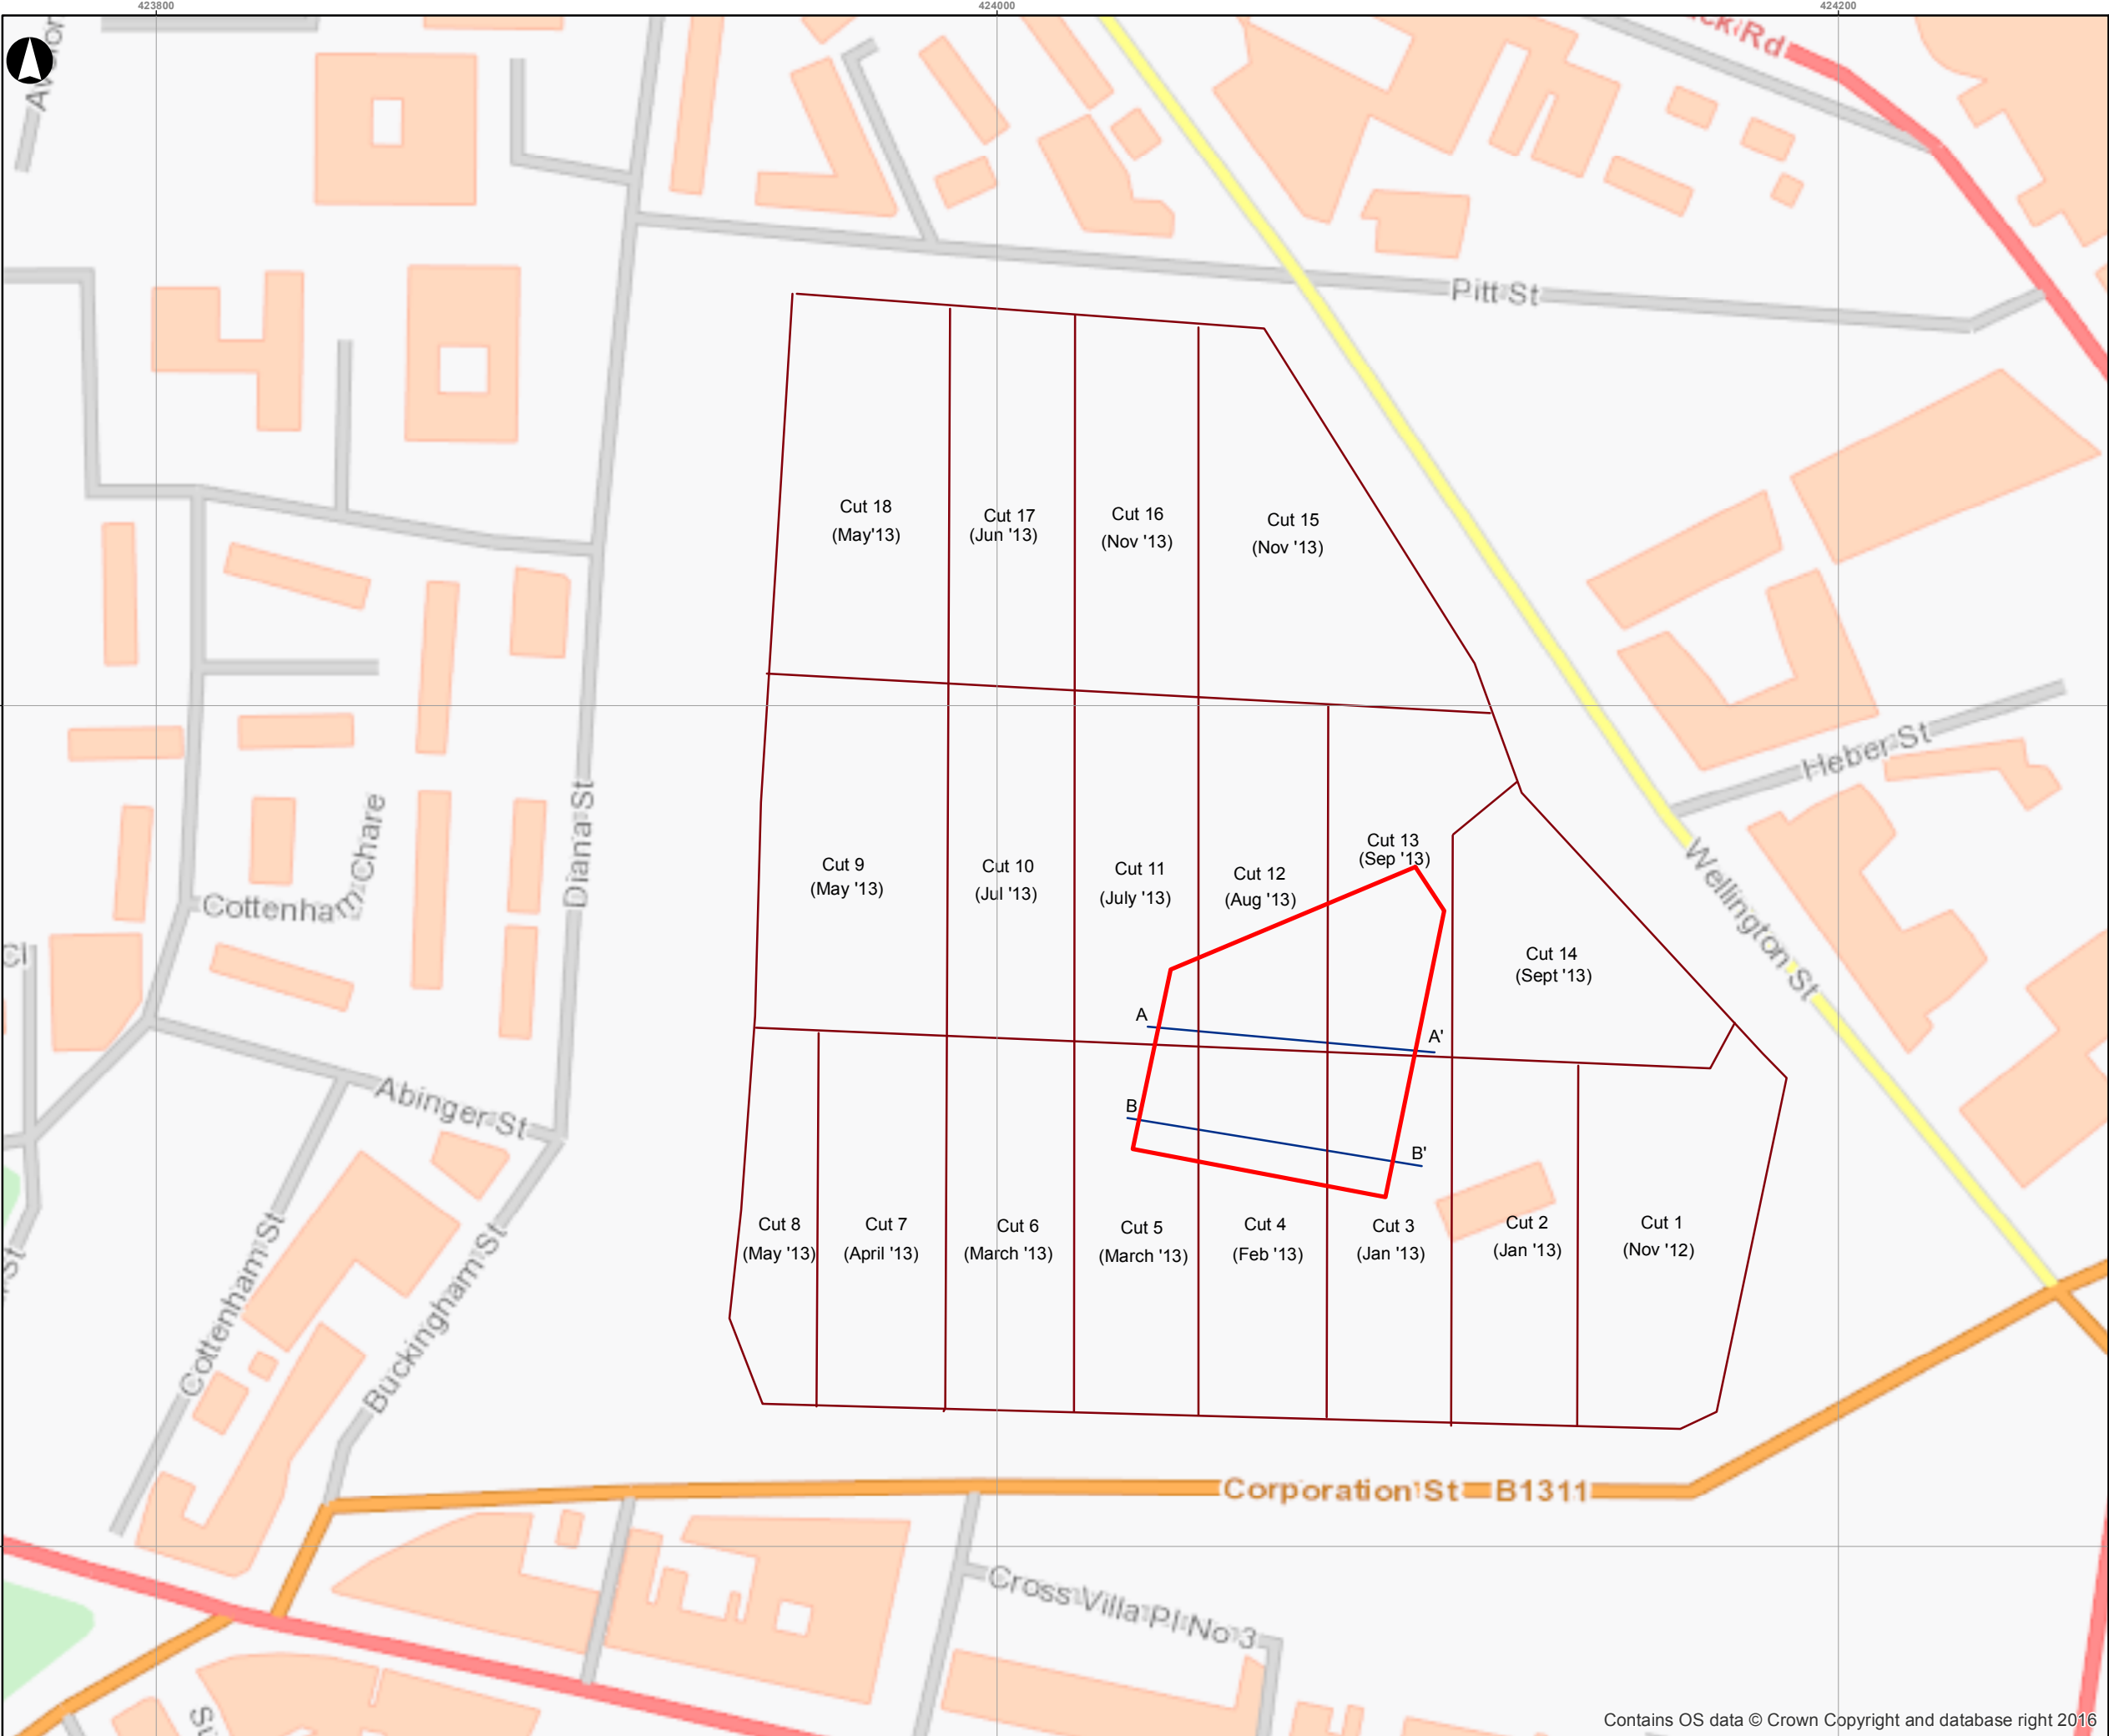
FIGURE 4

- Learning and Teaching Centre
- Excavation Boundaries
- Cross Sections
- (July '13) Date base of excavation validated

Locally higher pre-reclamation groundwater levels in the deeper aquifer are noted within instruments located to the west and southwest of the Science Central site. Lower groundwater levels were generally noted along the east, on holes located close to Wellington Street.

Recorded groundwater levels in the shallower deposits ranged from 55mOD to 75mOD around the perimeter of the excavation, and between 54mOD and 70mOD in the bedrock. Generally higher groundwater levels were recorded to the southwest of the Science Central site decreasing eastwards. Groundwater levels were reported to be generally stable with no significant variation within instruments recorded during monitoring. Some short term variation was noted in some instruments considered to be due to dewatering of the opencast excavation.

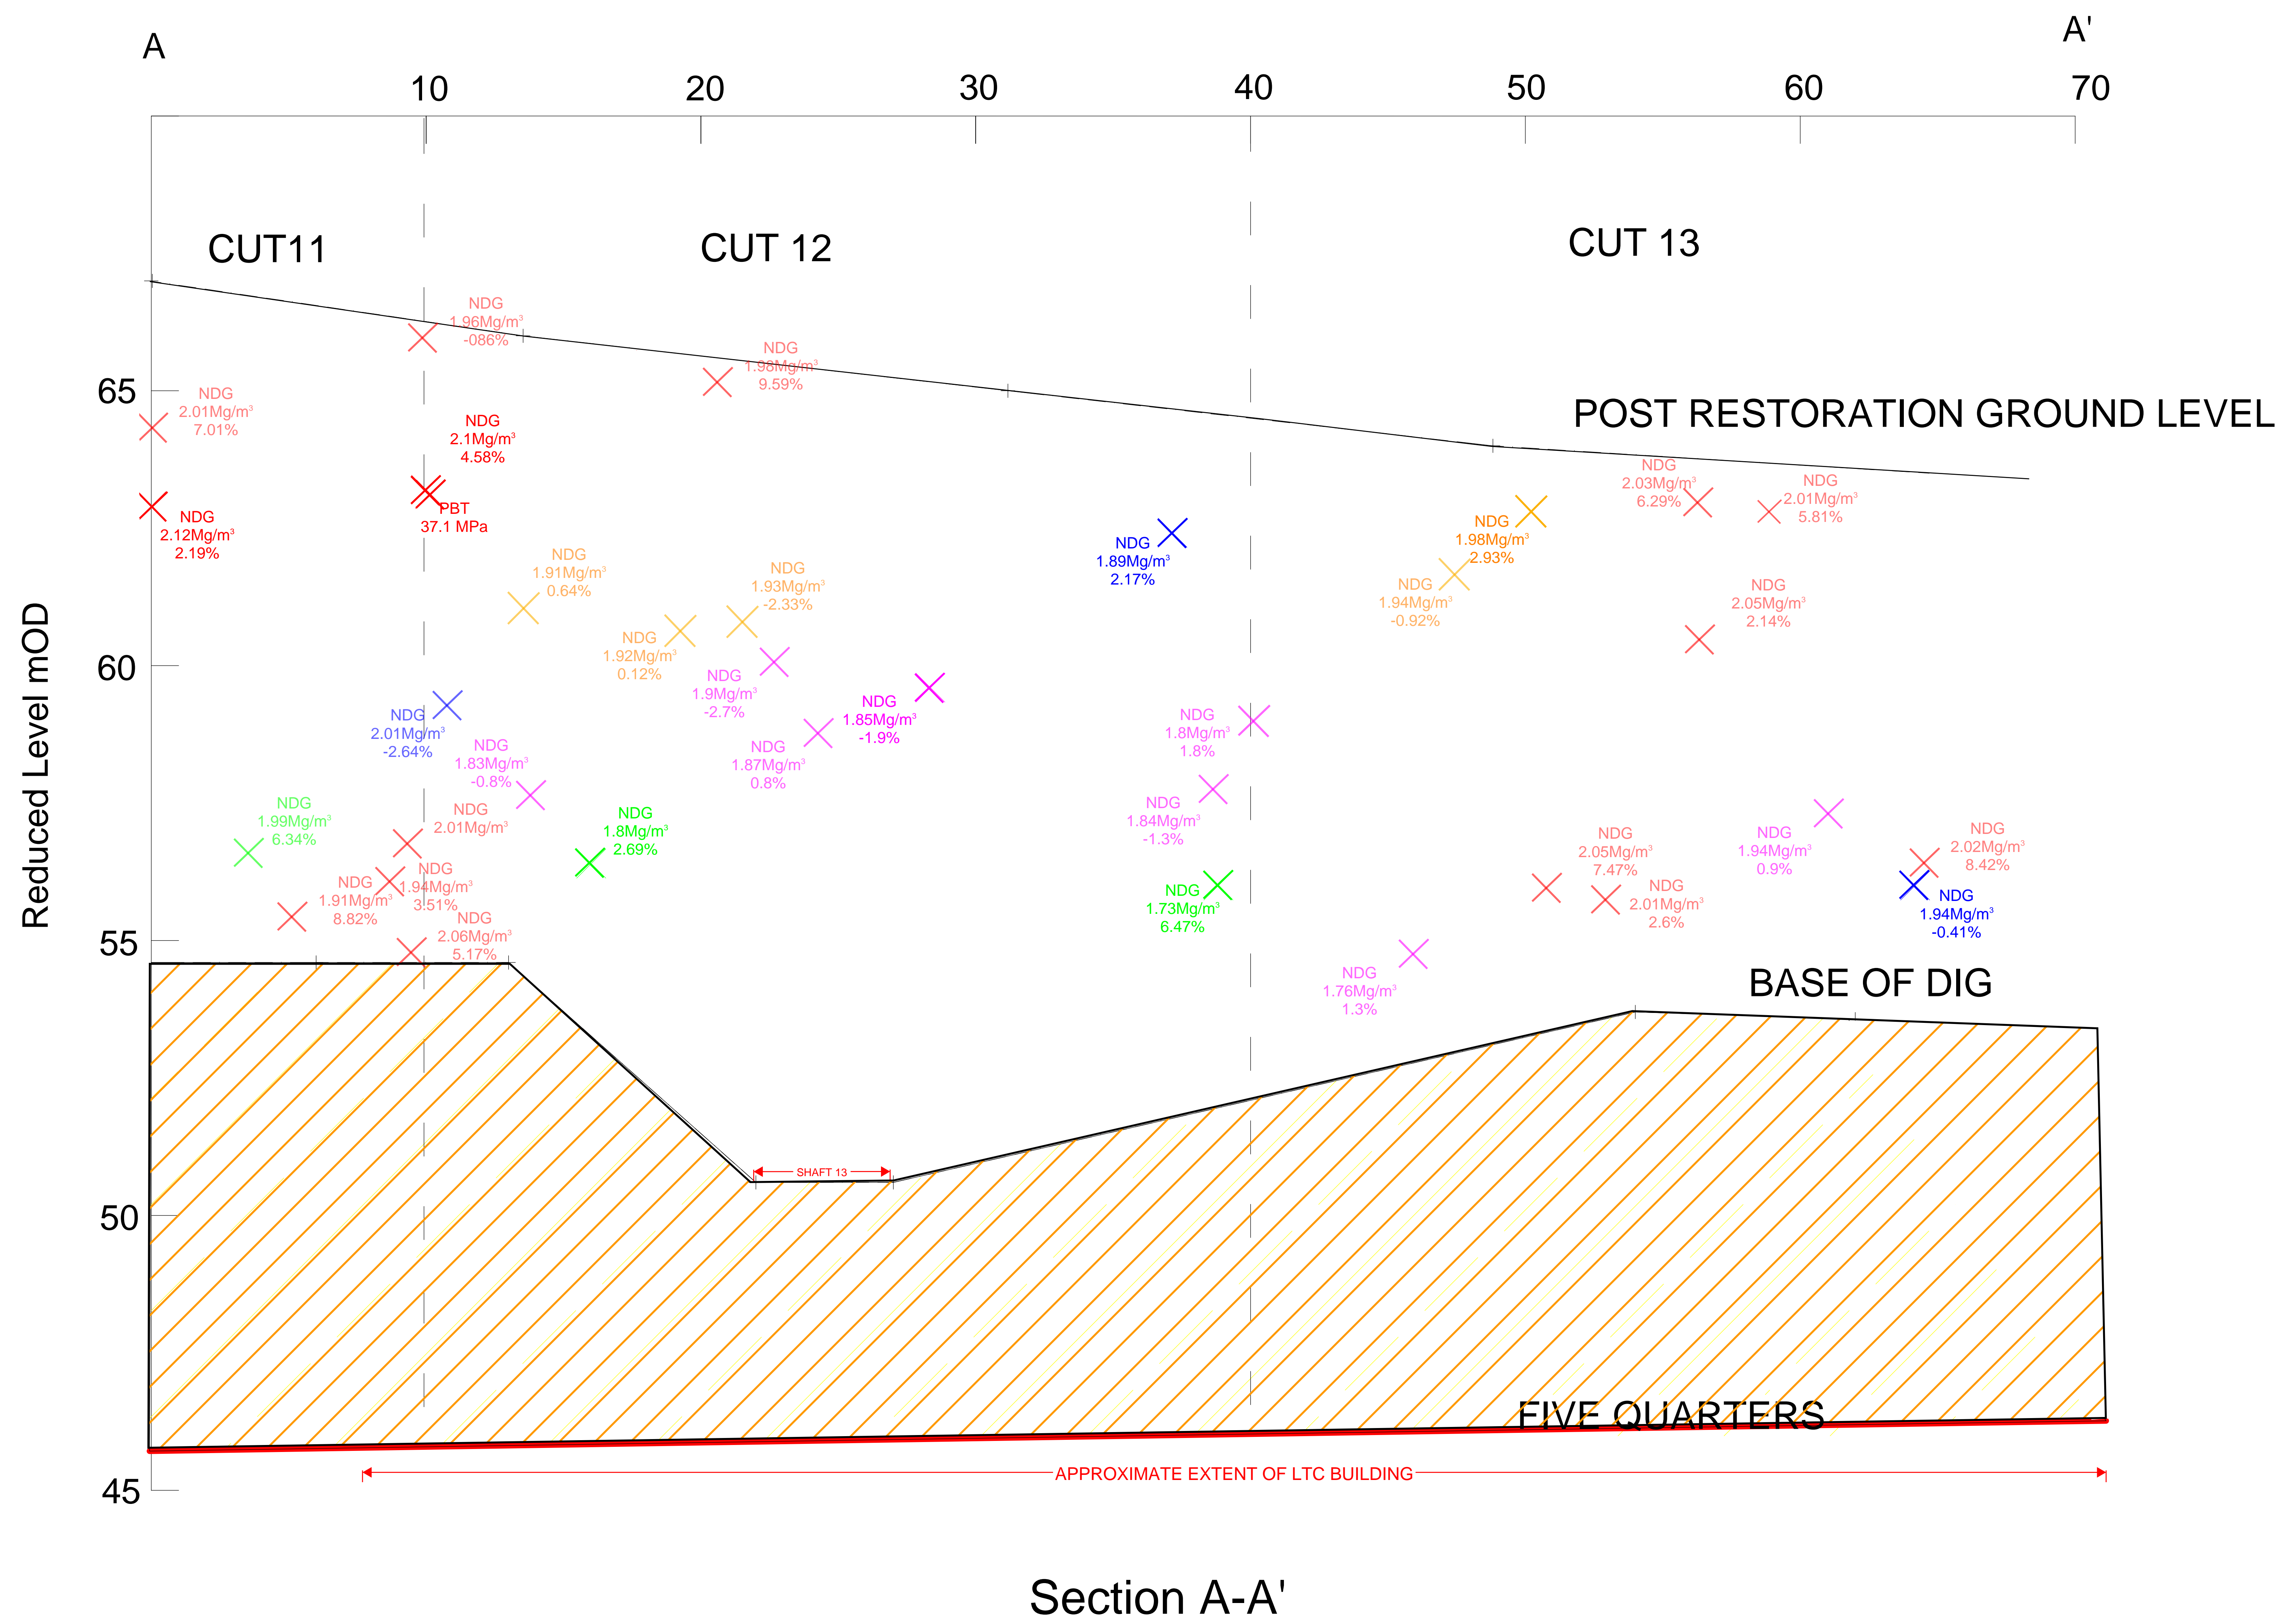
PBT (Plate Bearing tests)  
Stiffness MPa

Figures 6 and 7 summarise the findings of a review of reclamation test results available on and within the vicinity of the LTC site, and highlight areas of limited testing. Results from Nuclear Density Gauge tests carried out within the LTC site suggest densities to range from 91.65% to 110.44% of calculated maximum dry density. Void ratios are shown to range from negative values to 14.54% with an average of 1.5%. The greatest variation in void ratio was observed within the Fine Grained Rock, in which the average void ratio was found to be 5.91%, highlighting the variability in the compaction of these materials. A limited number

of Sand Replacement tests were conducted on the site and reflect results consistent with the Nuclear Density Gauge tests. In addition, a limited number of Plate Bearing Tests were conducted, all tests exceeded the target stiffness.
