## TECHNICAL NOTE

| SUBJECT | Poole Park Sluice Bridge Abutment Assessment | | |

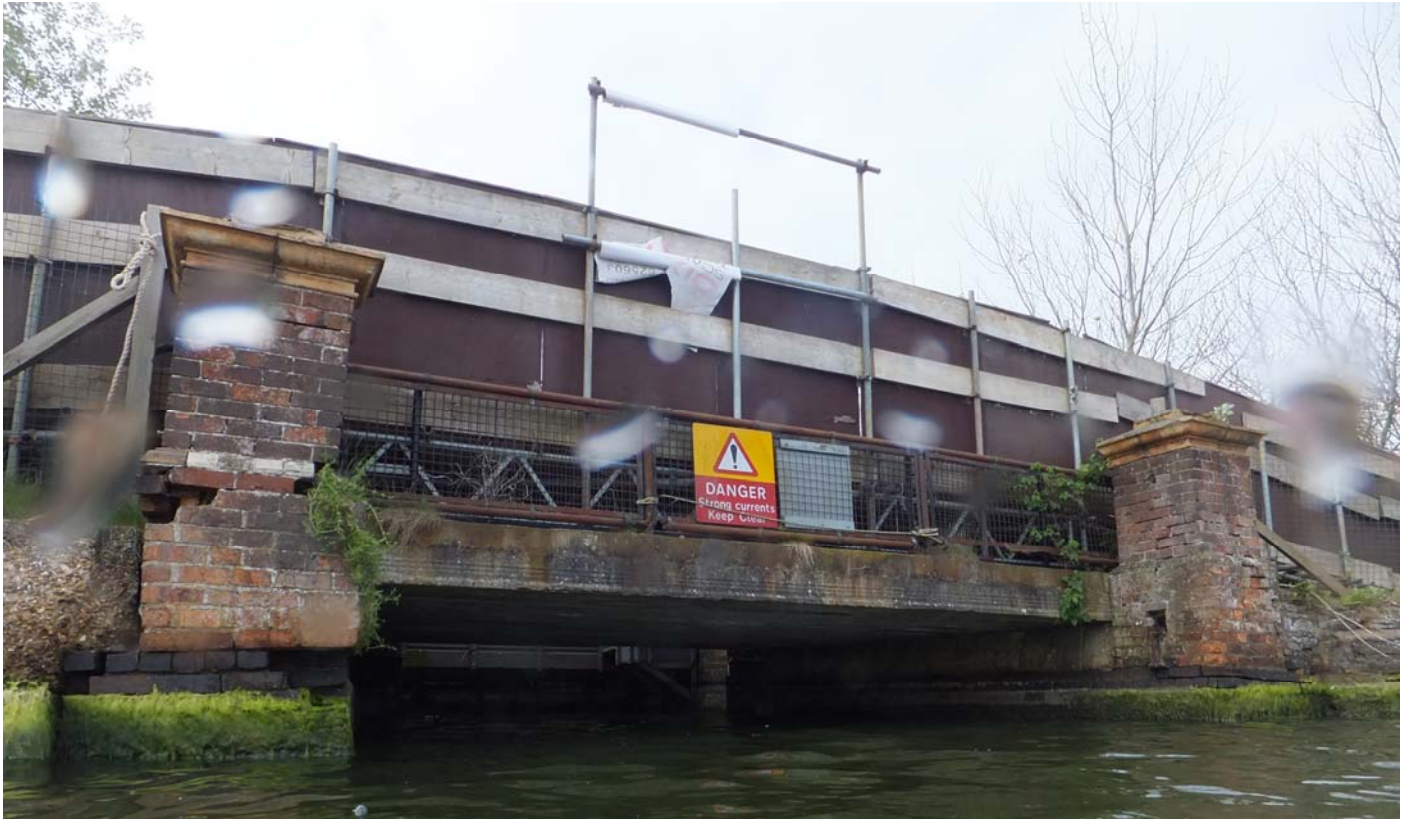
The stubs of the 'I' section beams from the previous deck are expansively corroding leading to the instability that can be seen in the left hand, eastern pilaster. The brick pilasters at each end of the bridge are listed and will be taken down, conserved and reconstructed.

It is therefore proposed to remove the scaffold footbridge, demolish the existing concrete bridge deck, and replace it with a Fibre Reinforced Plastic (FRP) deck, along with associated finishing works. The method for removing the existing structures and installing the new deck will be covered separately. This document will consider the sufficiency of the existing brick abutments for re-use.

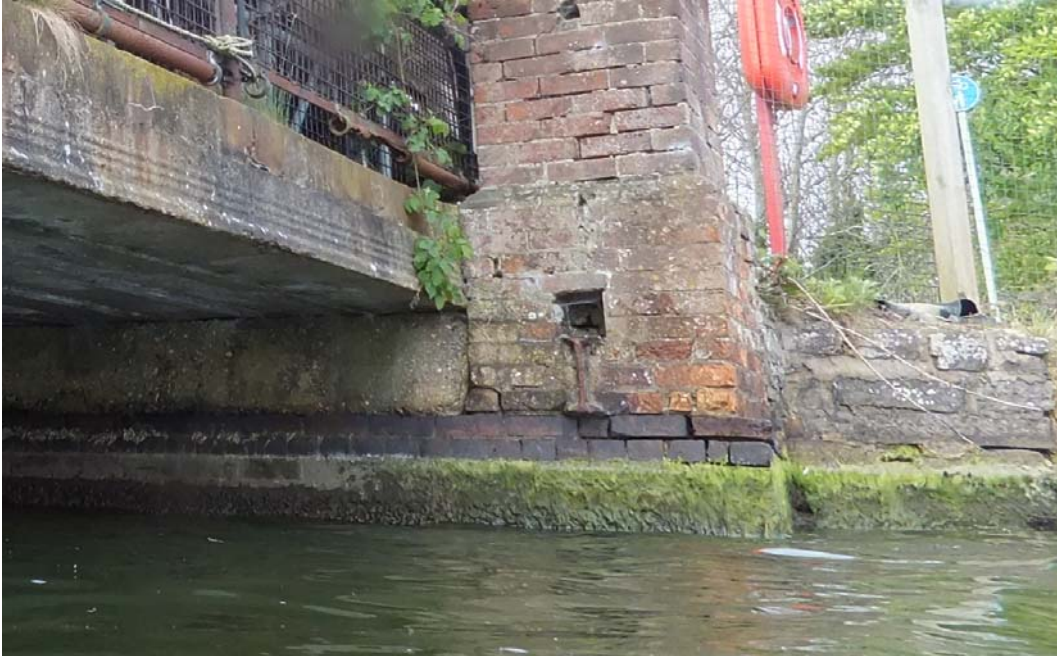
In this image the original blue engineering brick abutment can be seen below the concrete bearing beam and the “I” section beam from the previous deck indicating the previous soffit level of the structure.

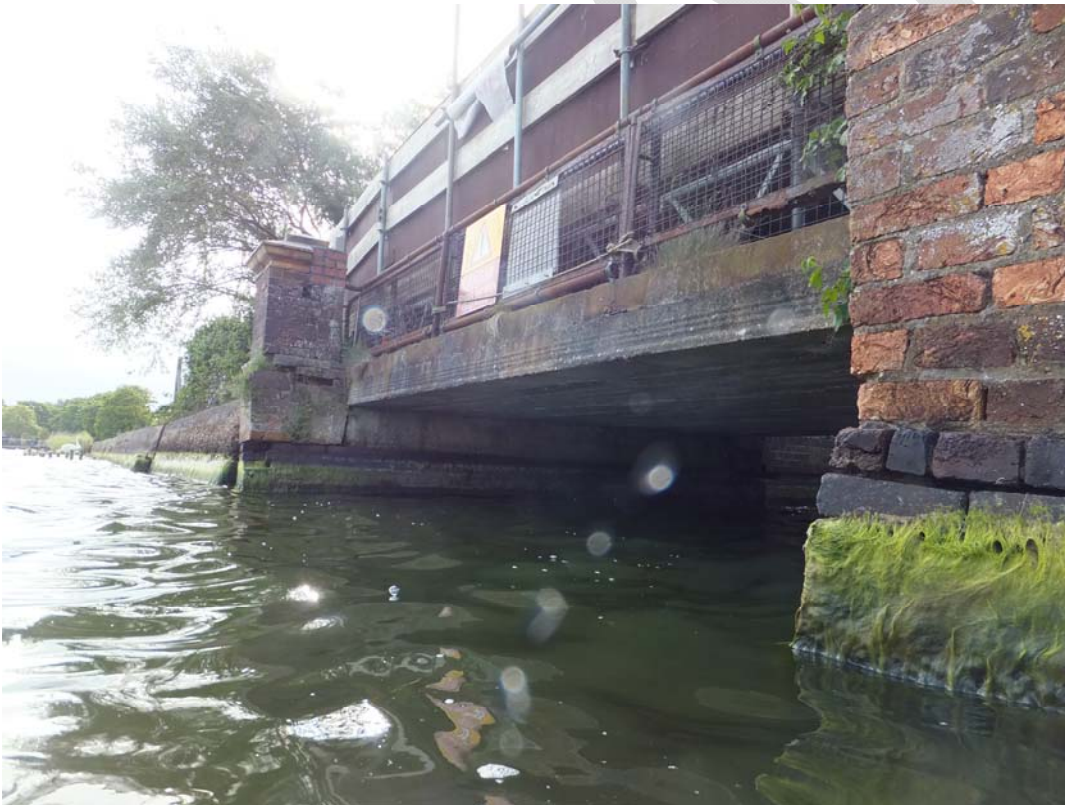
In this image, a view of the localised mortar loss under the east pilasterdeck elevation, east abutment, and scaffold bridge above

As can be seen above, other than the mortar loss below the pilasters, which will be repaired during the works, the abutments are in excellent condition. Diving inspections have also been undertaken confirm that there is no cracking, tilting, bulging or other deformation of the abutments that would indicate that they are not suitable to carry the loads to which they have been and are subjected to.

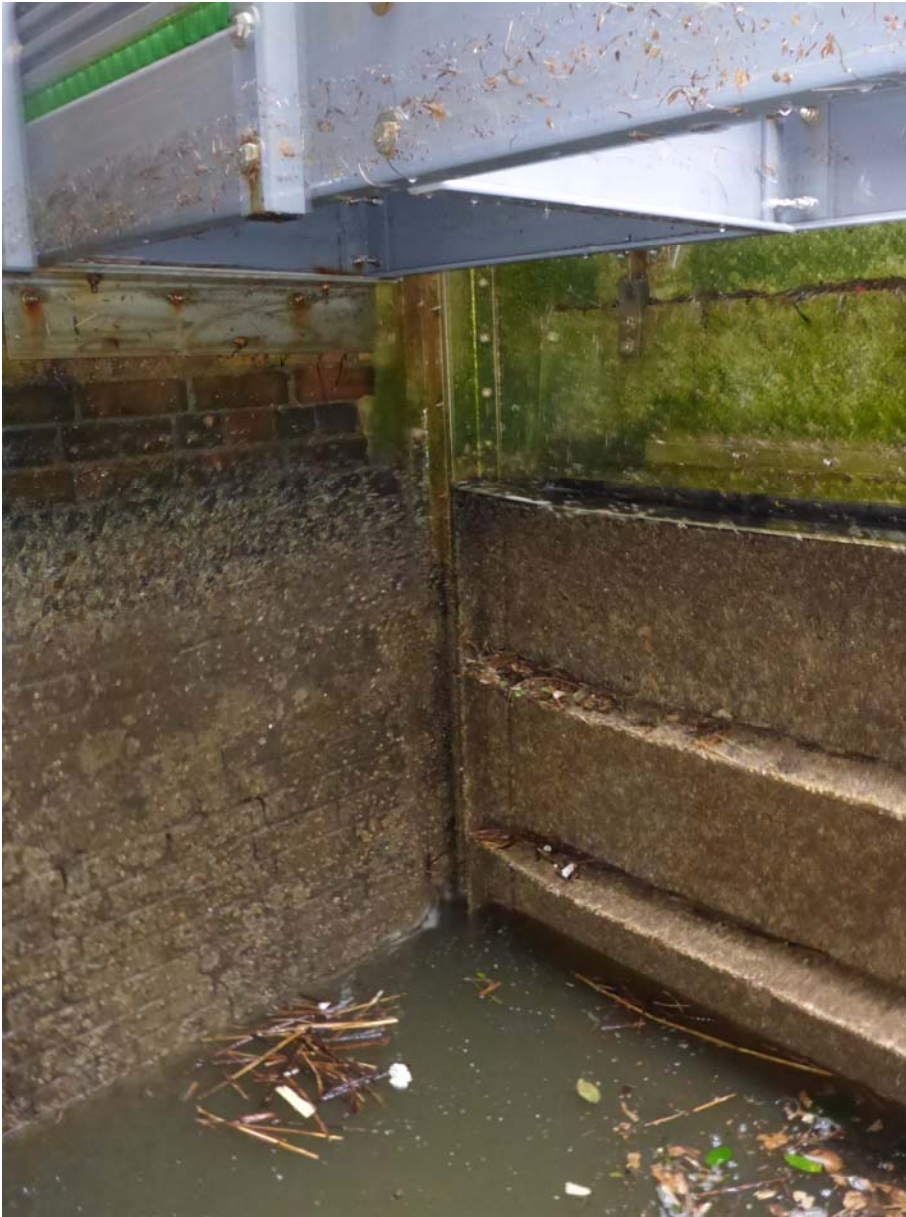
In this image the straight even coursing and filled mortar joints of the engineering brick abutment can be seen
