JOB: NEW ISLINGTON MILL No. 294

**0.551\_Rev** *FIRST ISSUE: 24.01.19*

PHOTO APPENDIX\_01

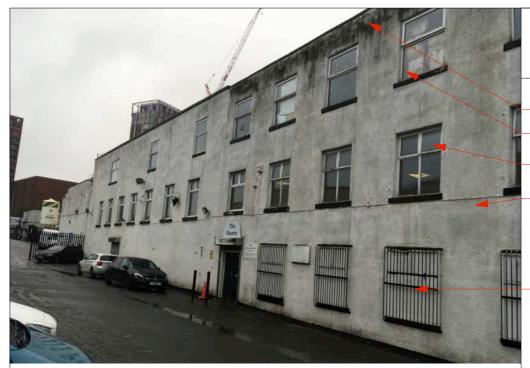
Damage to render likely caused by lack of rainwater pipe above or insufficient - coping overhang

Existing UVPC double glazed windows

Existing single glazed timber windows – with top hung openers.

Existing cementitious render with white painted finish

Existing blocked up openings

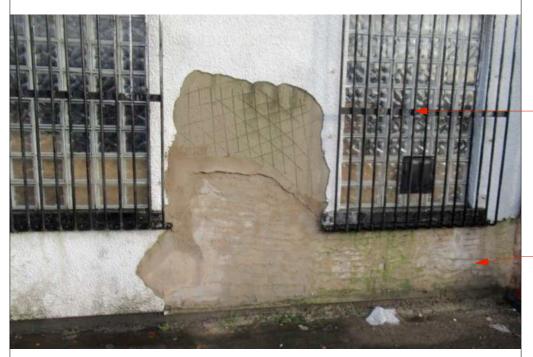
EX.02

- Existing blocked up openings

Existing cementitious render

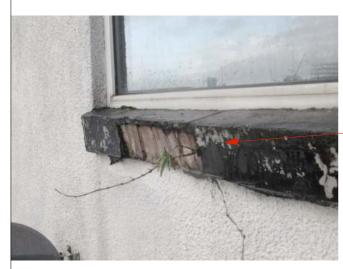
EX.03

- Existing window cill

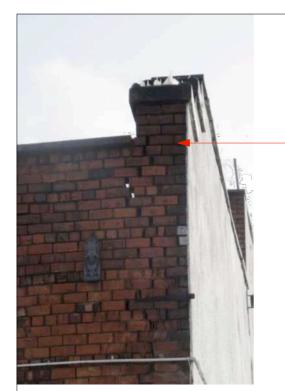
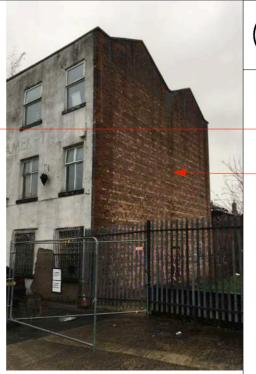
Existing parapet to corner building in need of structural repairs

Existing eastern gable

Existing water tower of Wilmington Mill behind

- Existing Engine house

Existing corner building

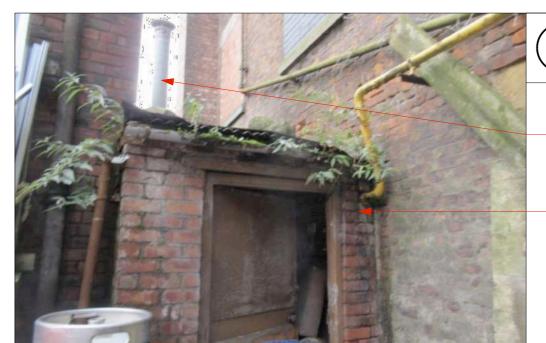
EX.07

- Existing extract to be removed

Existing single storey outrigger to be demolished with all redundant services - removed

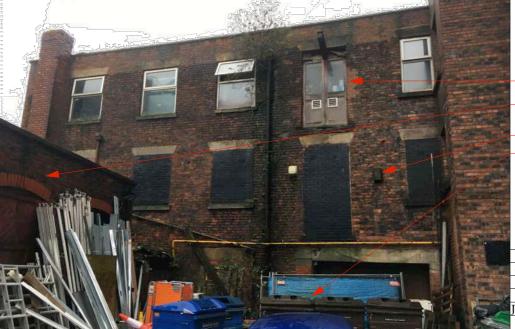
EX.10

Existing timber goods door with lifting beam above.

Existing stables. Refer to ownership plan 0.004

— Typical existing external lighting

Existing refuse arrangements

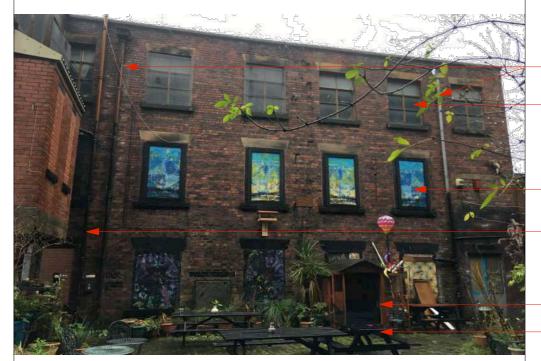
EX.13

Existing failing rain water goods.

- Existing timber single glazed windows

Existing blocked up window openings with temporary artwork infront

Existing soil vent pipe to be removed

Existing timber shed to be removed

Existing shared courtyard

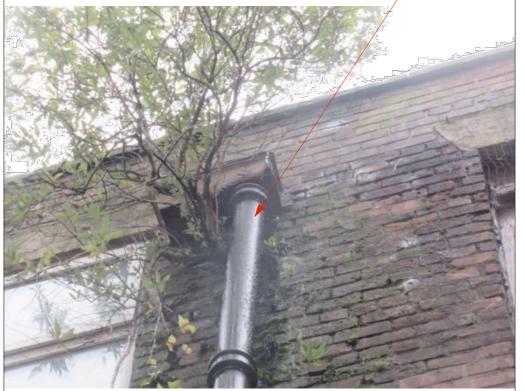
- Typical north elevation failing rain water pipe to be replaced. Existing masonry behind to be repointed where required using matching lime render with mortar beds to match the existing.

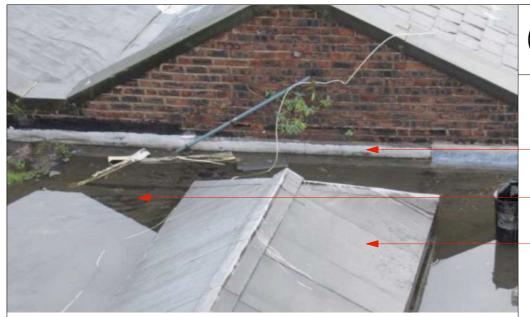
EX.23

Junction between pitched roof and flat roof of New Islington Mill

Current rain water pooling on flat roof — build up

- Roof lantern felted over

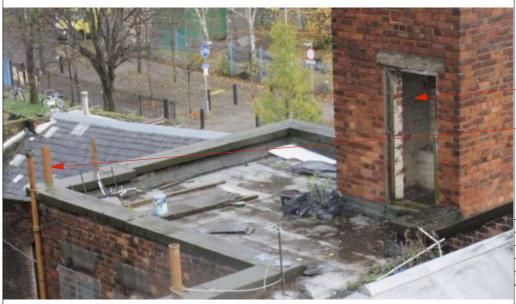
Existing roof access from current lift shaft. No door present.

- Soil vent pipes to be removed

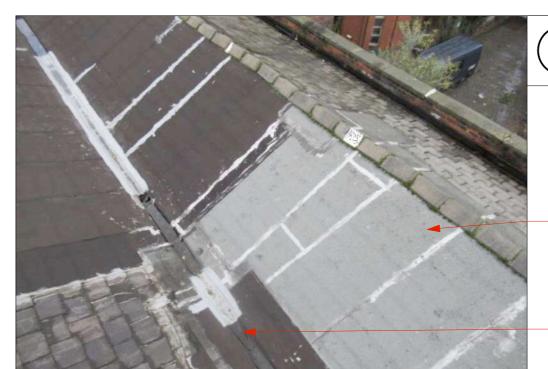
EX.26

Existing pitched roof with numerous repairs over existing roof slates

- Existing valley gutter to roof

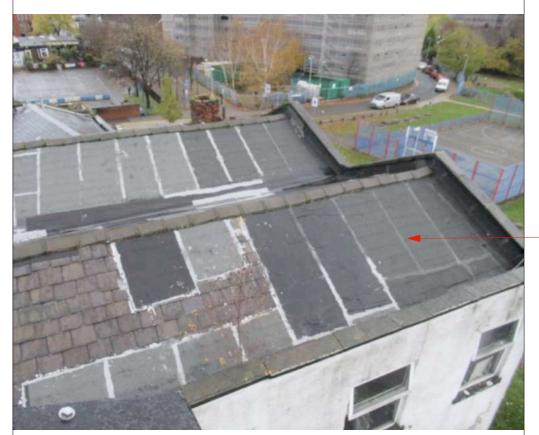
EX.27

- Existing pitched roof from south

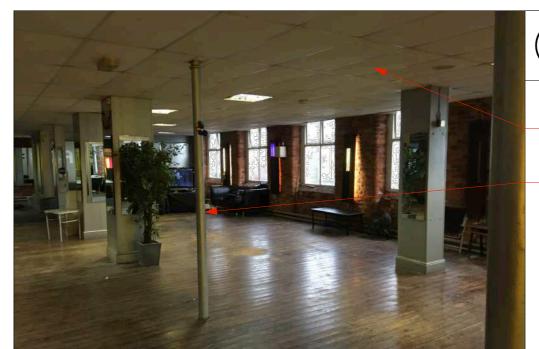
INT.12

- Existing suspended ceiling grid

Existing open plan first floor showing buildings current structural arrangement

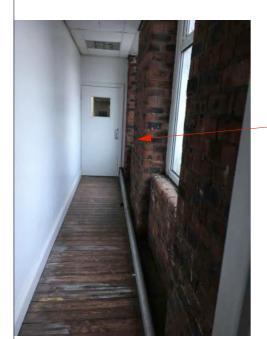
INT.14

Existing masonry wall sandblasted and sealed with existing timber floor boards sanded and treated.

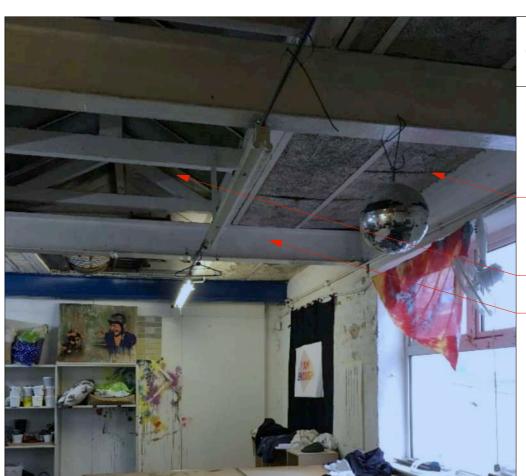
INT.19

Existing wood wool (or similar) acoustic panels to ceiling

Existing timber roof lantern structure above

Existing steel beam roof structure.

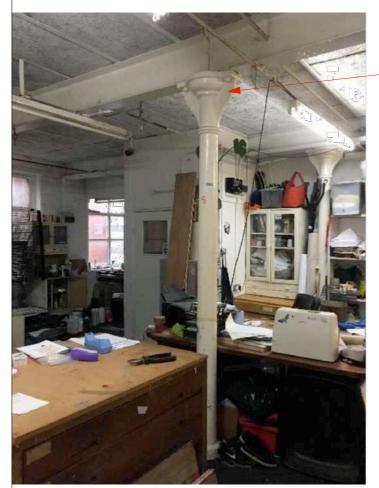
- Existing steel roof structure.
