ISLINGTON MILL - 294

FOR: TENDER	
CHECKED BY: TW	DRAWN BY: MS
SCALE: NTS	
PAPER SIZE: A3	
JOB: ISLINGTON MILL & No. 294	
0.401_Rev	
FIRST ISSUE: 09.04.20	
PHASE 01_PHOTO APPENDIX_01

INTERNAL PHOTOS - DATED. 26.09.2014

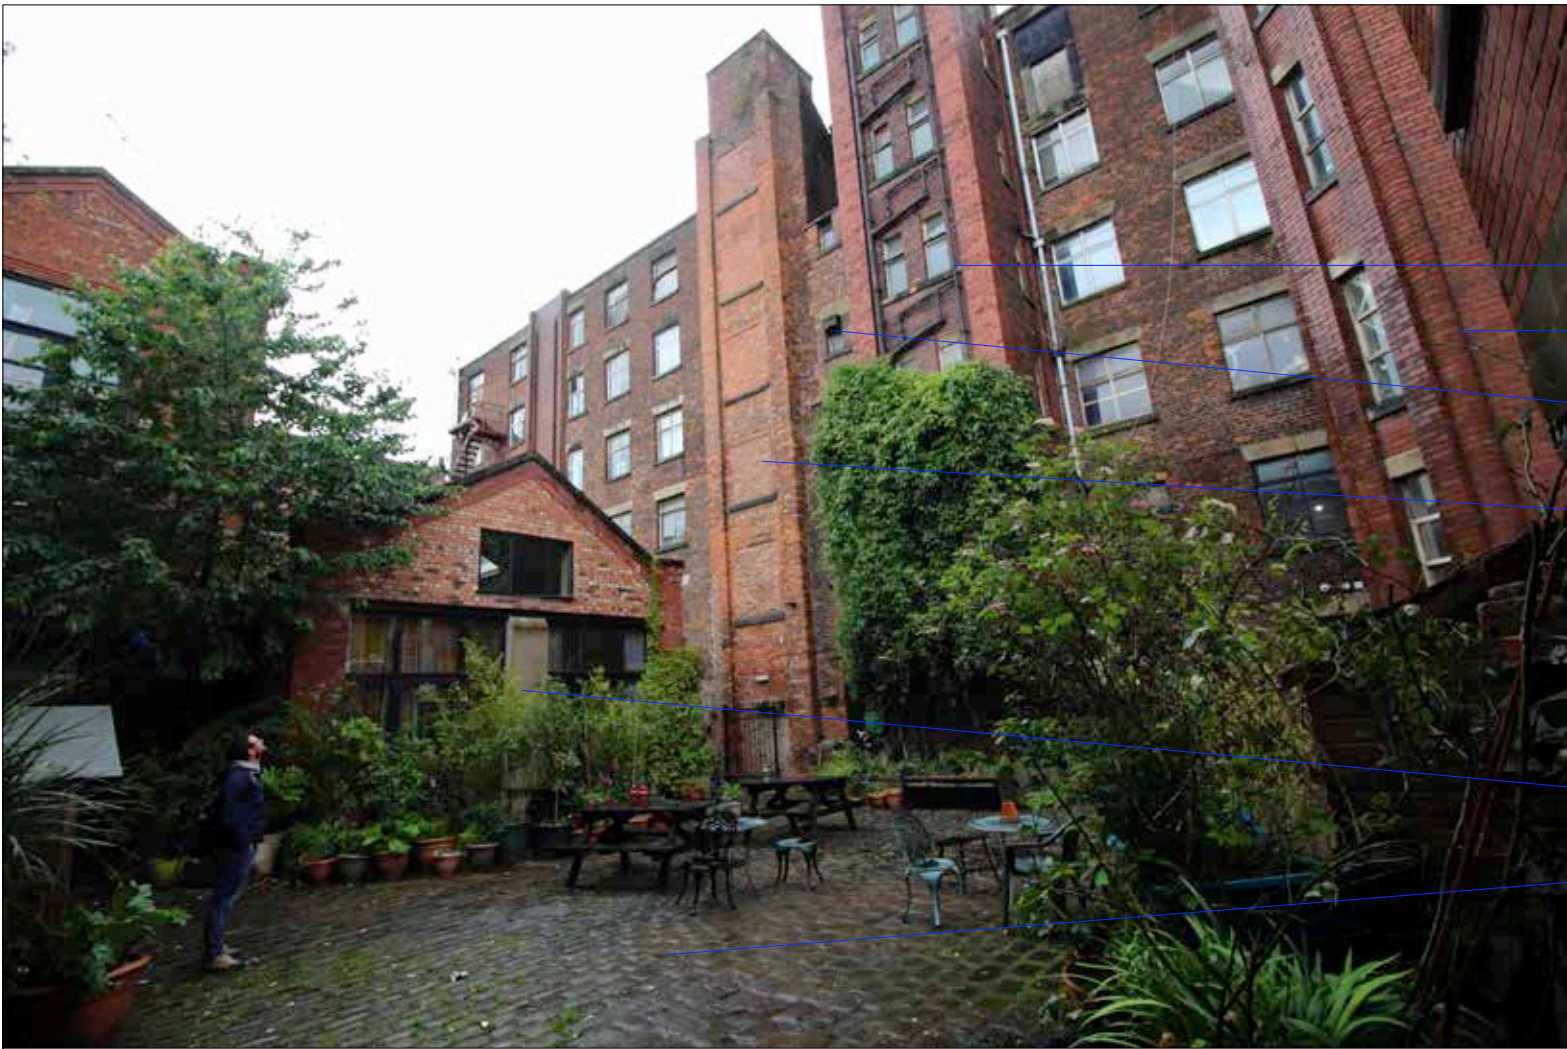
FIG: EX.01

- Existing "privy block"
- Existing stair tower.
- Existing infill between lift shaft and
privy block at certain floors.
- Existing redundant lift shaft. Lift shaft
overrun to be demolished in part, refer to
drawings.
- B&B under Islington Mill
ownership
- South elevation showing communal
courtyard within Islington Mill
(IMAC) ownership. NB: cobbled
surface to courtyard.

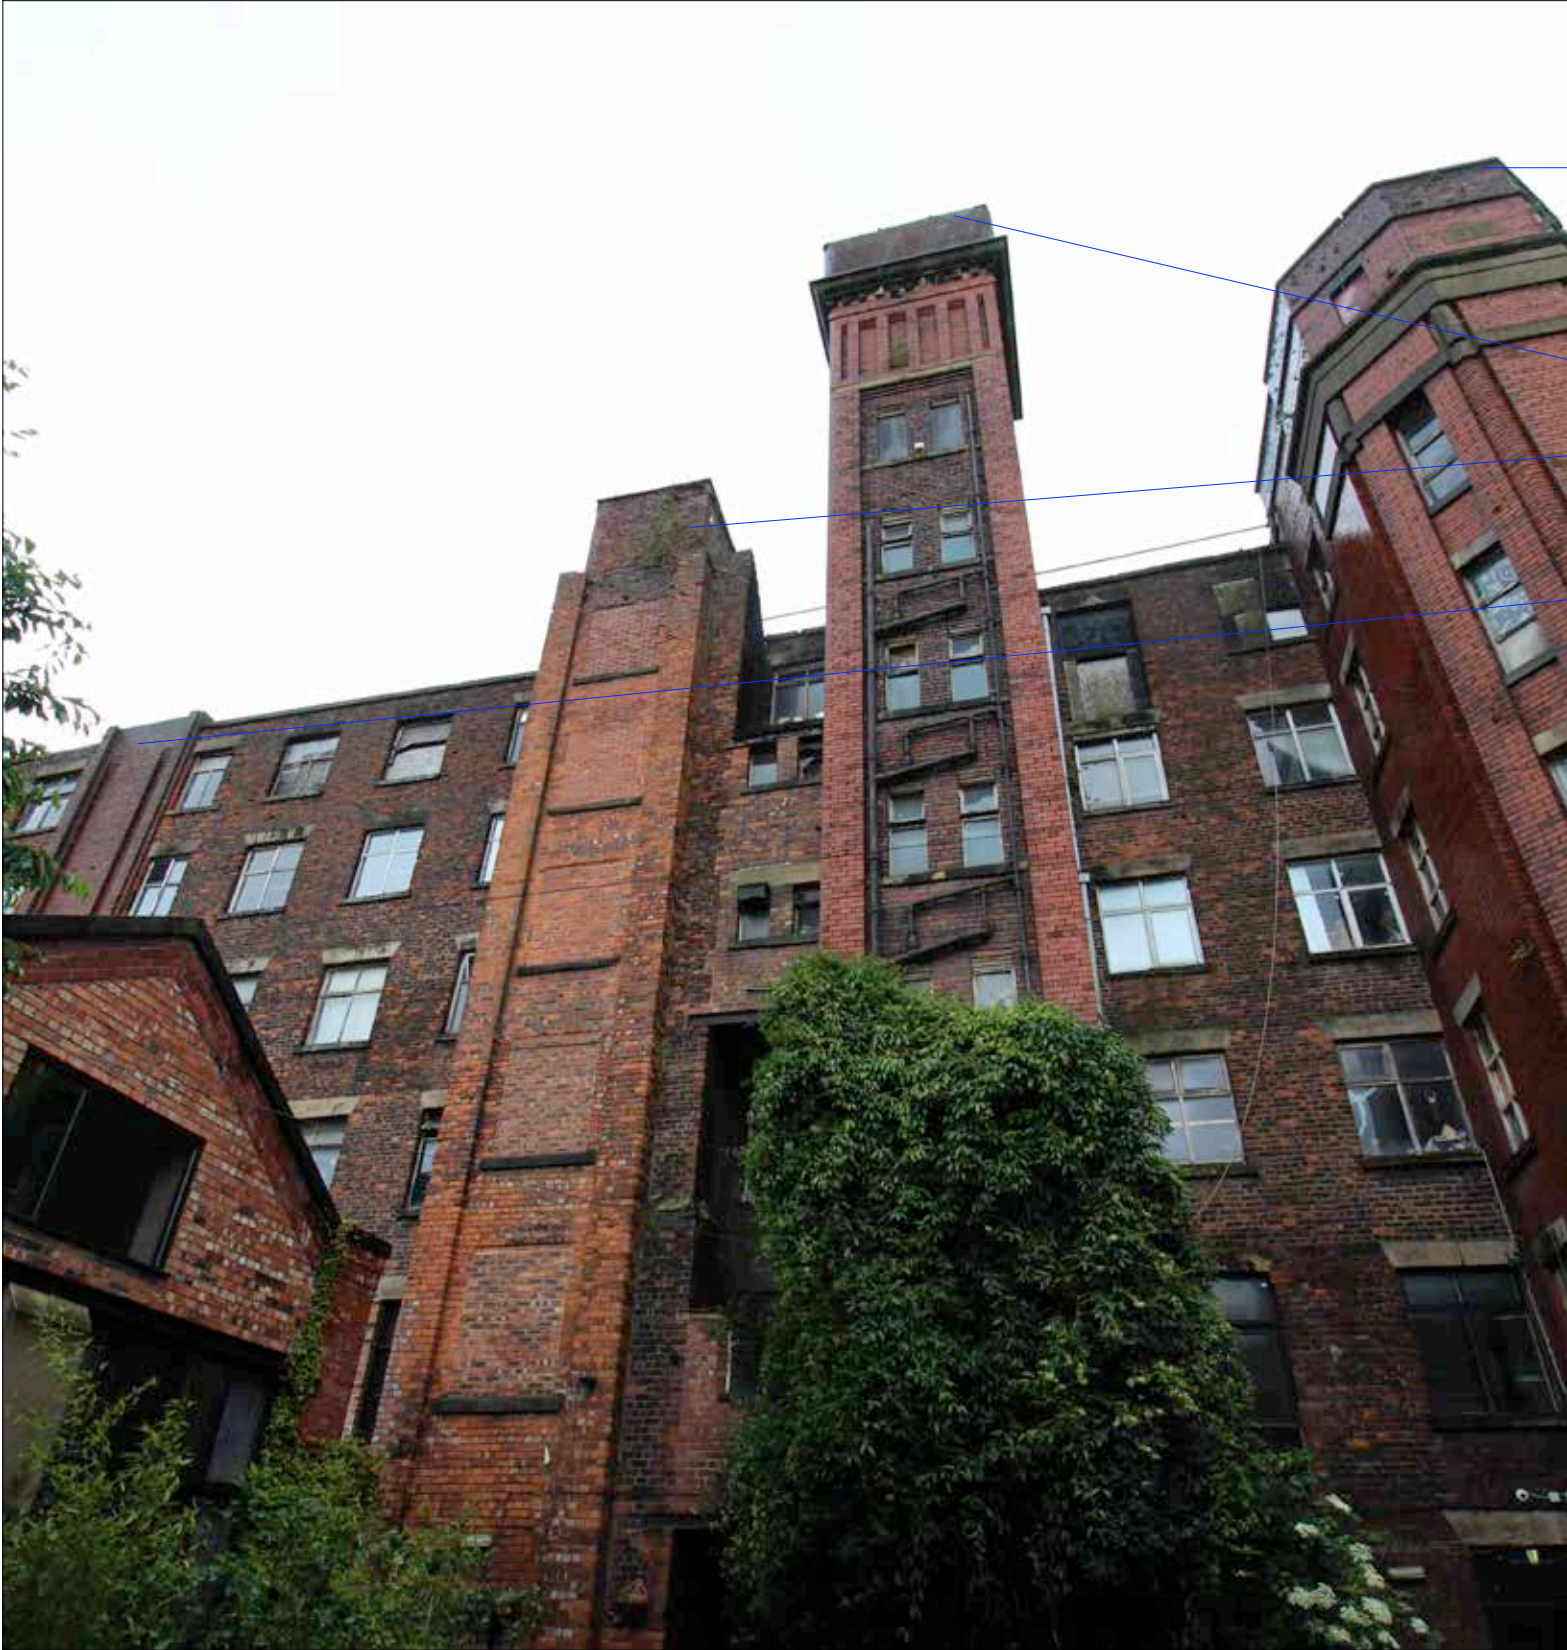
FIG: EX.02

- Stone copings to parapet around
stair tower roof.
- Existing water tank to top of privy
block outside of scope of works.
- Existing redundant lift shaft. Lift
shaft overrun to be demolished in
part, refer to drawings.
- Existing relief brick work from
previous historic stair tower. Roof
gutter kicks in to run around this
feature and is to be replicated in the
proposed.

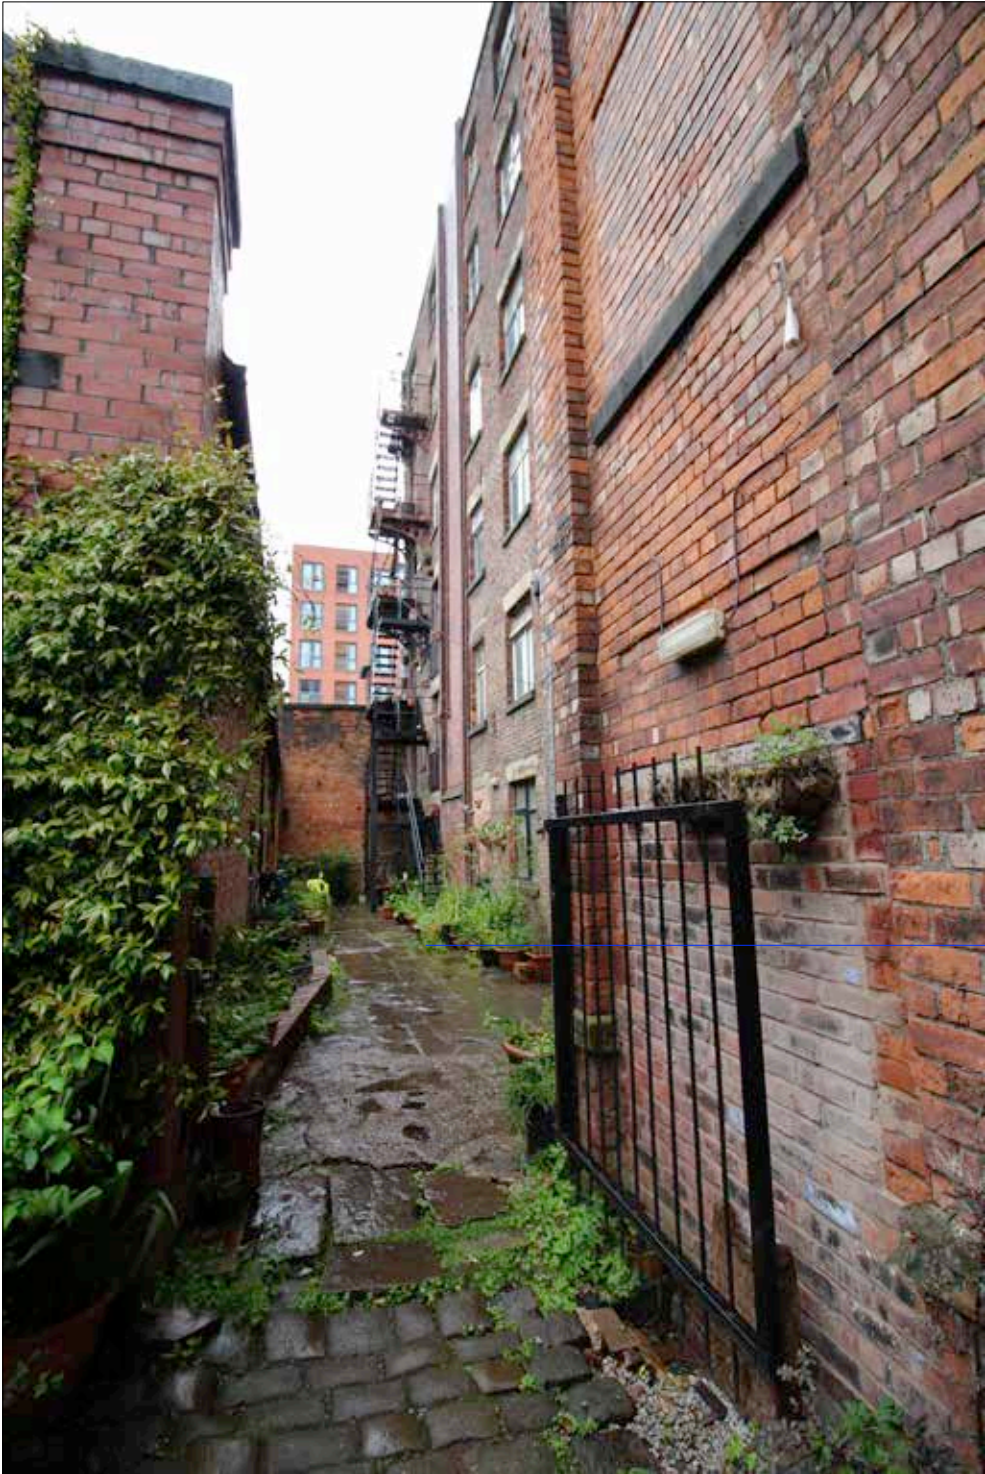
FIG: EX.03

Alleyway /narrowing between
Islington Mill and the B&B

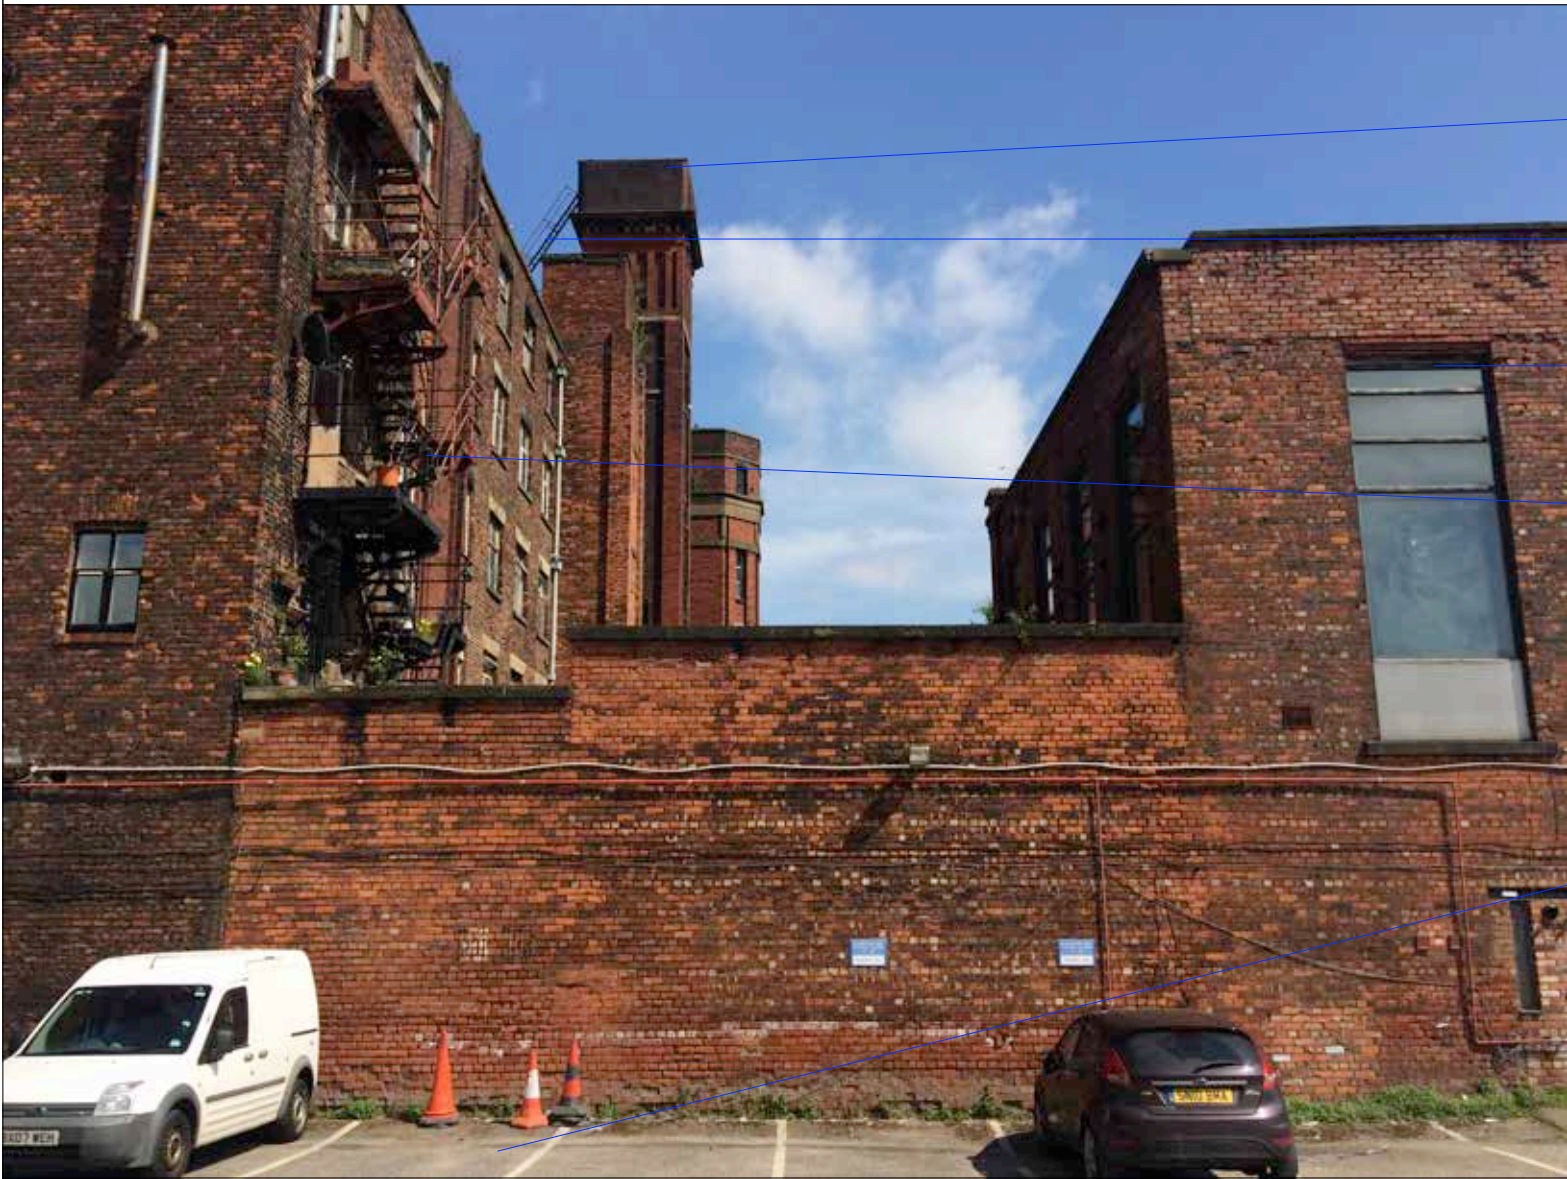
FIG: EX.04

Redundant water tank to top of
privy block outside of scope of
works.

'Engine House' alongside BnB
within Islington Mill (IMAC)
ownership

Existing redundant external stair.
Stair does not provide access due to
being structurally unsafe and is not
to be used for any part of the
construction period.

Car park outside of Islington Mill
ownership.

Metal access stair to water tank to
be removed as part of this tender.

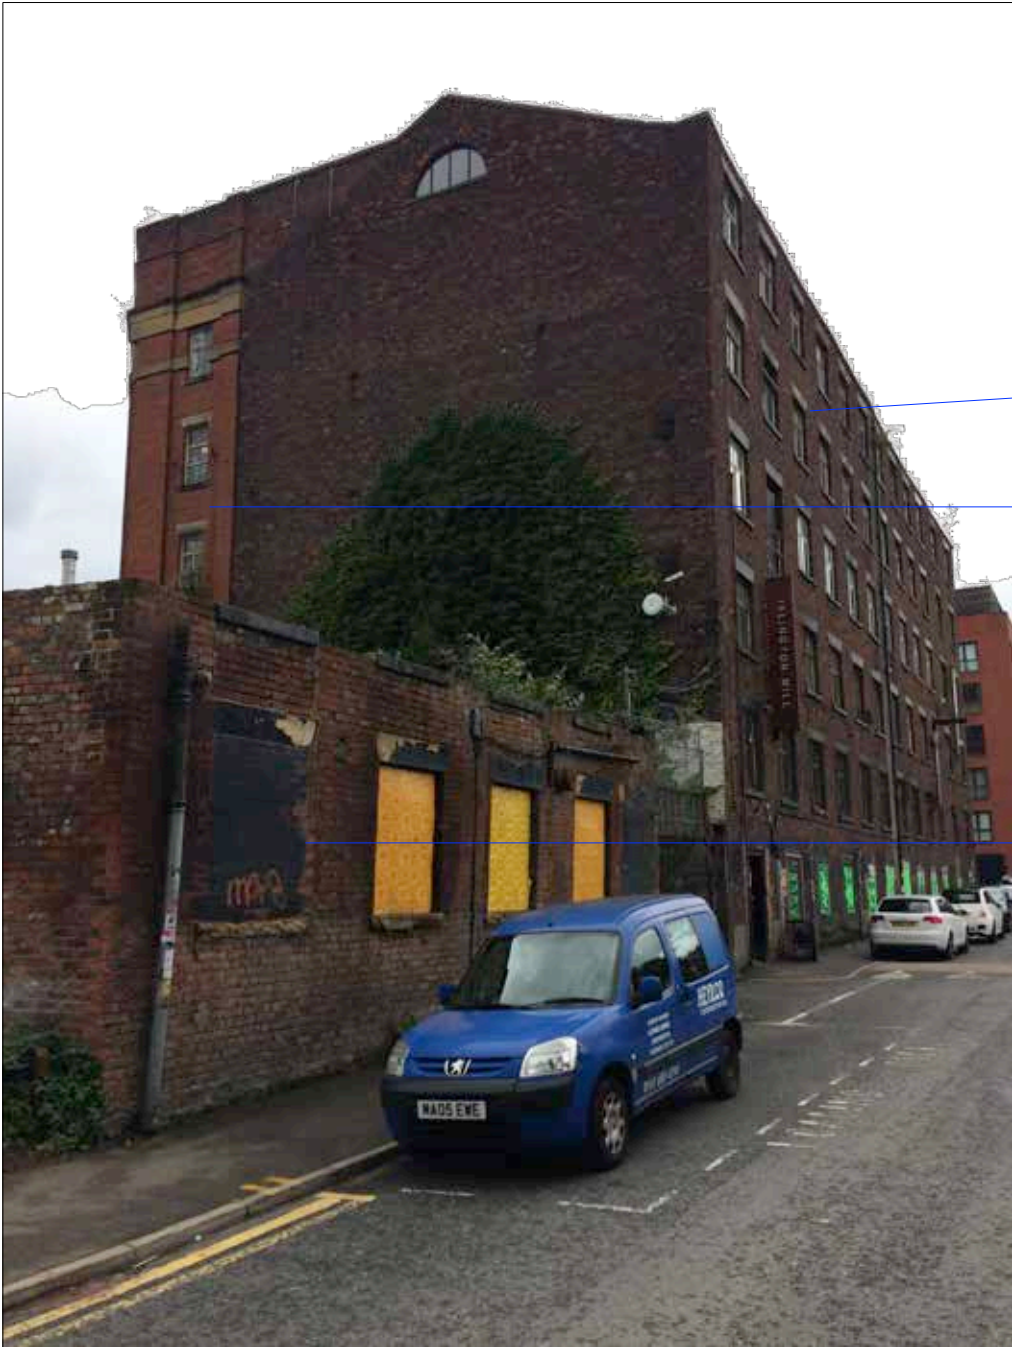
FIG: EX.05

North elevation to James Street.

Existing stir tower in contrasting brick and a later addition to the mill.

'Stables' building outside of Islington Mill (IMAC) ownership

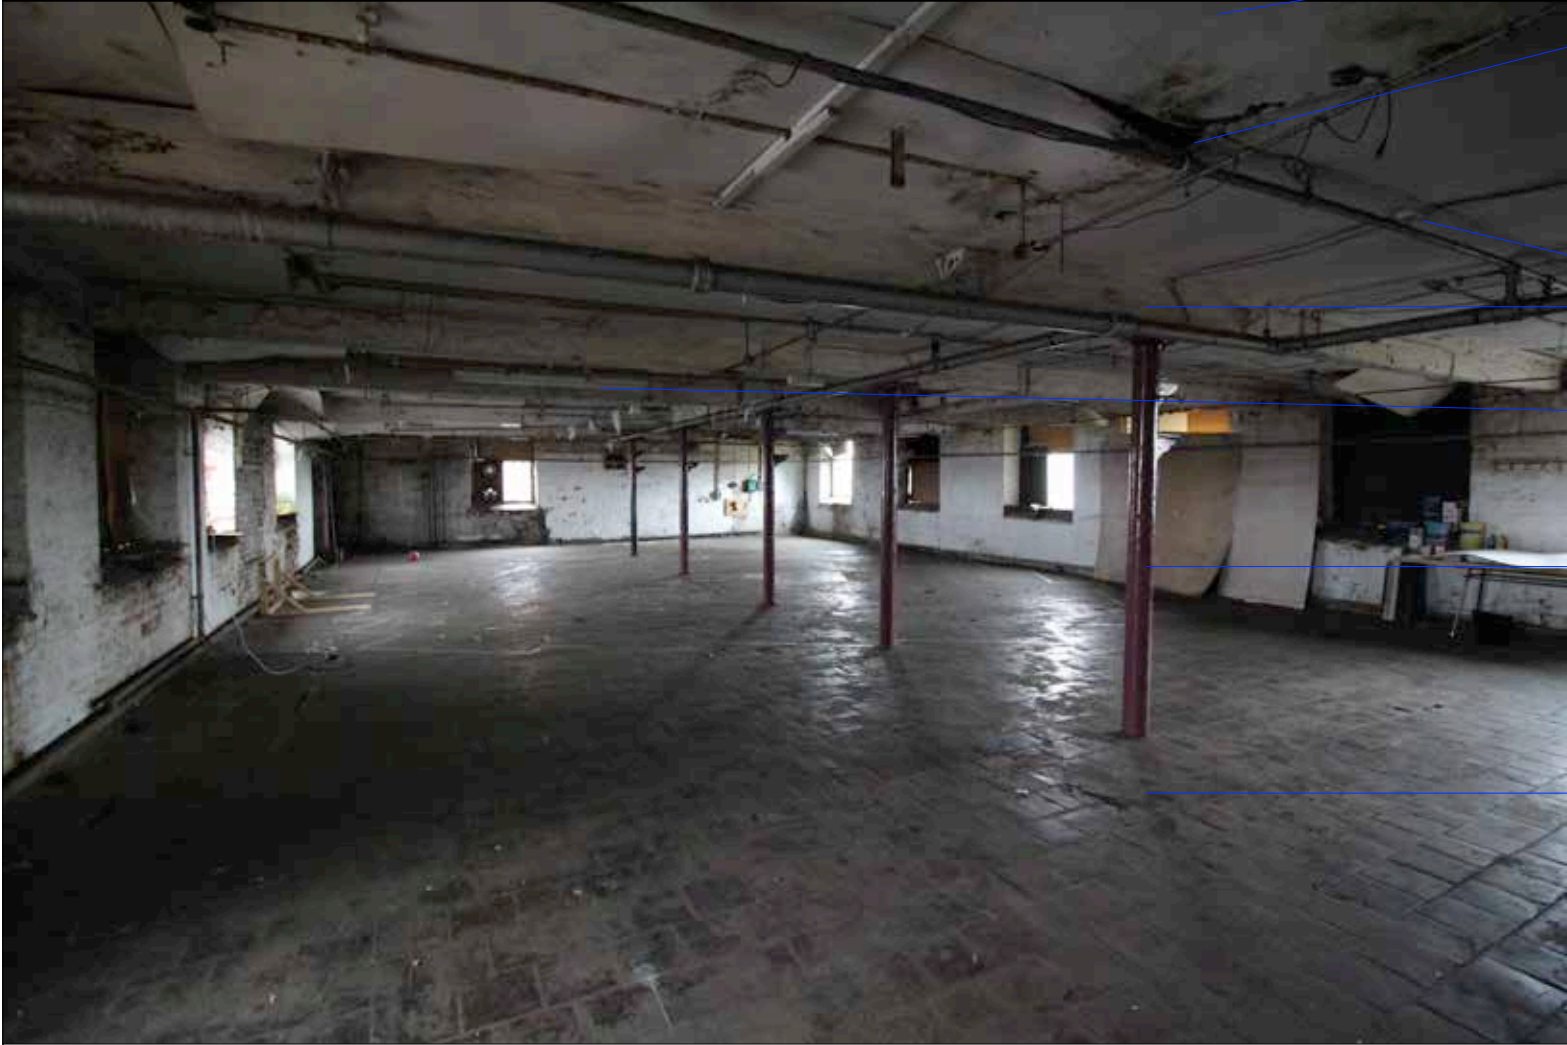
FIG: INT.01 - 5th Floor

Existing timber truss

Existing cast iron structural columns centred on the building to be retained.

Existing hardwood soffit to structural floor boards to be removed throughout 5th floor.

Redundant sprinkler system to be removed throughout

Existing fire alarm system to be removed to allow for works. Specialist contractor to advise on temporary alarm during the works and between phases with proposals to be agreed with the design team.

Existing lighting to be removed throughout

Existing quarry tile floor covering to be protected during the phase of works.

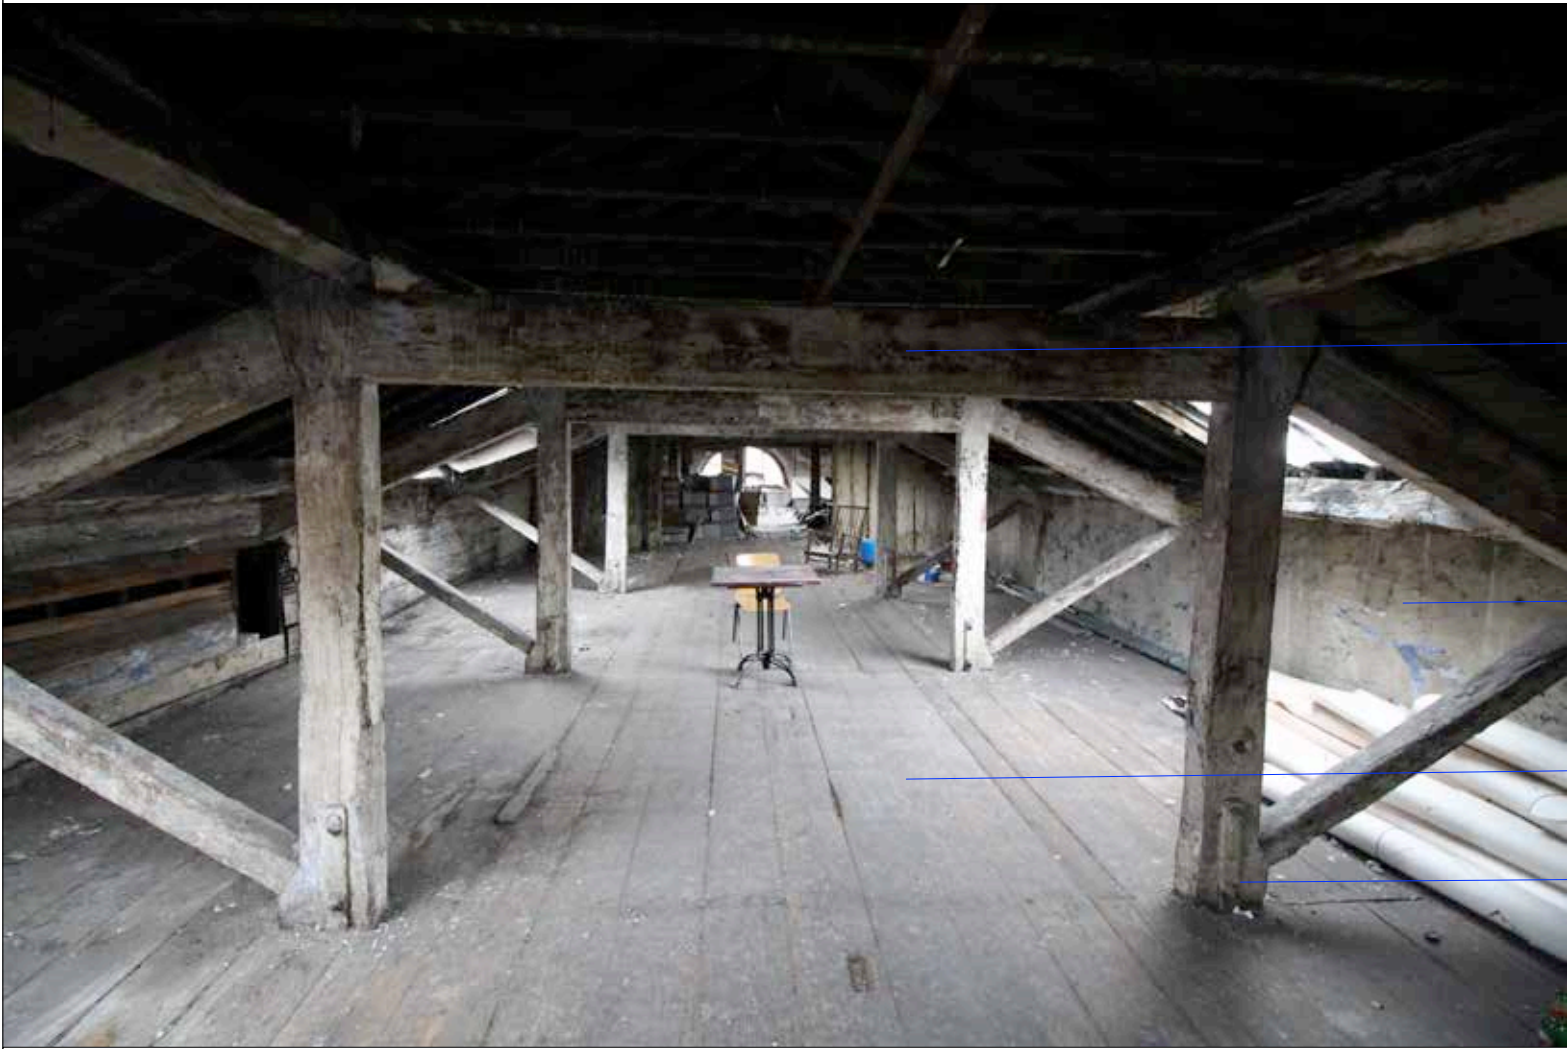
FIG: INT.05 - 6th Floor

Queen post truss

Existing partition to eaves to be removed. Partitions vary in build up from hardwood boarding to lathe and plaster construction.

Existing structural (c.70mm depth) floorboards to be lifted and retained for reuse.

Any existing fixings in the trusses to be sandblasted or appropriately cleaned by specialist and sealed as required.

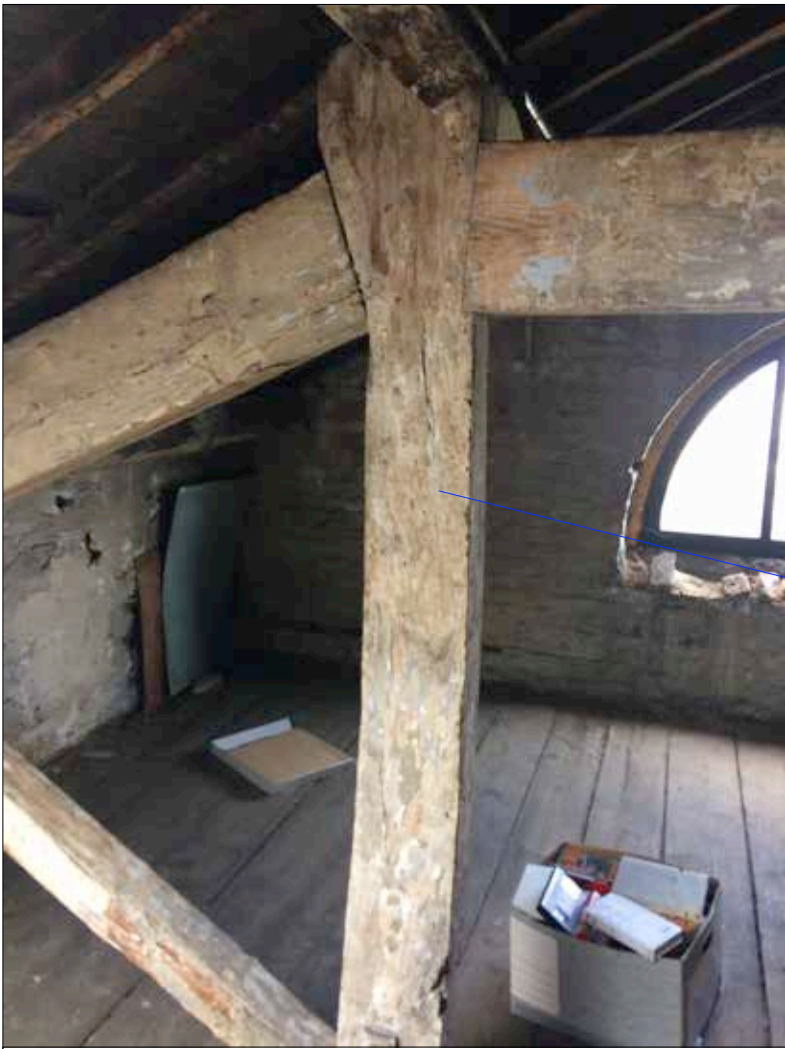
FIG: INT.06 - 6th Floor

Existing partition to eaves to be removed. Partitions vary in build up from hardwood boarding to lathe and plaster construction.

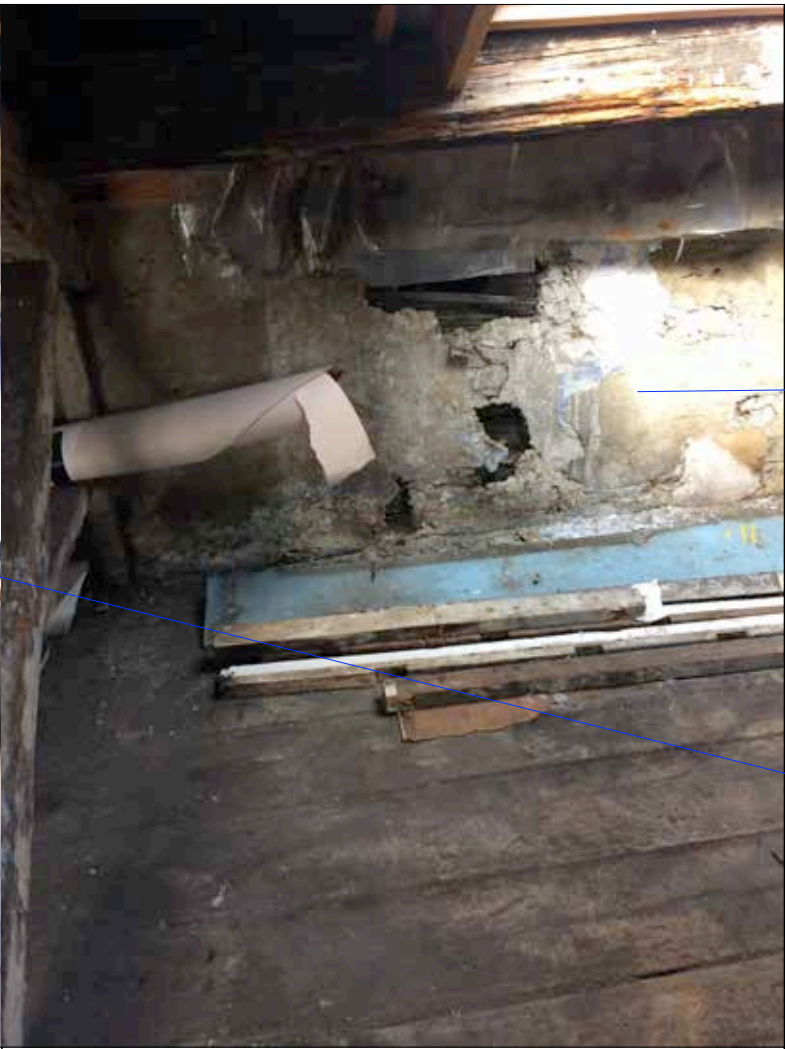
FIG: INT.07 - 6th Floor

Example of queen post truss detailing.

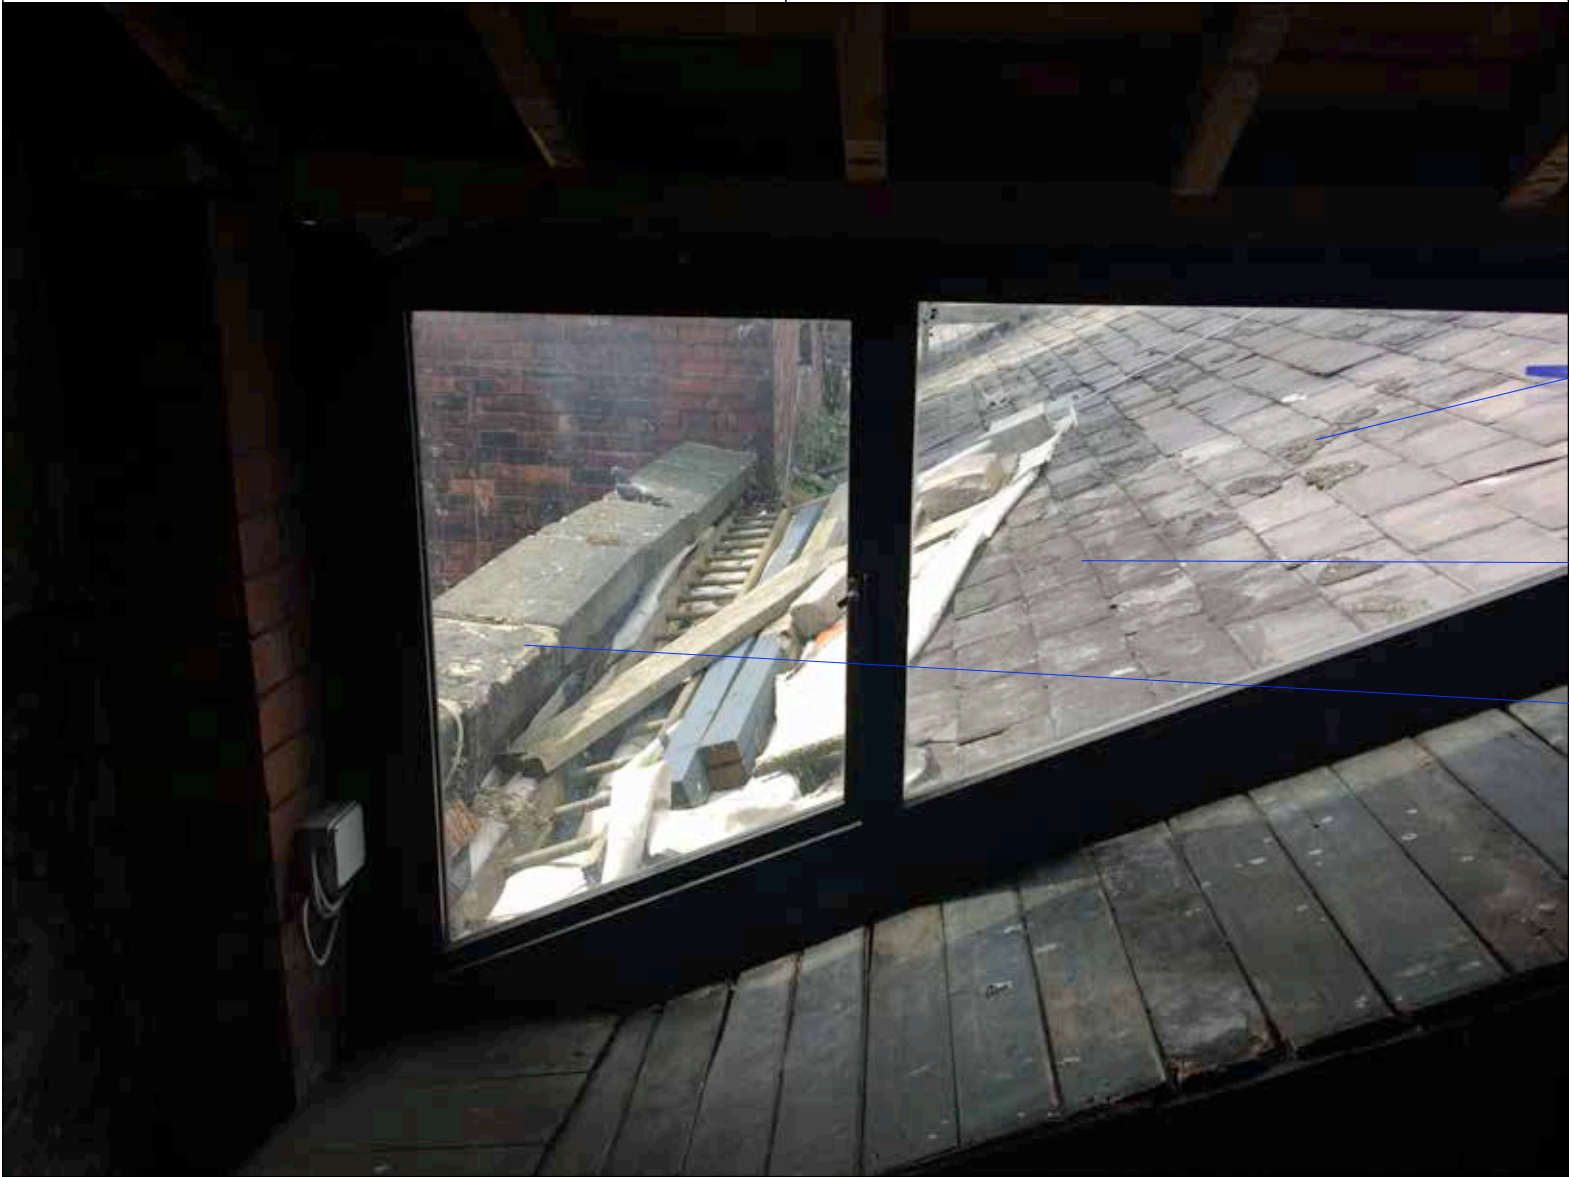
FIG: INT.08 - 6th Floor

Evidence of temporary roofing works previously carried out where felting has been adhered to the roof slates.

View of existing roof from 6th floor dormer window. Contractor to remove and dispose of any items on the roof at present.

Existing coping stones to be lifted, cleaned and rebbed. Any new copings stones to be matching to the existing

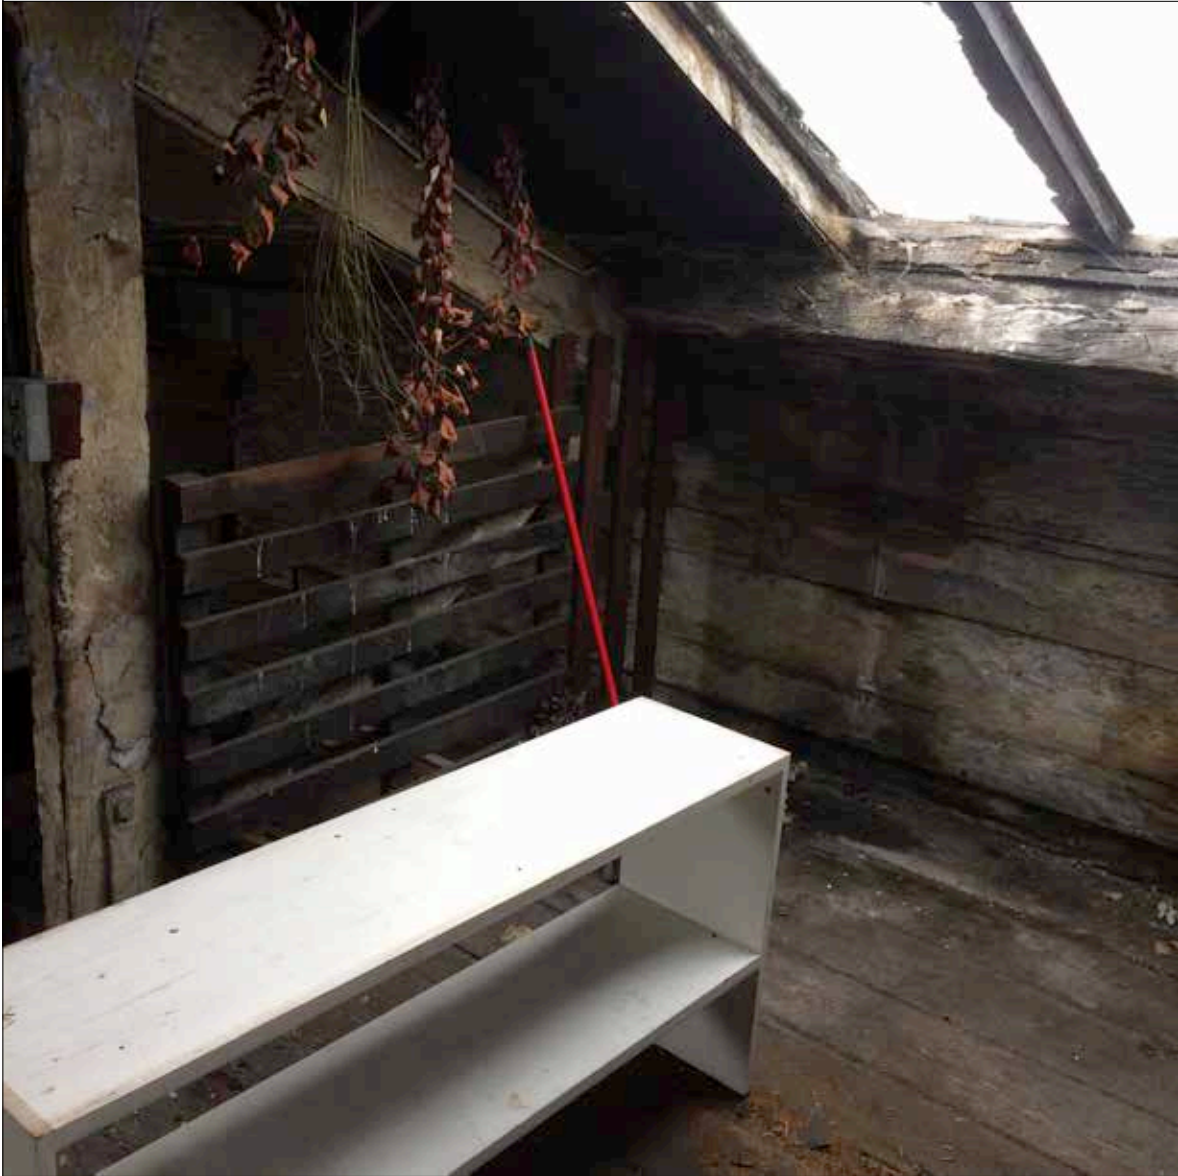
FIG: INT.12 - 6th Floor

Existing partition to eaves to be removed. Partitions vary in build up from hardwood boarding to lathe and plaster construction.

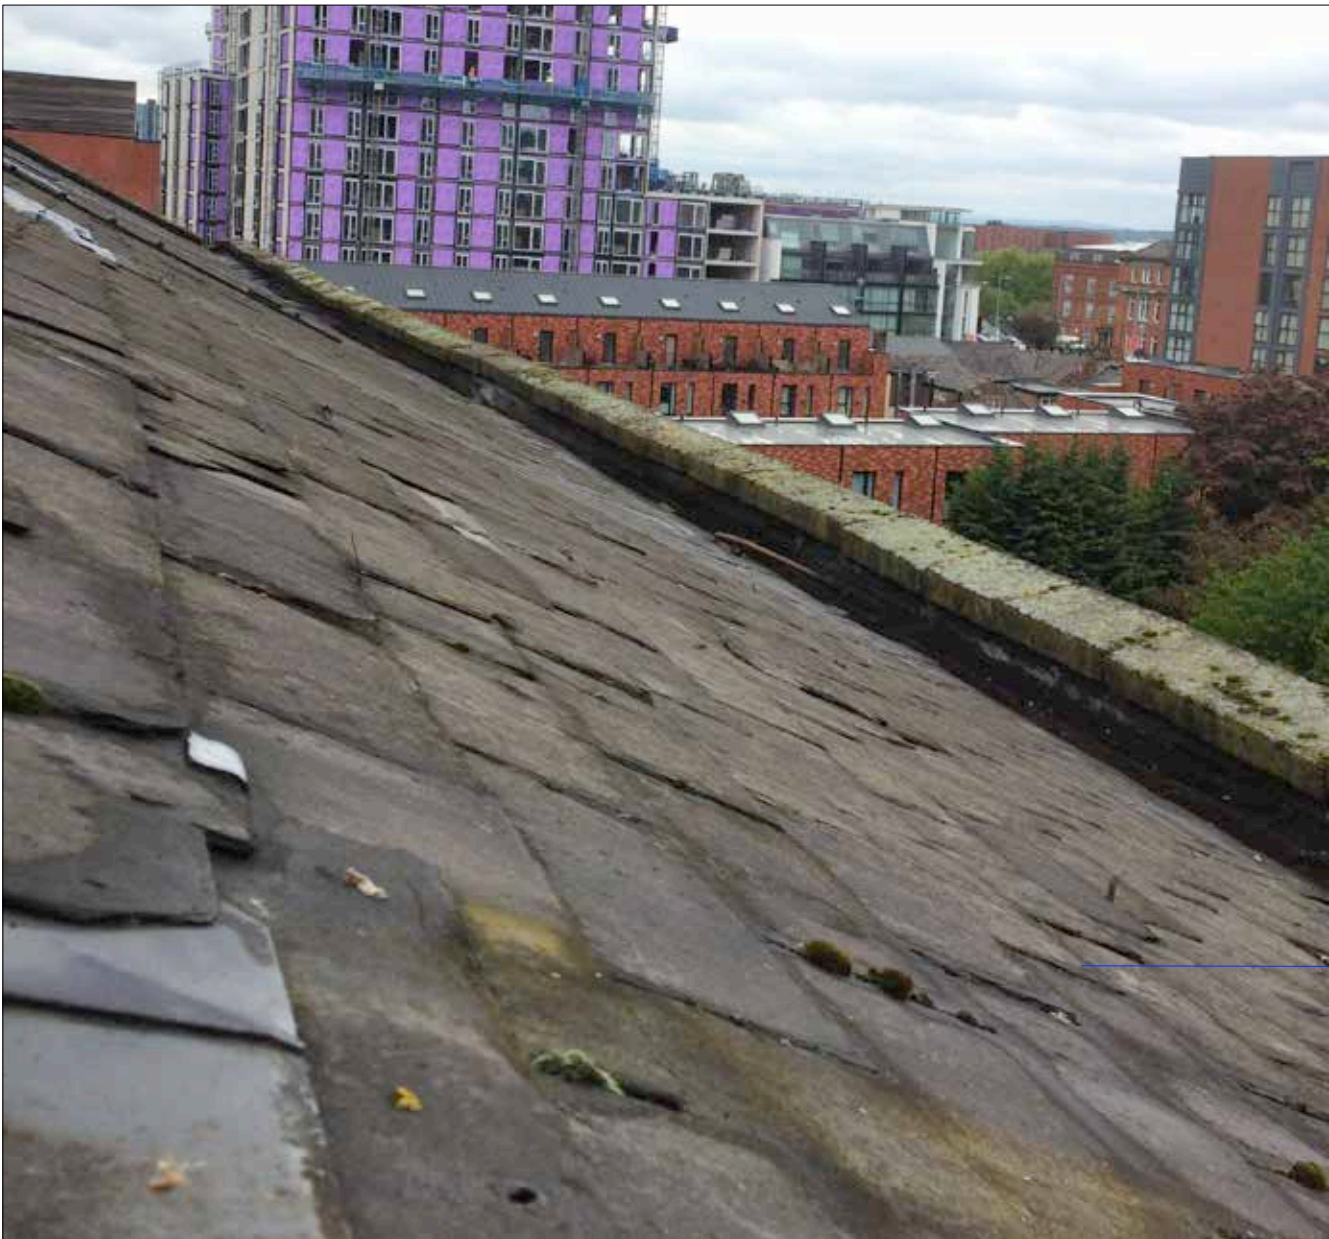
FIG: INT.13 - 6th Floor

View of existing roof from 6th floor
rooflight.

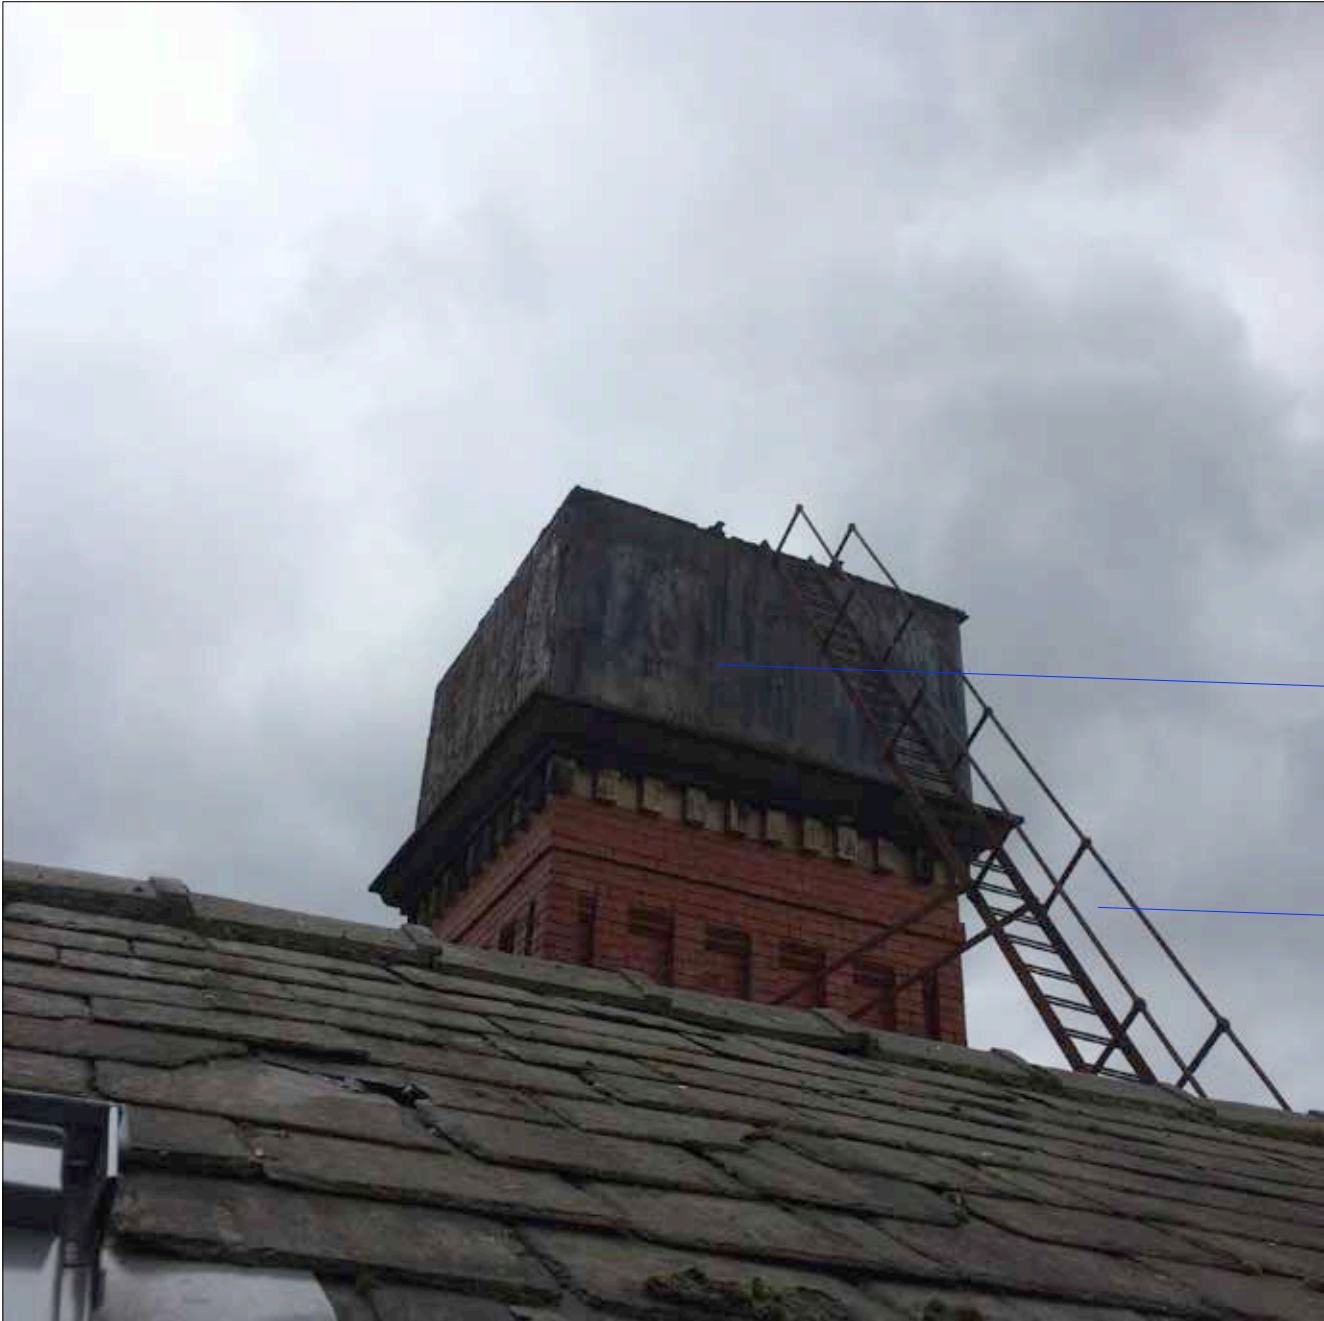
FIG: INT.15 - 6th Floor

View of redundant water tank to privy block from 6th floor rooflight. Water tank outside of scope of works.

Existing access stair to water tank to be removed and disposed of off site.

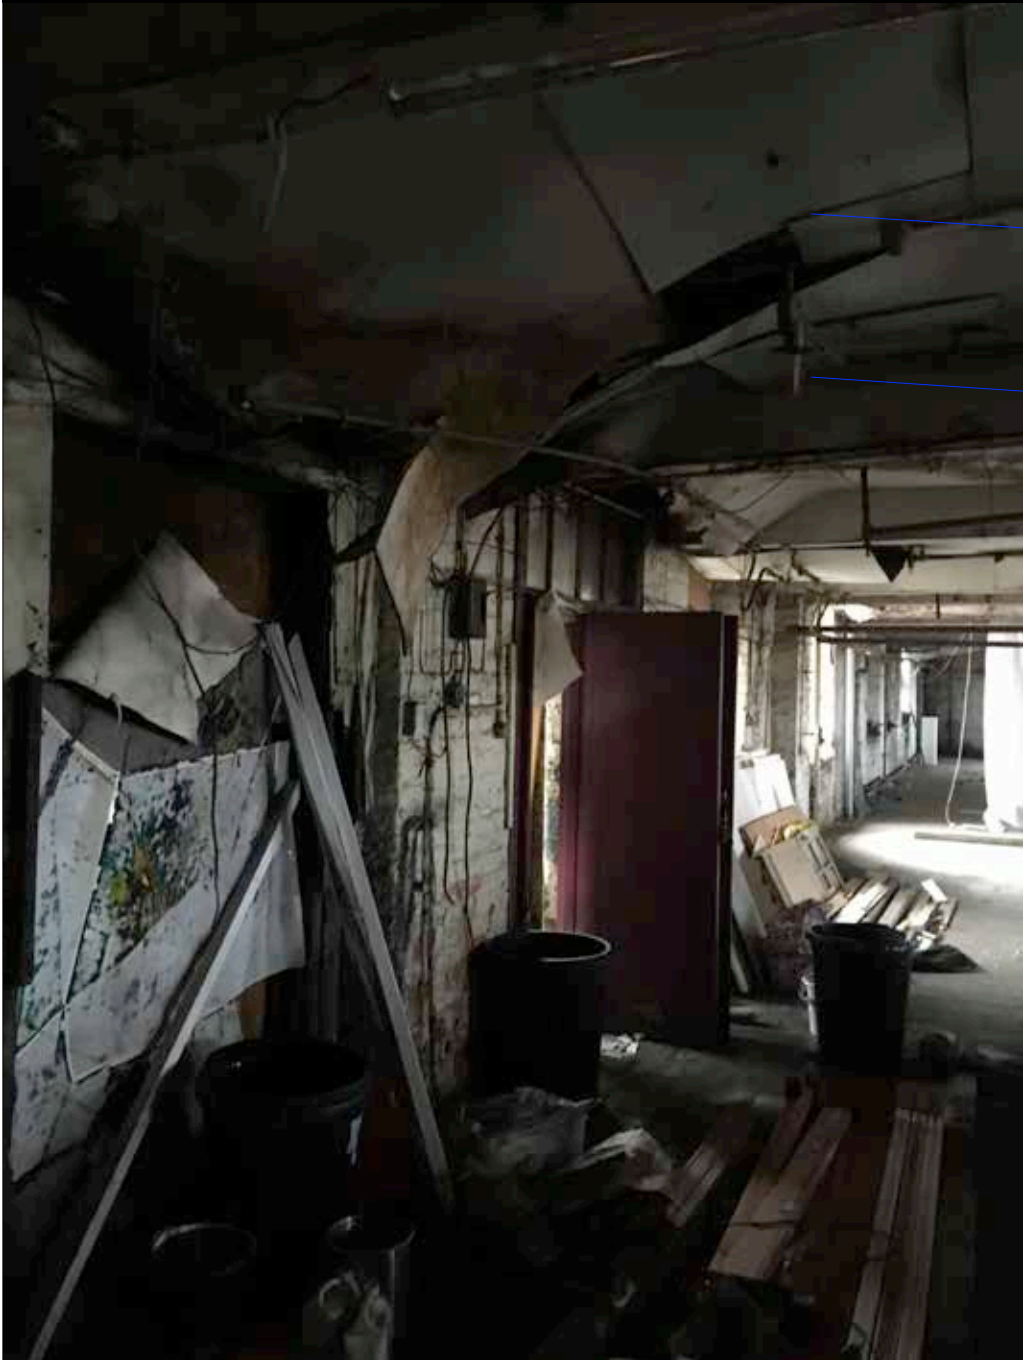
FIG: INT.16 - 5th Floor

Collapsed hardwood soffit

Deterioration to the condition of the fifth floor shown. The image shows the worst area affected of water ingress.
