ISLINGTON MILL - 294

FOR: TENDER	
CHECKED BY: TW	DRAWN BY: MS
SCALE: NTS	
PAPER SIZE: A3	
JOB: ISLINGTON MILL & No. 294	
0.401_Rev	
FIRST ISSUE: 09.04.20	
PHASE 01_PHOTO APPENDIX_01

INTERNAL PHOTOS - DATED. 26.09.2014

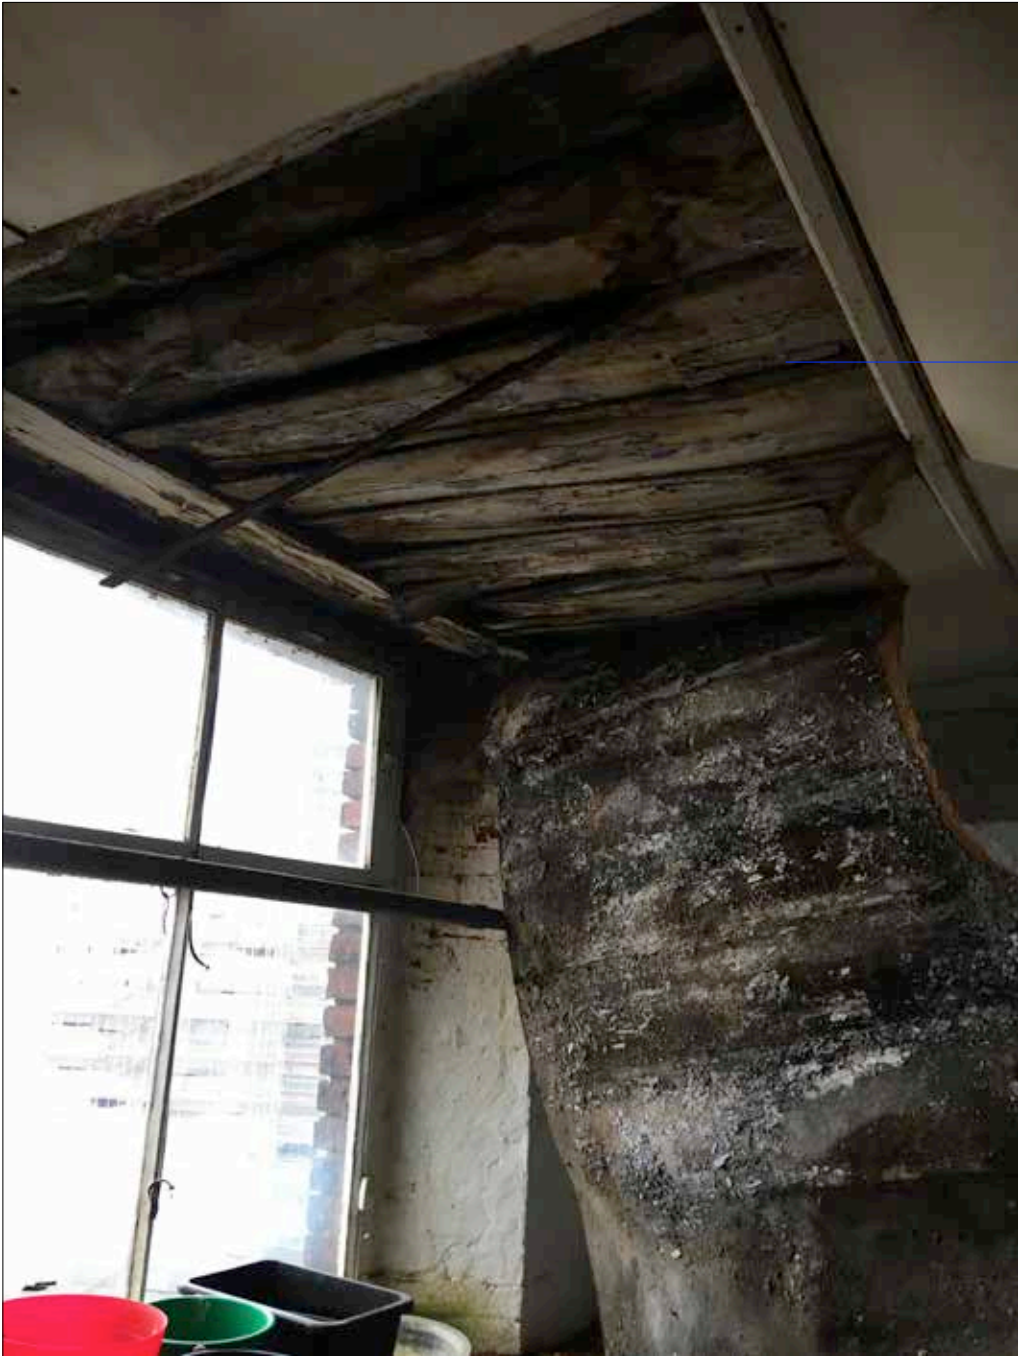
FIG: INT.17 - 5th Floor

Collapsed hardwood soffit revealing timber boarding behind to be removed.

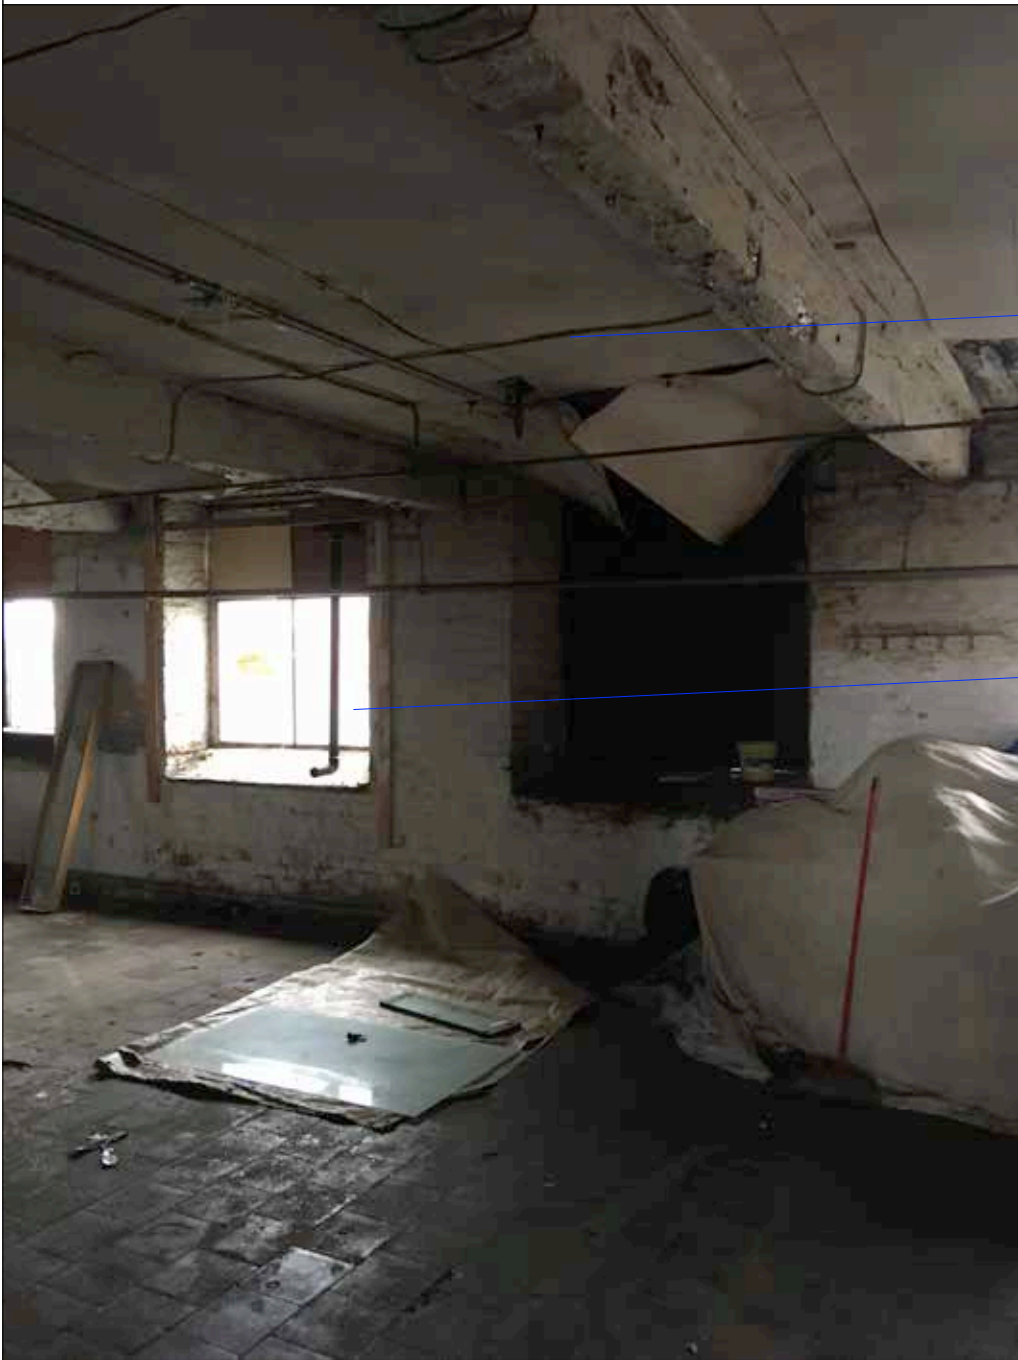
FIG: INT.18 - 5th Floor

Further examples of collapsed hardwood soffit evident across the 5th floor.

Any temporary roofing works to be removed and any fixings into the existing masonry to be removed.
