Plot 7 Science Central, Buckingham Street, Newcastle upon Tyne

Phase II Geo-environmental Assessment

Karbon Homes Limited

Report Ref	Issue	Prepared by	Reviewed by	Date	
P17-262/P2	1	N Watson	A Cooper	12.12.19

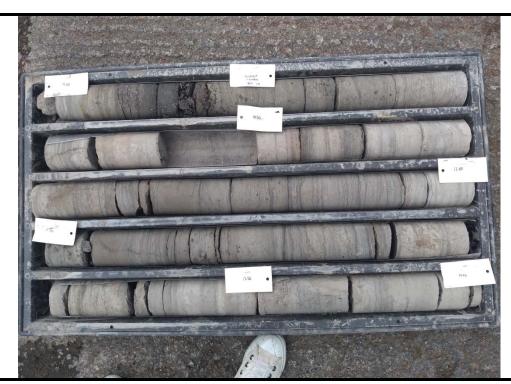
BH1A - 9.00m to 14.00m

- However, in borehole BH1A, made ground comprising mudstone and sandstone colliery spoil considered to also be attributable to the former open-cast working was noted to a depth of 9.00m (or 65.60m AOD) overlying sandstone bedrock. Based on previous information relating to the former open-cast site as workings included extraction of both the High Main and Metal coal seams, it is understood that this resulted in a basal depth of the open-cast working to depths of between 51.9m to 57.6m AOD.

Taking this into account, as made ground within BH1A was only recorded to a depth of 65.60m AOD it is considered that BH1A was likely sunk on the high-back wall itself. This is also potentially corroborated by general ground conditions noted this borehole location, which although the High Main seam is recorded as absent below this area (likely removed as part of the open-case operations) the workings and grouted gravel considered to be attributable to the Metal coal seam were noted between 15.90m to 16.50m, or 58.70m to 58.10m AOD, which concurs with the indicated basal depth of the open-cast workings (i.e. workings associated with this seam are still present and as such were not extracted).

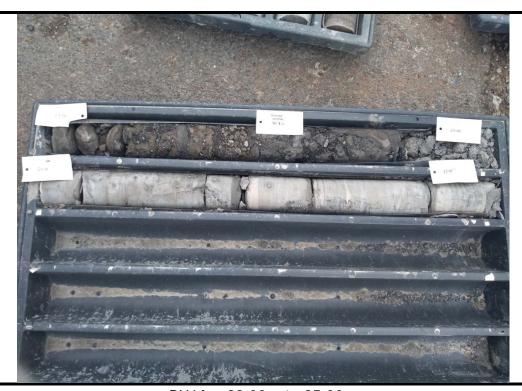
BH1A - 23.00m to 25.00m

23.10-24.00	51.50-50.60	0.90	Five Quarter Seam – noted to be filled with soft to firm clay / colliery spoil.
BH2	3.00?	74.80?	3.00-8.70	74.80-69.10	4.20-5.70	High Main Seam – Broken ground in grout matrix.

5.33 However, at the location of BH1A, workings considered to be attributable to the Five Quarter seam were noted at depths of between 23.1m to 24.0m, or 51.50m to 50.60m AOD, and thickness of 0.9m. In view the findings for BH1A, mine workings in the Five Quarter seam were noted to be filled for the full thickness with soft to firm clay containing mudstone, sandstone and coal (colliery spoil), supporting anecdotal evidence of workings within this seam as having been backfilled with 'packed waste'.

5.36 Therefore, it is considered that workings within the Five Quarter coal seam represent a potential risk to the proposed building within the northern site area through void migration towards the termination depth of proposed piled foundations. Subsequently, stabilisation by drilling and grouting are recommended for buildings extending onto the location of the former open-cast working, in consideration that a piled foundation solution will be required.

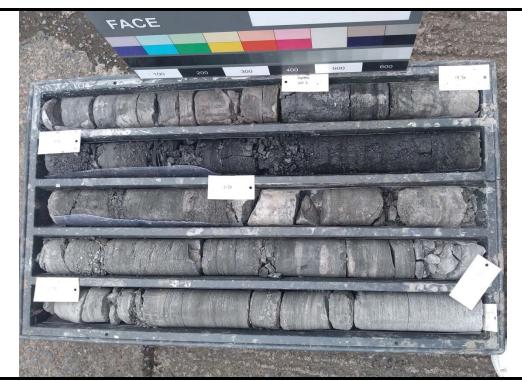
BH2 - 18.70m to 22.70m

19.00-19.60	58.80-58.20	0.60	Metal Seam – intact.
			6.00-9.10	72.20-69.10	3.10	High Main Seam – Broken ground in grout matrix.
BH3	4.00	74.20	18.00-19.07	60.20-59.13	1.07	Metal Seam – intact with grouted band noted between 18.50-18.57m.
BH120	3.00	73.25	5.60-8.20	70.65-68.05	2.60	High Main Seam – recorded as cavity and workings. Borehole completed prior to remedial grouting works.
