# Bailrigg Garden Village - Geo-Environmental Assessment

Final Version

March 2018

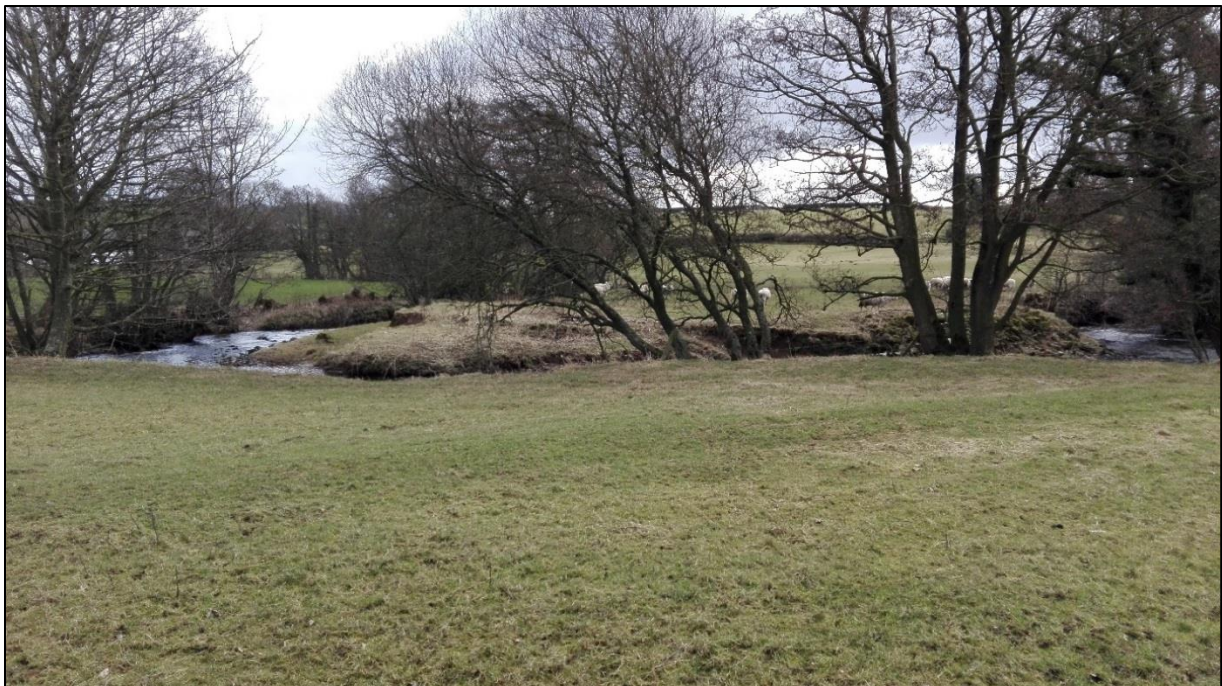
The River Conder flows through the southern reaches of the site (see Figure 2-3). The source of the Conder is located in the Bowland fells to the east of the site and it eventually drains into the Irish Sea at Conder Green, which is located approximately 1.5 km to the east of the site boundary.

Figure 2-3 Meander on the River Conder (looking south). Approximate NGR 349082 456434.

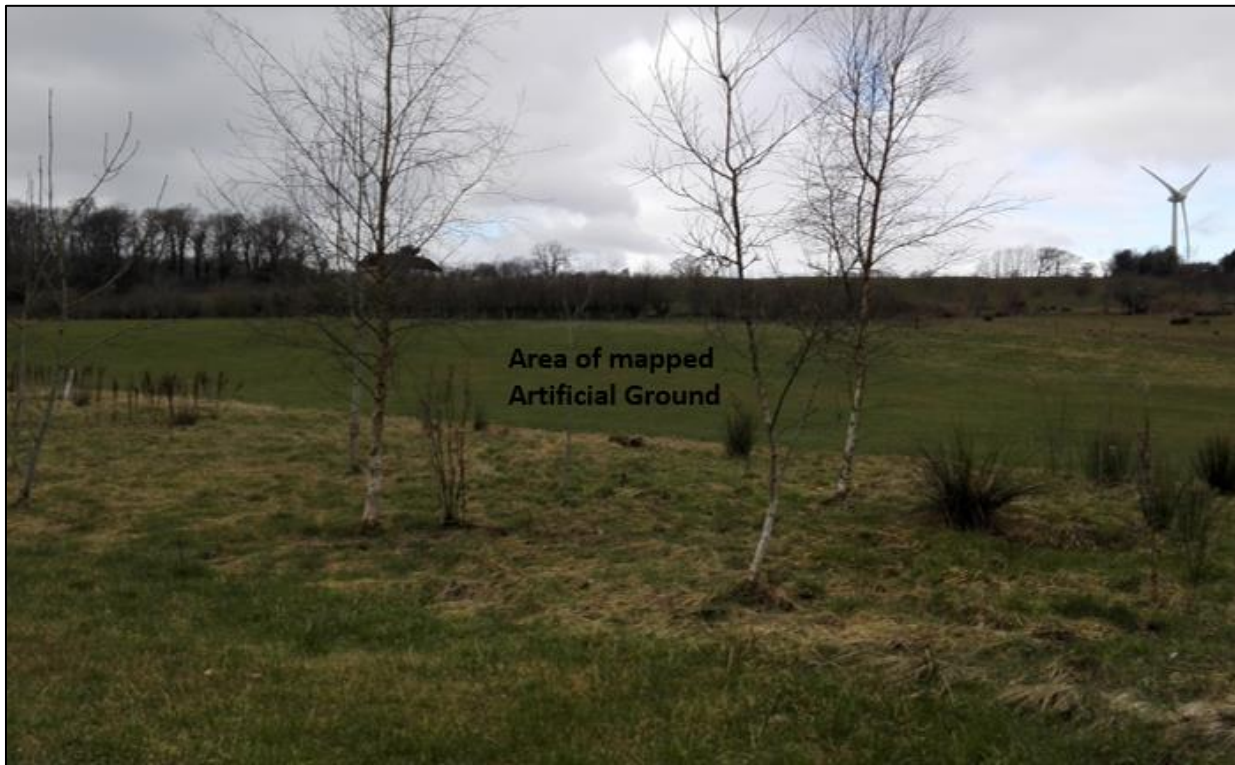
Figure 2-5 Area of artificial ground adjacent to Forrest Hills looking north (NGR 349451, 457170).

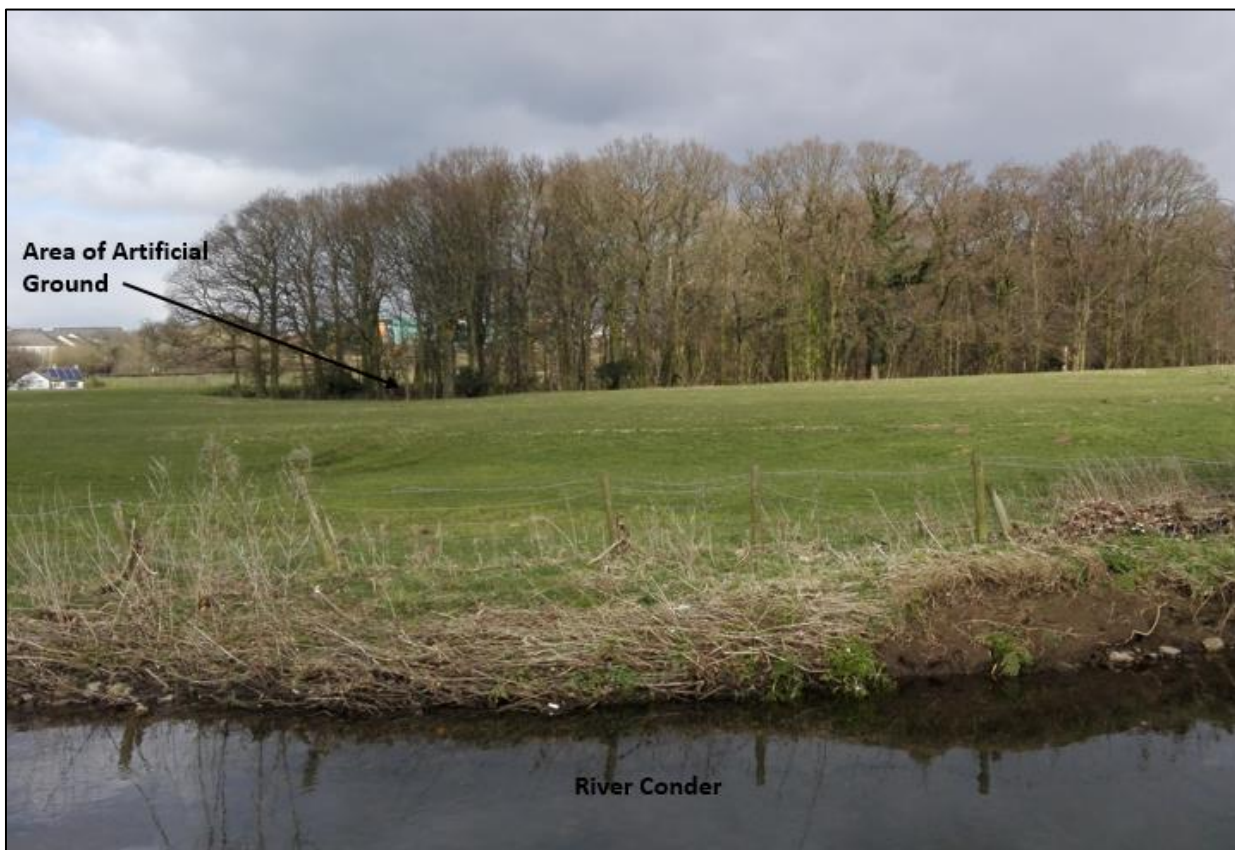
Figure 2-6 Area of artificial ground north east of Ellel looking north (NGR 348838, 456443).

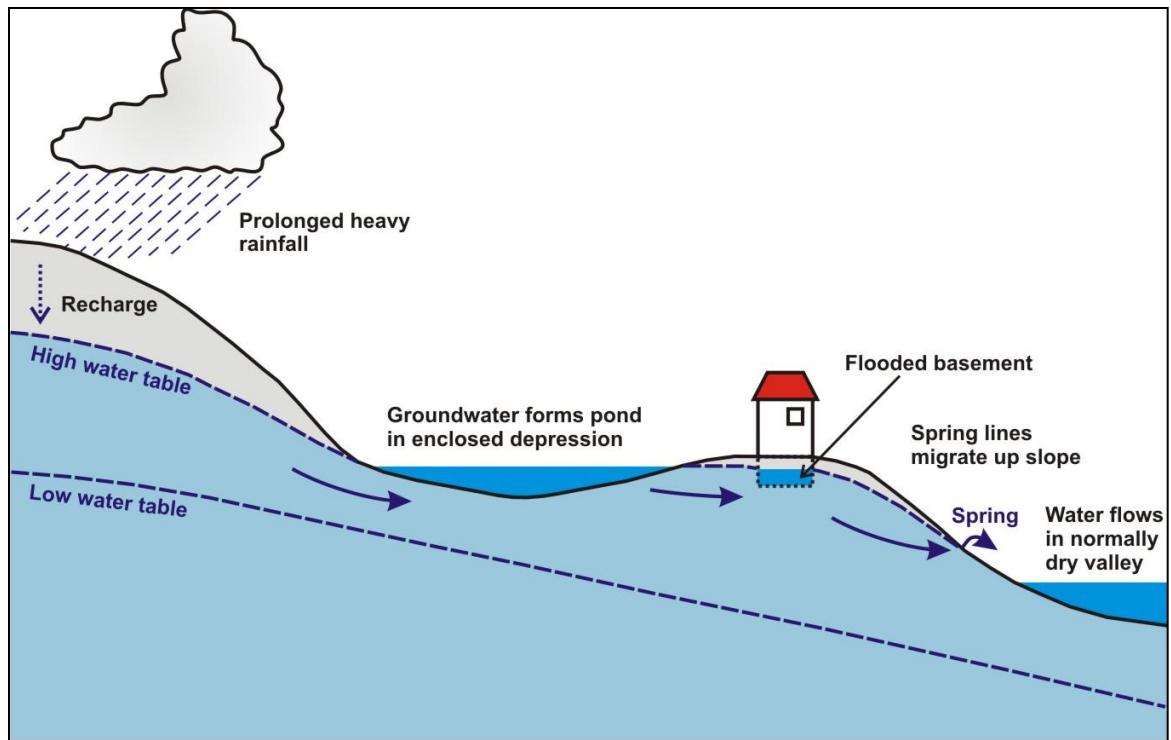
Figure 4-3 Conceptual Model for Clearwater Flooding

Prolonged heavy rainfall may cause the water table to rise above the ground surface in unconfined aquifer systems or above the floor level of underground structures such as basements. This mechanism is referred to as clearwater flooding (McKenzie *et al.*, 2007) ( Figure 4-3). It is most likely to occur in:

Unlike alluvial flooding, which represents the short-term response of a catchment to rainfall, groundwater flooding is often dependent on the longer-term water balance and the amount of water stored in the aquifer. For example, groundwater flooding is often more likely following a wet winter when groundwater levels are unusually high and little additional rainfall is required to bring the water table to the ground surface. However, if an aquifer has a very low storage capacity, or if additional sources of water are present (such as a river or a leaking water main), then a wet winter may not be necessary in order for groundwater flooding to occur.

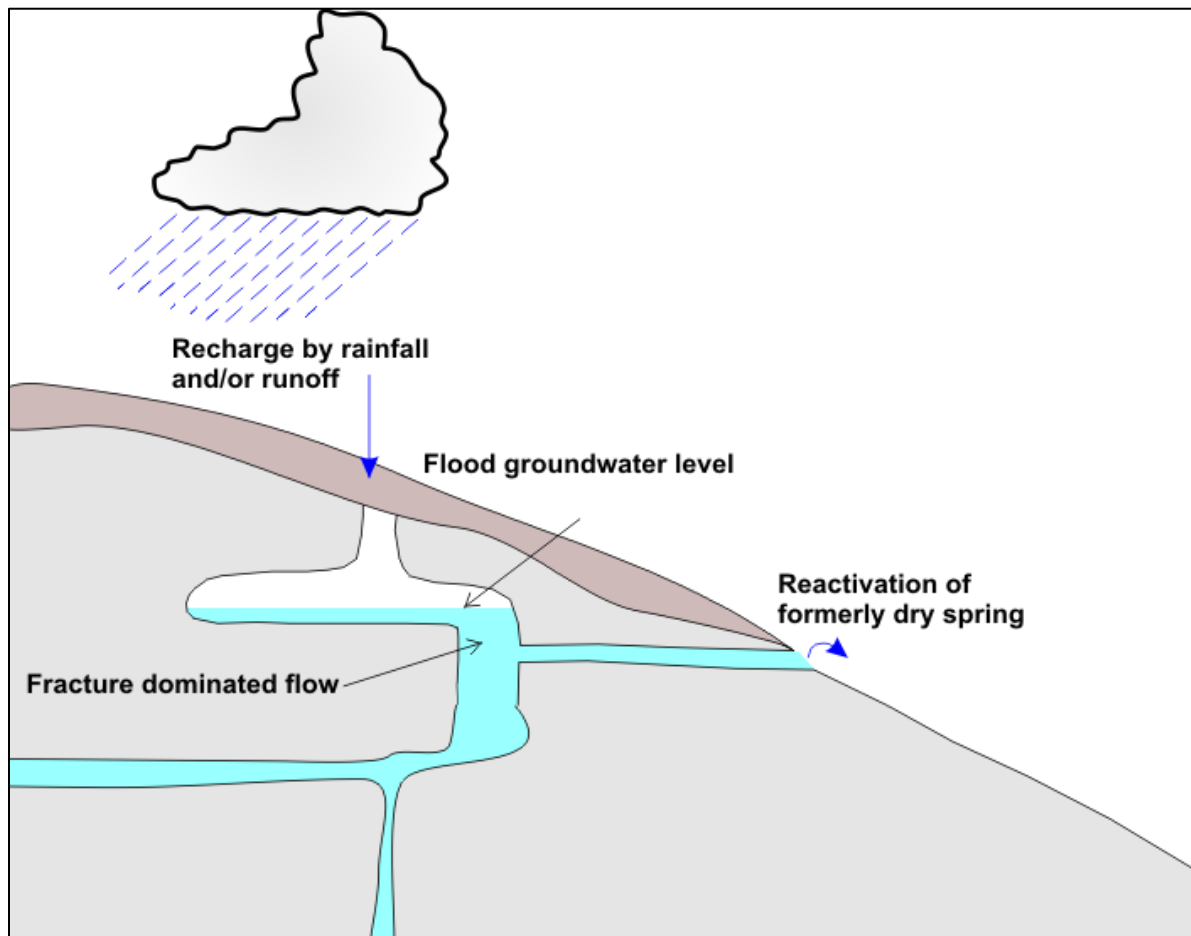
Figure 4-4 Conceptual Model for Spring Activated Flooding<sup>1</sup>

Spring activated groundwater flooding is a subset of clearwater flooding (see Figure 4-4). Where groundwater flow within a bedrock unit is dominated by fracture flow, periods of prolonged heavy rainfall can lead to: a) the activation of ephemeral springs, or b) significant increases in existing spring activity.

<sup>1</sup> Size of the fractures are not to scale and have been added only to aid conceptualisation  
2017s6815Bailrigg - Geo-environmental and Groundwater flooding\_Final\_Issue\_080318

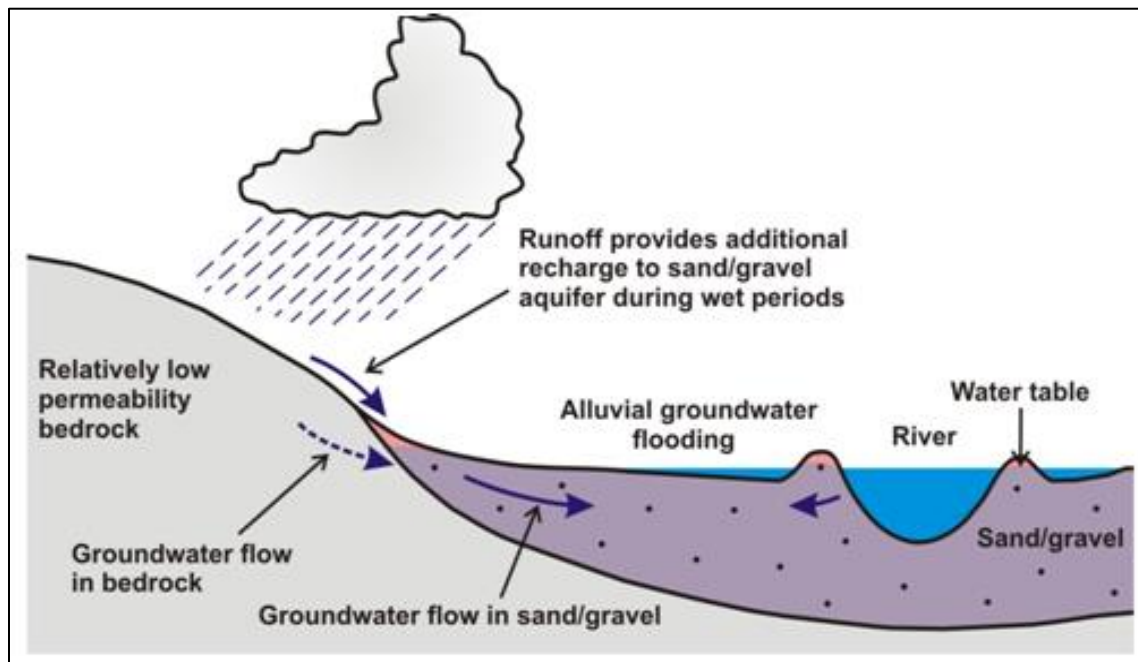
Figure 4-5 Conceptual model for Alluvial Groundwater Flooding

Where an aquifer (such as a deposit of river gravel) is in hydraulic continuity with a river, high river levels will, if sustained for a long enough period of time, lead to high groundwater levels within the aquifer (Jacobs, 2007). If groundwater levels exceed the elevation of the floodplain (or the floor level of underground structures such as basements) then groundwater flooding will likely occur. This can happen even when the river remains in-bank. There are two mechanisms involved: (i) flow of water from the river into the aquifer and (ii) a reduction in the ability of water to drain from the aquifer into the river (due to the higher river level). The first of these mechanisms is most likely to be important where the river is raised within levees (or confined by flood defences) above the level of the floodplain.

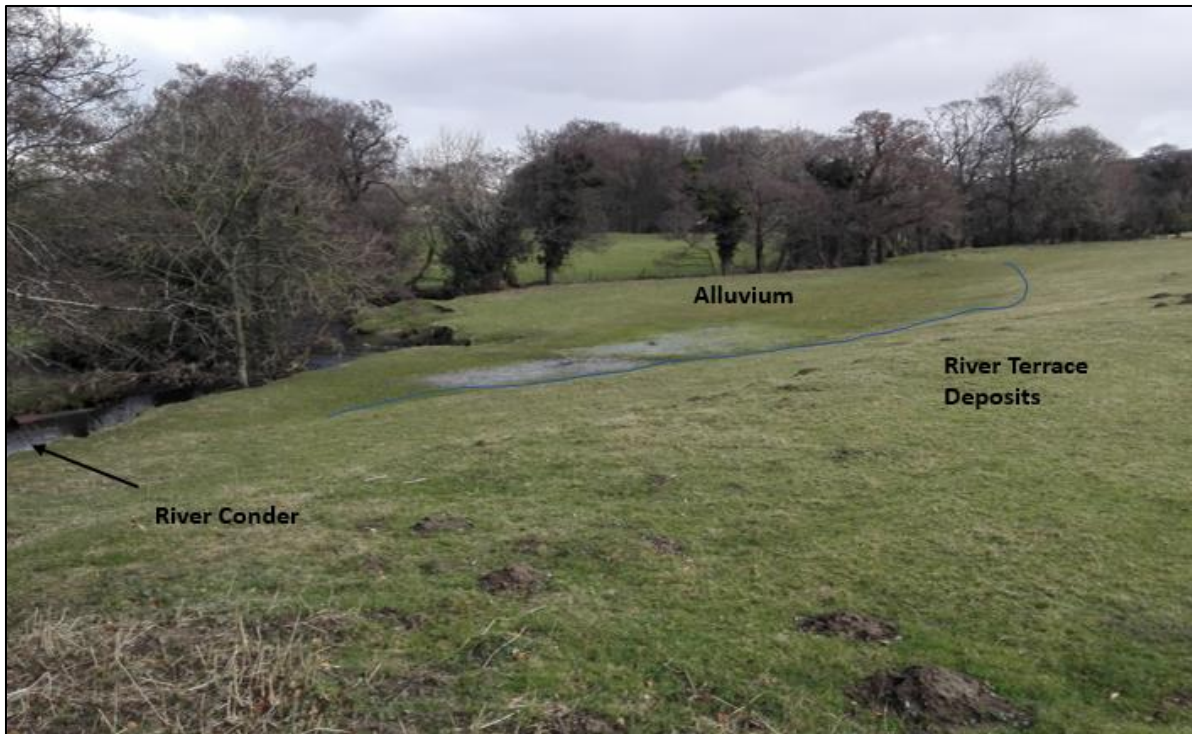
Figure 4-8 Evidence of high groundwater levels in alluvium along the River Conder (looking east).  
Approximate NGR 348680 456224.

The corridor of high permeability sands and gravels underlying the alluvium, and forming river terrace deposits, and glacial fluvial deposits along the River Condor, is most likely to be prone to alluvial groundwater flooding. This area is highlighted by the blue polygon in Figure 4-7 below. Saturated ground was evident in this area during the JBA site visit (see Figure 4-8 and Figure 4-9).

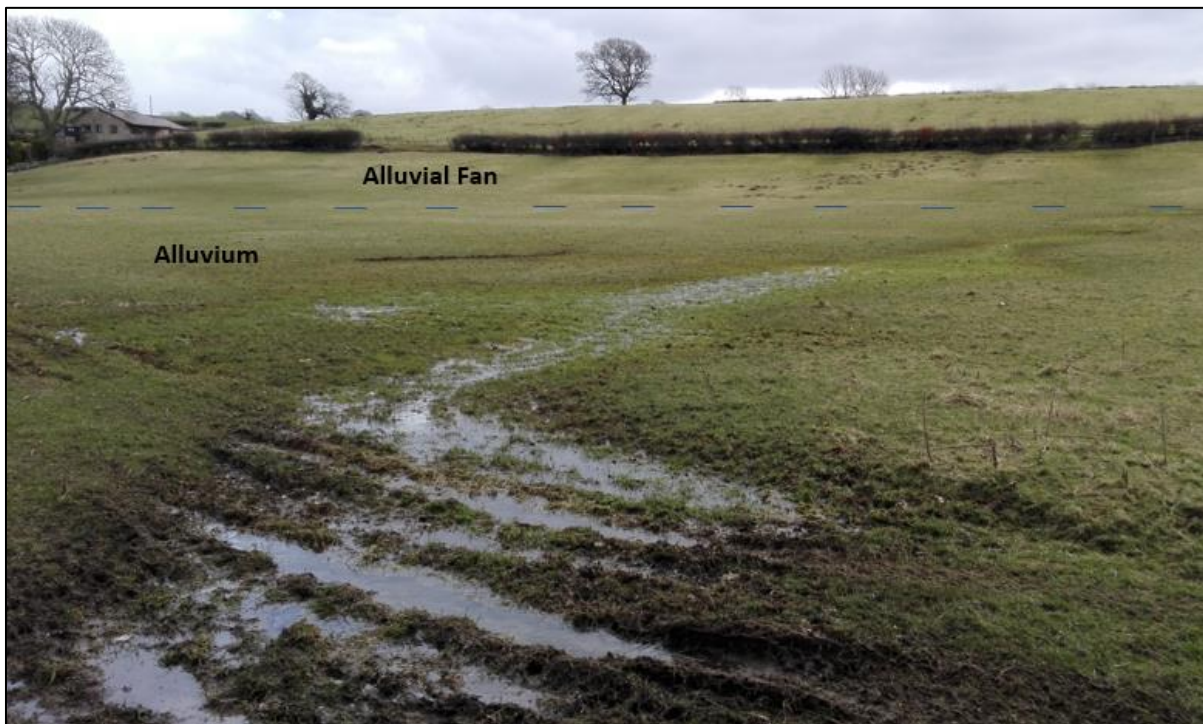
Figure 4-9 Evidence of high groundwater levels in alluvium along the River Conder (looking south). Approximate NGR 349196 456387.
