Roof Survey Report

Whiterock Academy
Davies Avenue, PAIGNTON
TQ4 7AW, England

1 August 2022
Project Reference: B223924/1

PREPARED FOR:
Simon Wright
Torbay Development Agency

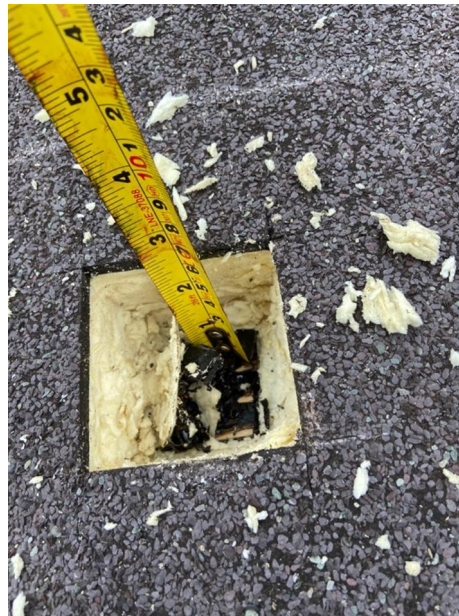
Core 2

No. of core samples taken:	1
Construction Type:	Warm Roof
Surfacing:	Slate mineral finish
Waterproofing:	SBS modified built-up bituminous membrane system
Insulation:	Rigid PUR/ PIR board 60mm thick
Vapour Control:	Bituminous membrane vapour control layer
Roof Deck:	Timber boarding
Condition of core sample:	The core showed that the roof was dry and would be suitable to overlay

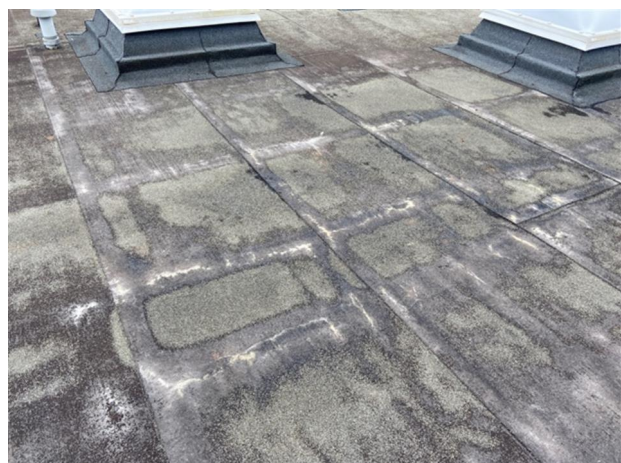
At the time of our survey the roof surface was dry. However, we noted visual evidence that some standing water does occur on the roof surface after rainfall. This indicates inadequate falls which can be viewed as undesirable, excessive standing water can impact the performance of the roof and/or supporting structure. Adequate falls should be provided as part of the roof refurbishment in accordance with BS6229:2018.

Tide marks are evident and would suggest that roof holds water
