Site Details	Torquay Central Library Torquay	Asset Ref: T0470AF
Survey Type	Type 2 Survey/Management Asbestos Survey	
Client Details	Torbay Development Agency	
Survey Date	25.08.05 Re-inspected 09.04.08 Re-inspected 16.02.11 Re-inspected 12.04.12 Re-inspected 15.04.13	
Report Date	24/04/2013	Issue No. Five
Surveyor	Peter Whetman Re-inspected by Daniel Jenkins Re-inspection by Charlotte Parry Re-inspection by Tom Palmer Re-inspection by Tom Palmer	
Job No.	J17597

Site Address: Torquay Central Library, Asset No. TO470AF.

Re-inspection date: 15/04/2013 by Tom Palmer

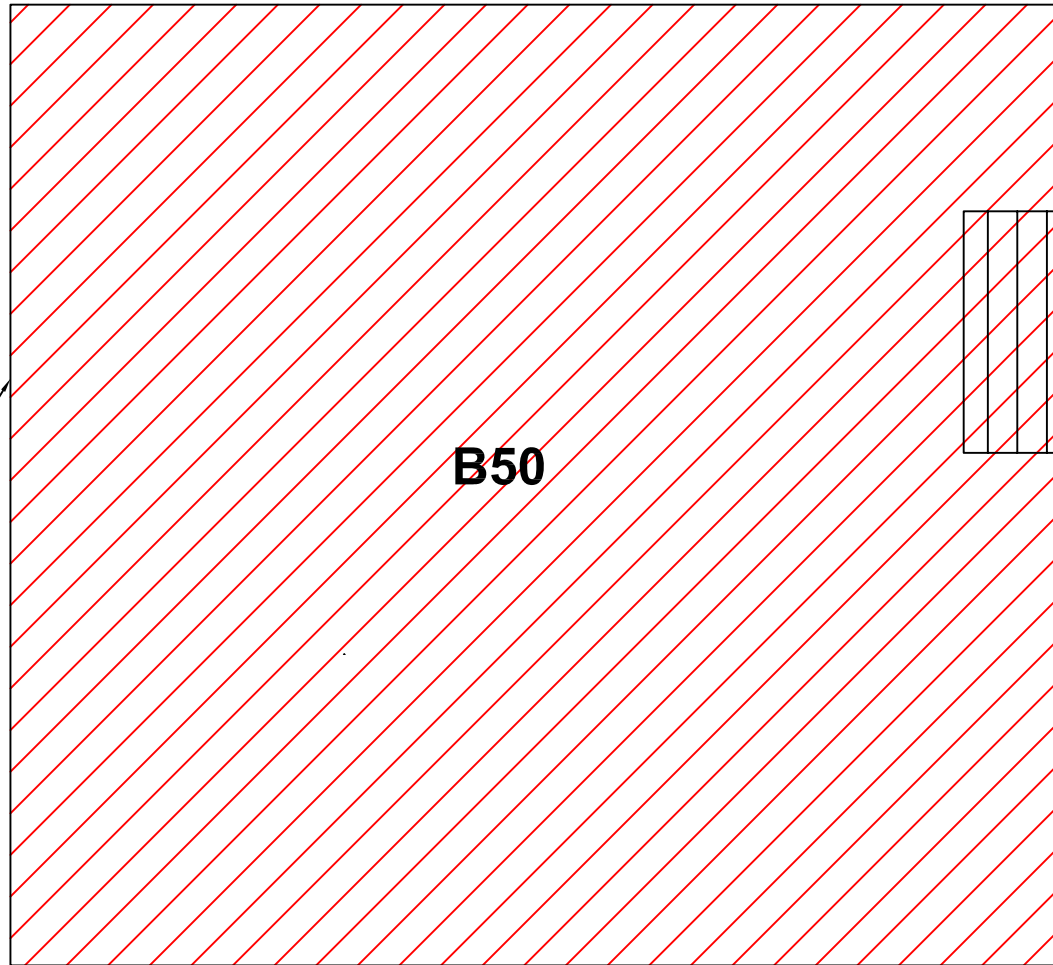
BASEMENT B50

Base 07ST			N.A.V.D.									
Base 08OF	Pipe beside & above door to 09ST	Thermal Insulation	PW250805/01 N.A.D.I.S.		6 lm	7096						
Base 09ST			N.A.V.D.									
Base B50 (Town Hall Basement)	Pipe above window to moat	Thermal Insulation	PW250805/04 IDENTIFIED	Amosite (Brown)	1 lm	7097	Low	Painted	Good	Glued	15/04/2013	6- Manage
Boiler Room Areas to Town Hall Basement	Cable Run Positions Only		N.A.V.D.									
Lower Ground Floor												
Pipe work sheathed with Asbestos Cement presumed throughout floor/ceiling slab and wall cavities												
LGF 01SA	Vinyl Floor Tile to Stairs	Bonded	PW250805/03 N.A.D.I.S.		8 m ²							
LGF 01SA	Grey vinyl floor tiles and adhesive	Vinyl Tile and Adhesive	DJ090408/01 IDENTIFIED	Chrysotile (White)	8 m ²	824	Medium	Sealed	Good	Glued	15/04/2013	2- Manage
LGF 02OF			N.A.V.D.									
LGF 03LS			N.A.V.D.

The one meter length section of asbestos thermal insulation located in the town hall basement (B50) is at high level on a pipe and was sampled and identified as containing Amosite (Brown) asbestos. The insulation is painted, in good condition and is unlikely to be disturbed.

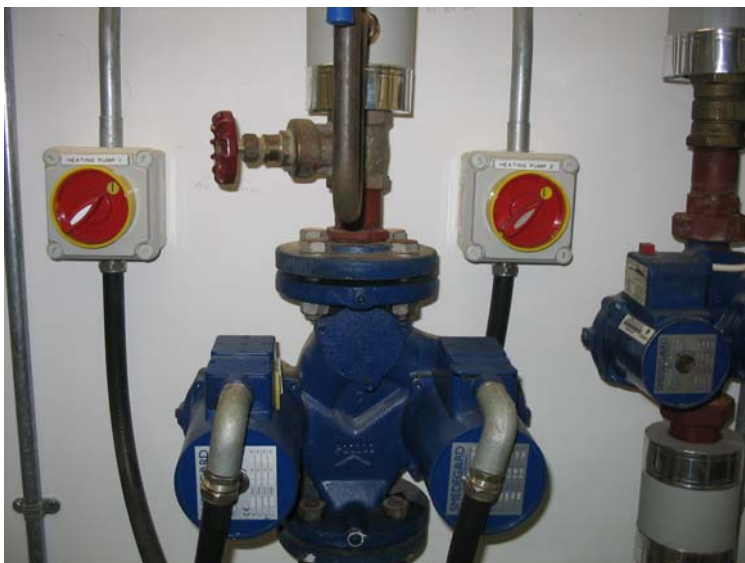
**Photograph No.
9551**

2F03 Plant Room	Ceiling Panels & Beams	Insulation Board	Refer to sample RC070807/02 N.A.D.I.S.		21m ²							
2F03 Plant Room	Collars To Trunking & Services	Insulation Board	Refer to sample RC070807/02 N.A.D.I.S.		3m ²							
2F03 Plant Room	Gaskets To Flanged Joints	Bonded	RC070807/03 N.A.D.I.S.		x4	9551						
2F03 Plant Room	Boiler		No Access			9552						
2F03 Plant Room	Air Extraction Units		No Access			9553/ 9554						
2F03 Plant Room	Electrical Switch Gear		No Access									
2F04 Lift Motor Room	Insulation To Beams	Spayed Coating	Refer to sample RC070807/01 N.A.D.I.S.									
2F04 Lift Motor Room	Electrical Switch Gear		No Access			9555						
2F05 Stairs & Landing	Insulation To Beams	Spayed Coating	Refer to sample RC070807/01 N.A.D.I.S.		5m ²							
2F05 Stairs & Landing	Black Vinyl Stair Nosing	Bonded	RC070807/04 N.A.D.I.S.		21Lm	9557						
2F06 Book Hoist	Locked		No Access			9556
