Asbestos Management Survey Report

Clarence House, Civic Campus, Euclid Street, Swindon, SN1 2SG

Executive Summary

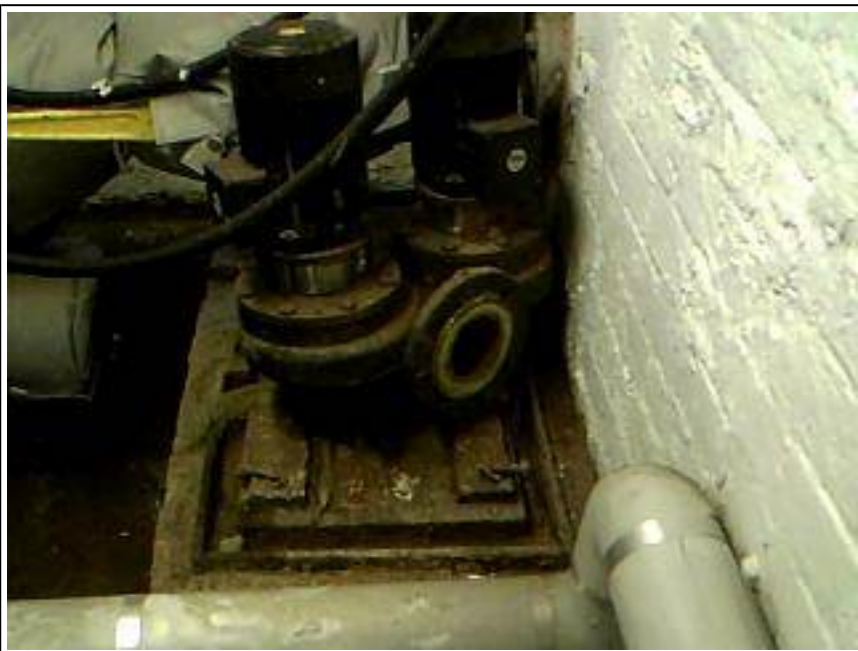
Survey Data Sheet: Conclusions & Recommendations
 Site Location: Clarence House, Civic Campus, Euclid Street, Swindon, SN1 2SG
 Building Designation: 01
 Unique item Number: 2

Sample Ref	FI	Location	Description	Qty	Analysis Result	Total M.A.S	Licensed Material Y/N
AD006138	Z-Sub Level 1	Boiler Room. B02	Floor - Gaskets - Textiles/Paper	<1m²	NADIS		N

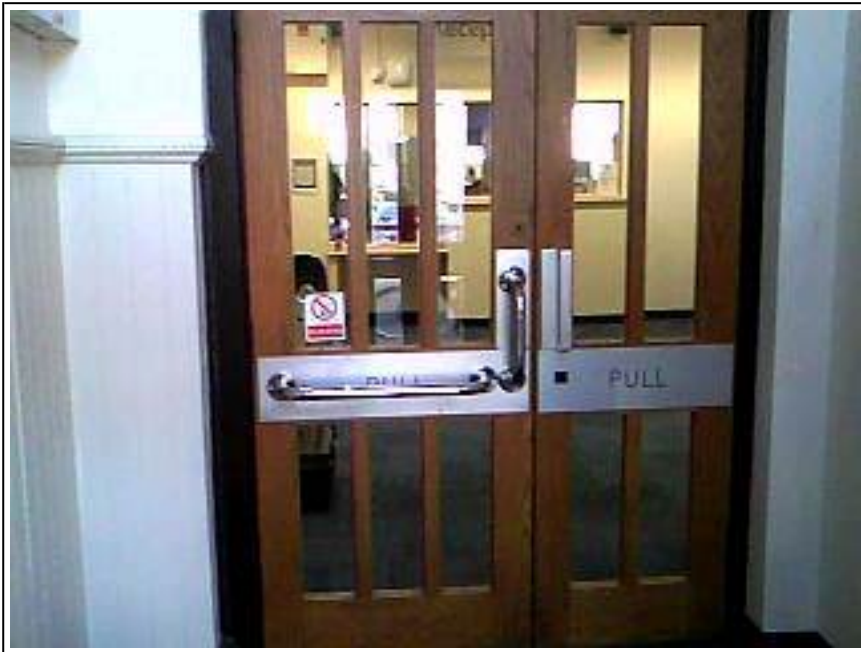
Survey Data Sheet: Conclusions & Recommendations
 Site Location: Clarence House, Civic Campus, Euclid Street, Swindon, SN1 2SG
 Building Designation: 01
 Unique item Number: 8

Sample Ref	FI	Location	Description	Qty	Analysis Result	Total M.A.S	Licensed Material Y/N
Surveyed	Ground Floor	Entrance Hall. 001	No asbestos detected -		N/A		N

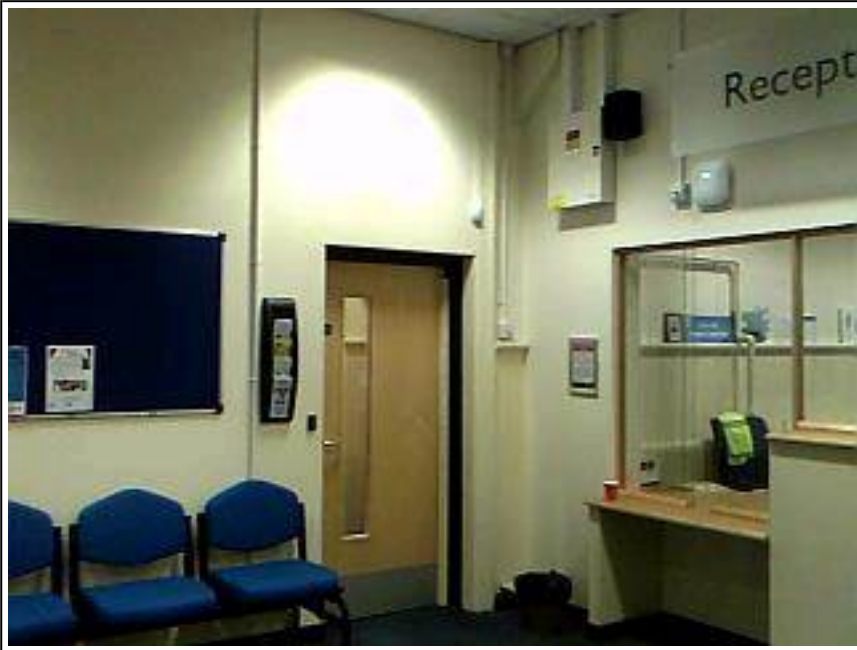
Survey Data Sheet: Conclusions & Recommendations
 Site Location: Clarence House, Civic Campus, Euclid Street, Swindon, SN1 2SG
 Building Designation: 01
 Unique item Number: 9

Sample Ref	FI	Location	Description	Qty	Analysis Result	Total M.A.S	Licensed Material Y/N
Surveyed	Ground Floor	Reception. 002	No asbestos detected -		N/A		N

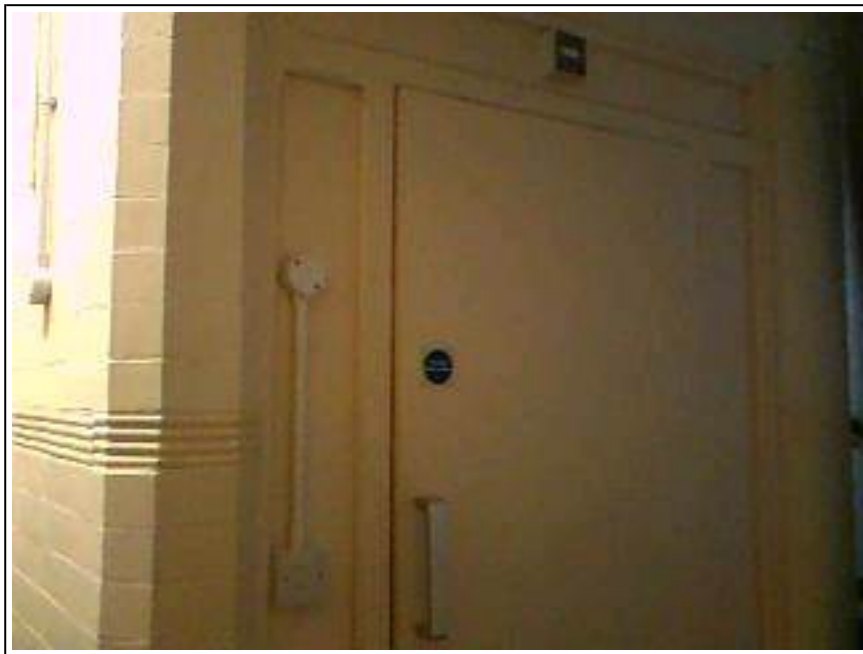
Survey Data Sheet: Conclusions & Recommendations
 Site Location: Clarence House, Civic Campus, Euclid Street, Swindon, SN1 2SG
 Building Designation: 01
 Unique item Number: 11

Sample Ref	FI	Location	Description	Qty	Analysis Result	Total M.A.S	Licensed Material Y/N
No Access	Ground Floor	Understairs Cupboard. 004			No Access

This area must be presumed to contain asbestos materials pending further investigation.

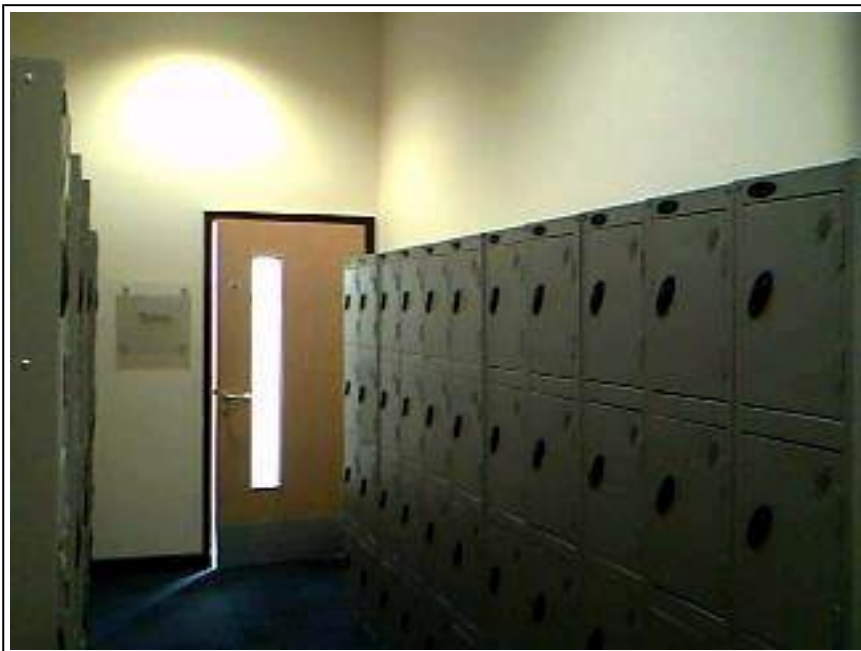
Survey Data Sheet: Conclusions & Recommendations
 Site Location: Clarence House, Civic Campus, Euclid Street, Swindon, SN1 2SG
 Building Designation: 01
 Unique item Number: 12

Sample Ref	FI	Location	Description	Qty	Analysis Result	Total M.A.S	Licensed Material Y/N
Surveyed	Ground Floor	Locker Room. 005	No asbestos detected -		N/A		N

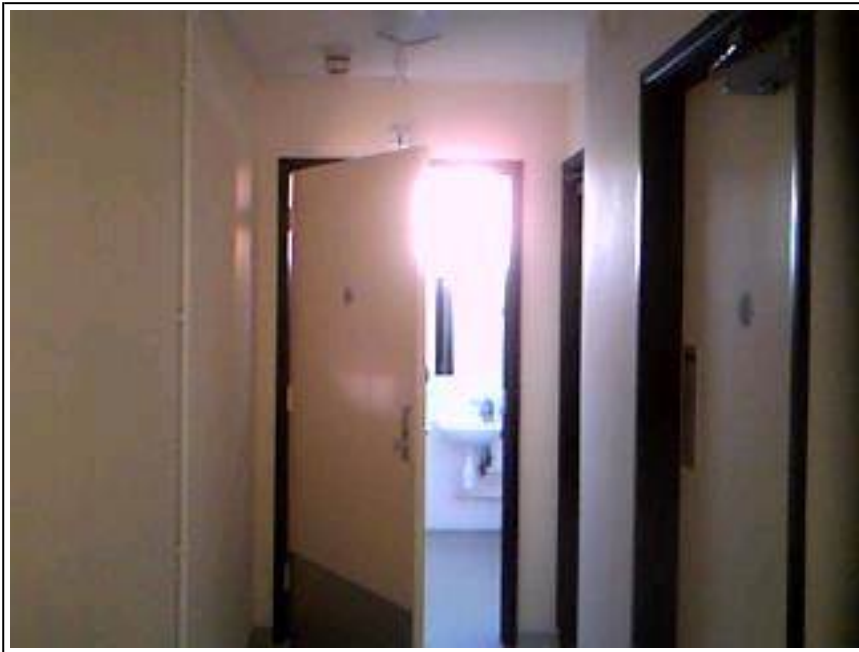
Survey Data Sheet: Conclusions & Recommendations
 Site Location: Clarence House, Civic Campus, Euclid Street, Swindon, SN1 2SG
 Building Designation: 01
 Unique item Number: 13

Sample Ref	FI	Location	Description	Qty	Analysis Result	Total M.A.S	Licensed Material Y/N
Surveyed	Ground Floor	Circulation. 006	No asbestos detected -		N/A		N

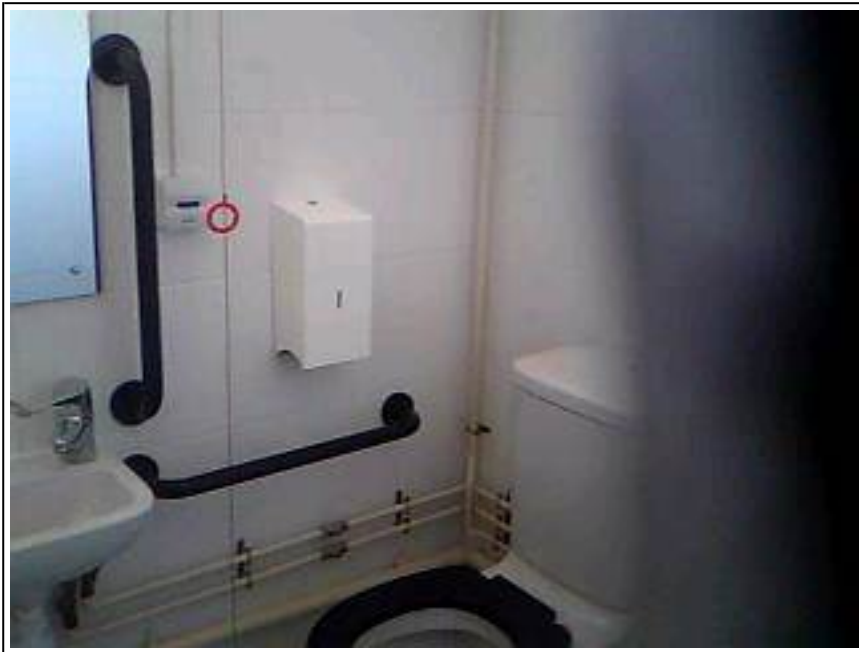
Survey Data Sheet: Conclusions & Recommendations
 Site Location: Clarence House, Civic Campus, Euclid Street, Swindon, SN1 2SG
 Building Designation: 01
 Unique item Number: 14

Sample Ref	FI	Location	Description	Qty	Analysis Result	Total M.A.S	Licensed Material Y/N
Surveyed	Ground Floor	Disabled Toilet. 007	No asbestos detected -		N/A		N

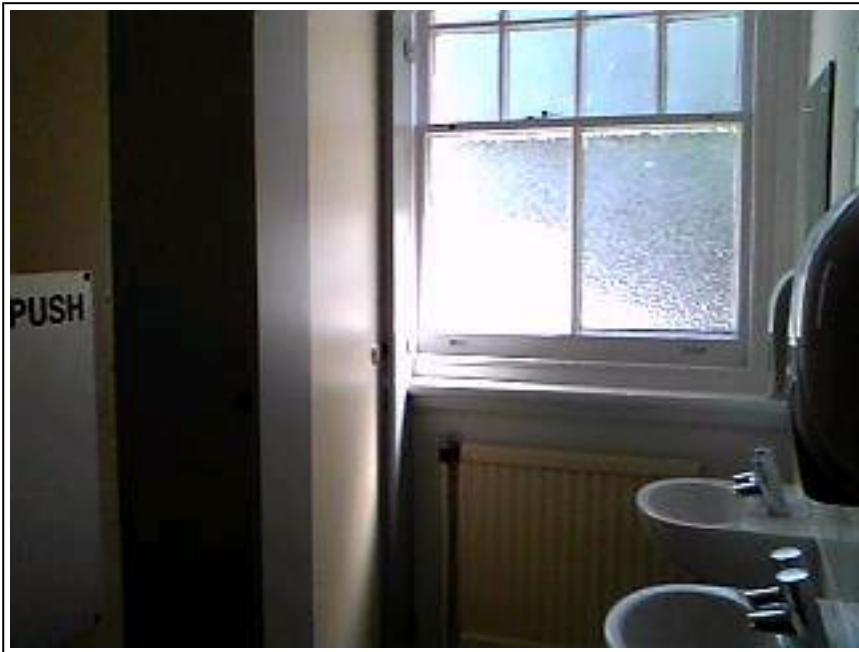
Survey Data Sheet: Conclusions & Recommendations
 Site Location: Clarence House, Civic Campus, Euclid Street, Swindon, SN1 2SG
 Building Designation: 01
 Unique item Number: 15

Sample Ref	FI	Location	Description	Qty	Analysis Result	Total M.A.S	Licensed Material Y/N
Surveyed	Ground Floor	Female Toilet. 008	No asbestos detected -		N/A		N

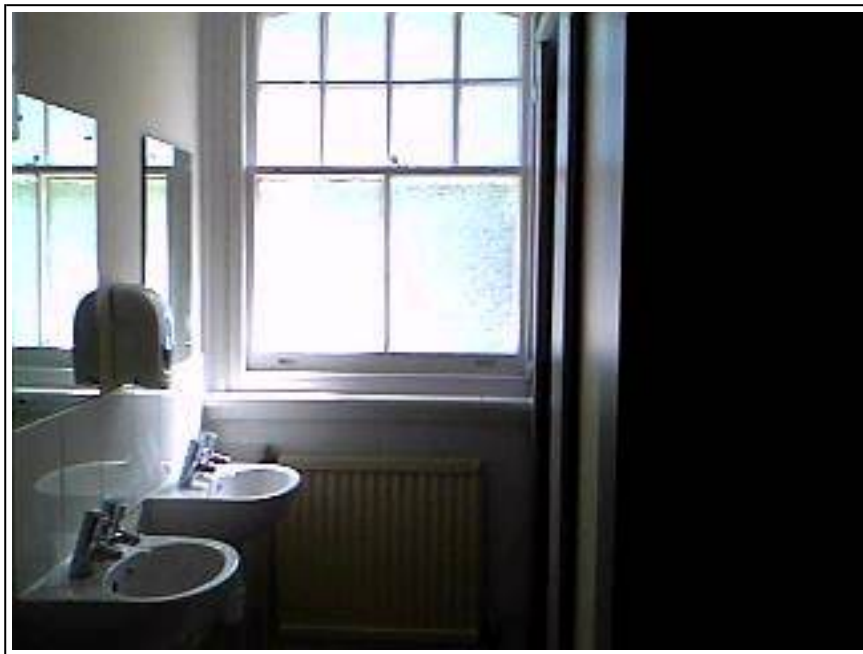
Survey Data Sheet: Conclusions & Recommendations
 Site Location: Clarence House, Civic Campus, Euclid Street, Swindon, SN1 2SG
 Building Designation: 01
 Unique item Number: 16

Sample Ref	FI	Location	Description	Qty	Analysis Result	Total M.A.S	Licensed Material Y/N
Surveyed	Ground Floor	Male Toilet. 009	No asbestos detected -		N/A		N

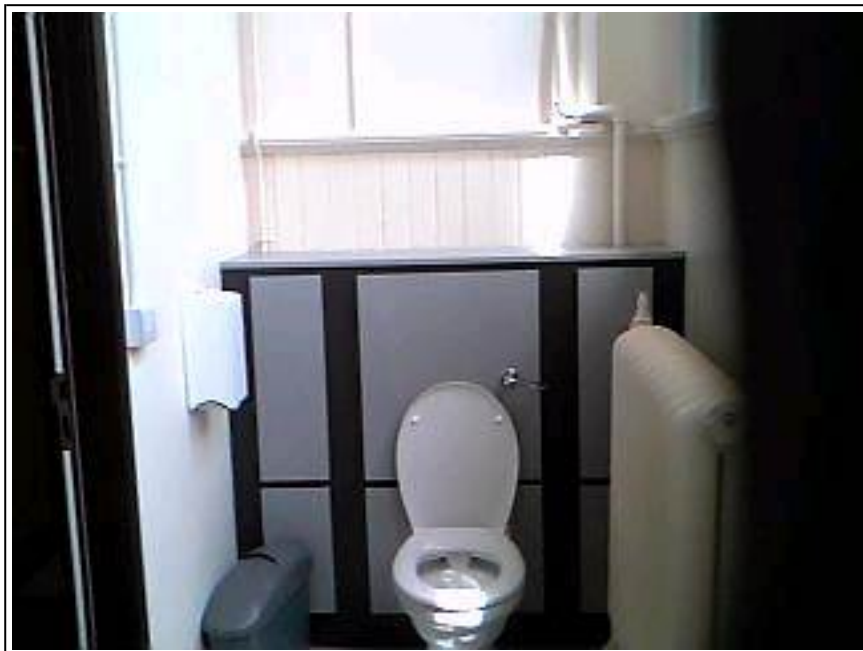
Survey Data Sheet: Conclusions & Recommendations
 Site Location: Clarence House, Civic Campus, Euclid Street, Swindon, SN1 2SG
 Building Designation: 01
 Unique item Number: 17

Sample Ref	FI	Location	Description	Qty	Analysis Result	Total M.A.S	Licensed Material Y/N
Surveyed	Ground Floor	Disabled Toilet. 010	No asbestos detected -		N/A		N

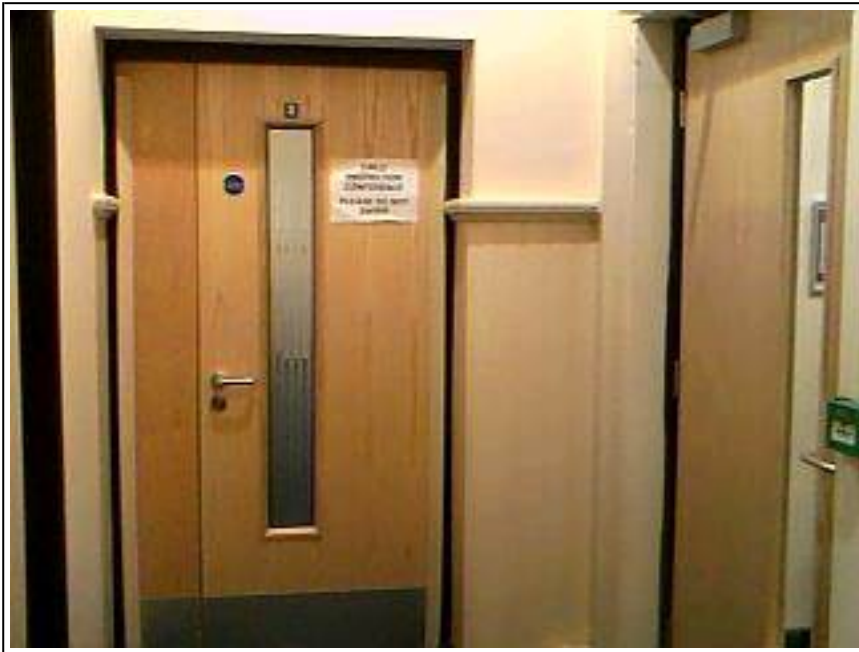
Survey Data Sheet: Conclusions & Recommendations
 Site Location: Clarence House, Civic Campus, Euclid Street, Swindon, SN1 2SG
 Building Designation: 01
 Unique item Number: 18

Sample Ref	FI	Location	Description	Qty	Analysis Result	Total M.A.S	Licensed Material Y/N
Surveyed	Ground Floor	Corridor. 011	No asbestos detected -		N/A		N

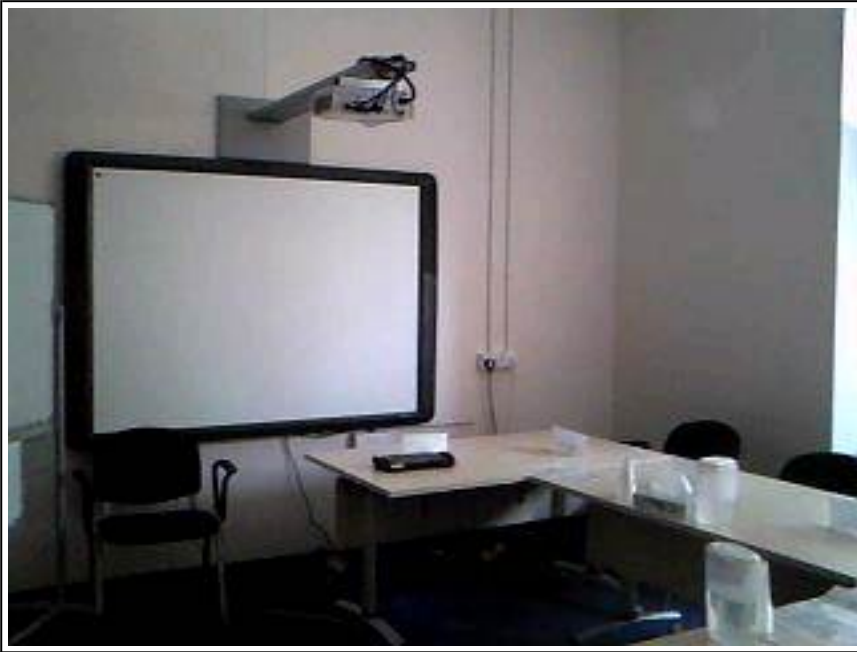
Survey Data Sheet: Conclusions & Recommendations
 Site Location: Clarence House, Civic Campus, Euclid Street, Swindon, SN1 2SG
 Building Designation: 01
 Unique item Number: 19

Sample Ref	Fl	Location	Description	Qty	Analysis Result	Total M.A.S	Licensed Material Y/N
Surveyed	Ground Floor	Conference Room. 012	No asbestos detected -		N/A		N

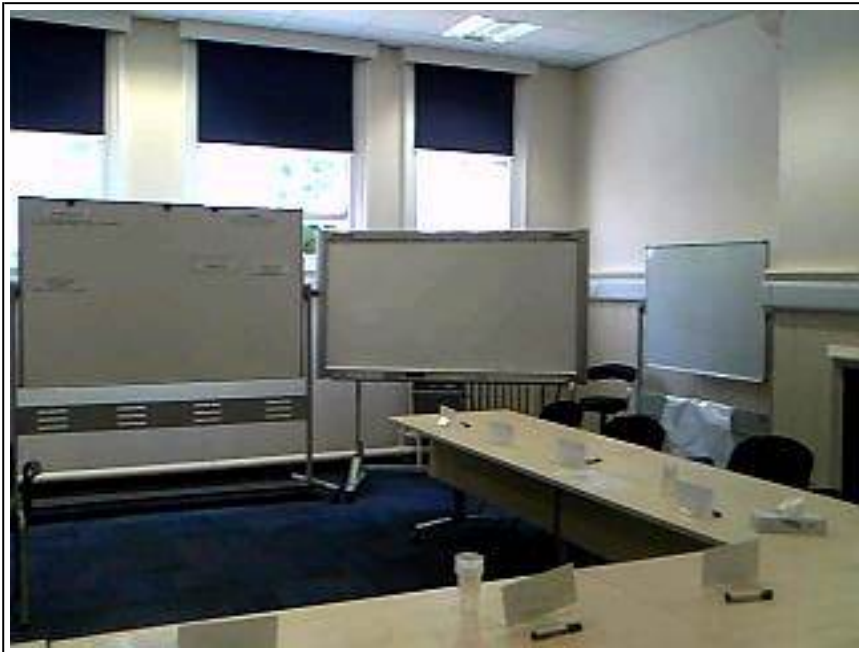
Survey Data Sheet: Conclusions & Recommendations
 Site Location: Clarence House, Civic Campus, Euclid Street, Swindon, SN1 2SG
 Building Designation: 01
 Unique item Number: 20

Sample Ref	Fl	Location	Description	Qty	Analysis Result	Total M.A.S	Licensed Material Y/N
Surveyed	Ground Floor	Conference Room. 013	No asbestos detected -		N/A		N

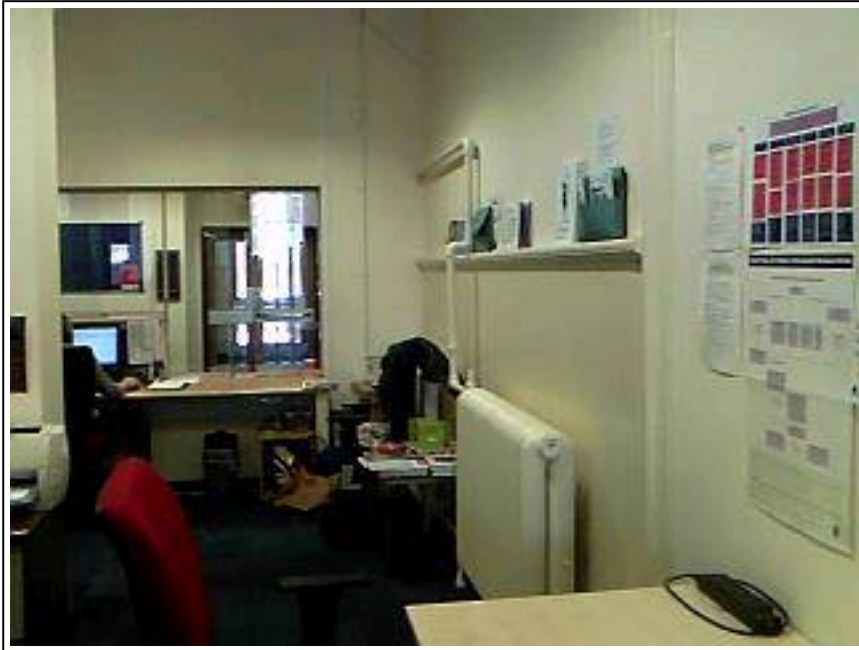
Survey Data Sheet: Conclusions & Recommendations
 Site Location: Clarence House, Civic Campus, Euclid Street, Swindon, SN1 2SG
 Building Designation: 01
 Unique item Number: 21

Sample Ref	Fl	Location	Description	Qty	Analysis Result	Total M.A.S	Licensed Material Y/N
Surveyed	Ground Floor	Open Plan Office. 014	No asbestos detected -		N/A		N

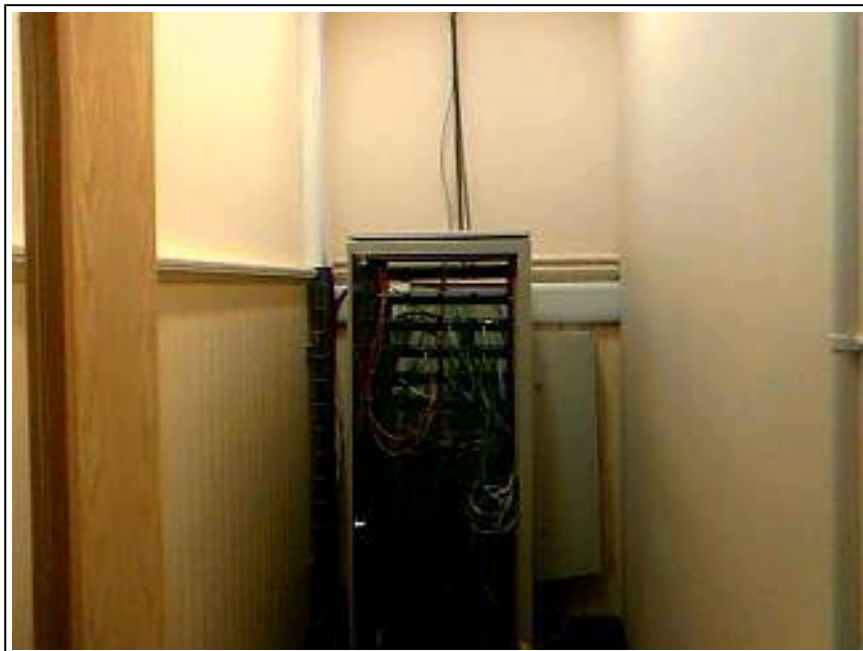
Survey Data Sheet: Conclusions & Recommendations
 Site Location: Clarence House, Civic Campus, Euclid Street, Swindon, SN1 2SG
 Building Designation: 01
 Unique item Number: 22

Sample Ref	FI	Location	Description	Qty	Analysis Result	Total M.A.S	Licensed Material Y/N
Surveyed	Ground Floor	Comms Room. 015	No asbestos detected -		N/A		N

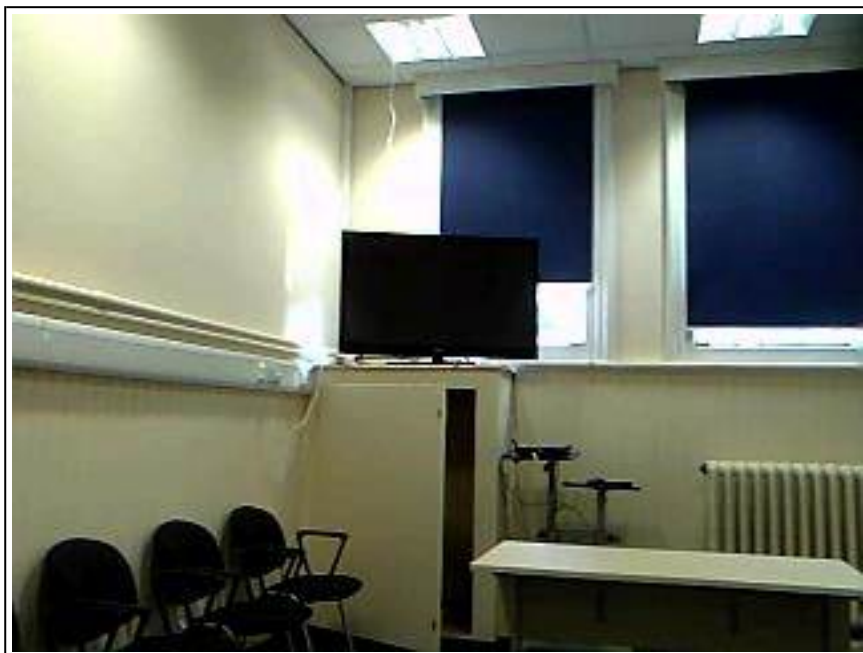
Survey Data Sheet: Conclusions & Recommendations
 Site Location: Clarence House, Civic Campus, Euclid Street, Swindon, SN1 2SG
 Building Designation: 01
 Unique item Number: 23

Sample Ref	Fl	Location	Description	Qty	Analysis Result	Total M.A.S	Licensed Material Y/N
Surveyed	Ground Floor	Conference Room. 016	No asbestos detected -		N/A		N

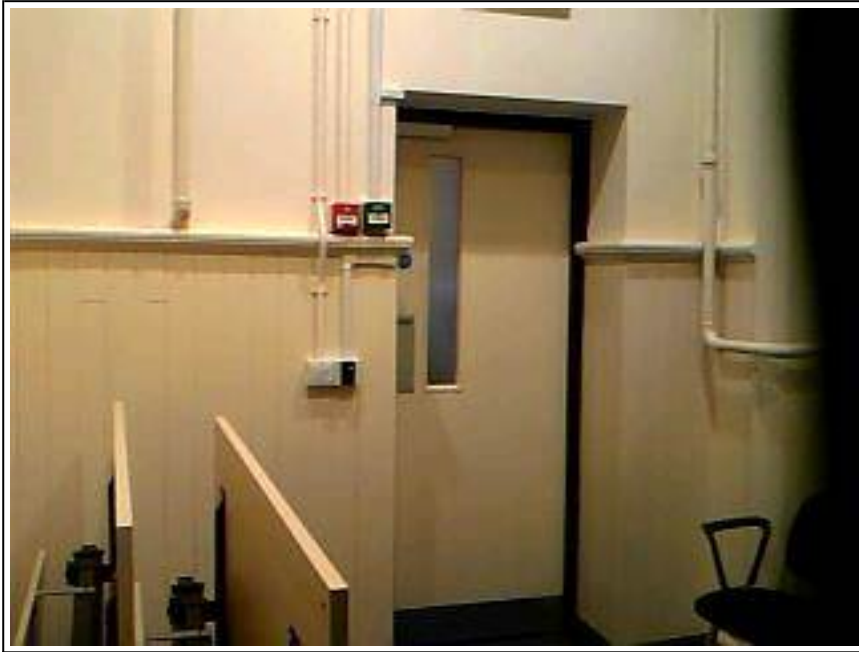
Survey Data Sheet: Conclusions & Recommendations
 Site Location: Clarence House, Civic Campus, Euclid Street, Swindon, SN1 2SG
 Building Designation: 01
 Unique item Number: 24

Sample Ref	FI	Location	Description	Qty	Analysis Result	Total M.A.S	Licensed Material Y/N
Surveyed	Ground Floor	Circulation. 017	No asbestos detected -		N/A		N

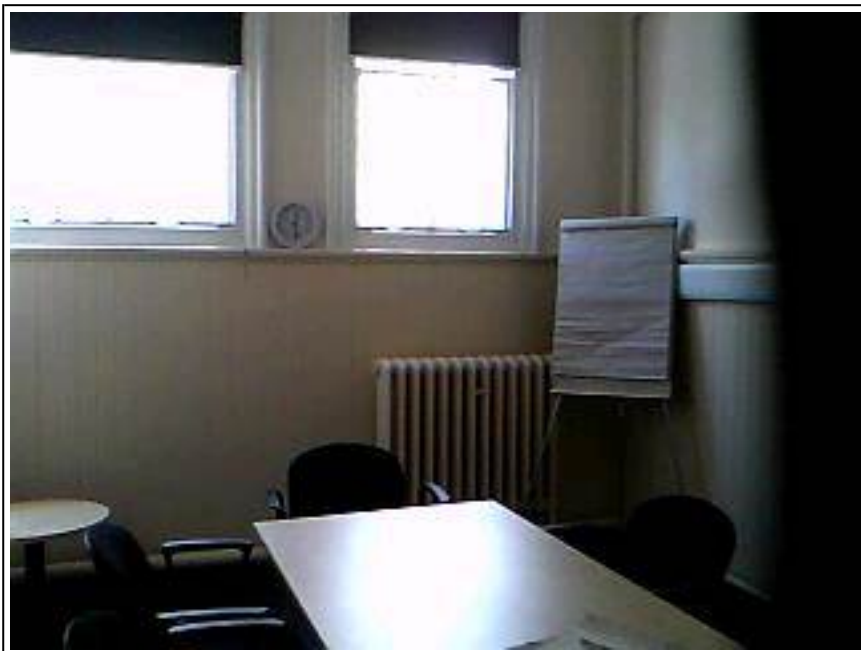
Survey Data Sheet: Conclusions & Recommendations
 Site Location: Clarence House, Civic Campus, Euclid Street, Swindon, SN1 2SG
 Building Designation: 01
 Unique item Number: 25

Sample Ref	FI	Location	Description	Qty	Analysis Result	Total M.A.S	Licensed Material Y/N
Surveyed	Ground Floor	Office. 018	No asbestos detected -		N/A		N

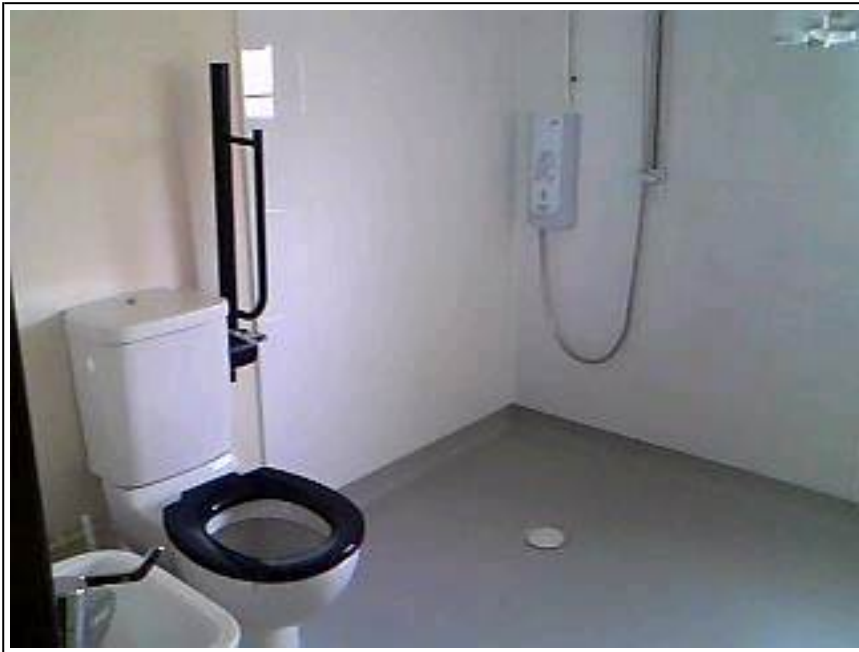
Survey Data Sheet: Conclusions & Recommendations
 Site Location: Clarence House, Civic Campus, Euclid Street, Swindon, SN1 2SG
 Building Designation: 01
 Unique item Number: 29

Sample Ref	FI	Location	Description	Qty	Analysis Result	Total M.A.S	Licensed Material Y/N
Surveyed	Ground Floor	Disabled Toilet. 022	No asbestos detected -		N/A		N

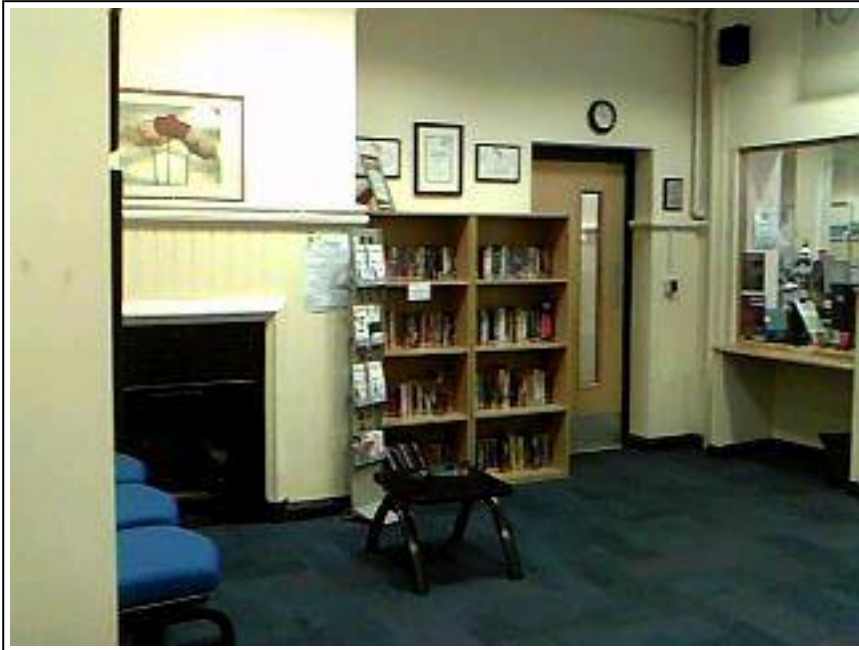
Survey Data Sheet: Conclusions & Recommendations
 Site Location: Clarence House, Civic Campus, Euclid Street, Swindon, SN1 2SG
 Building Designation: 01
 Unique item Number: 33

Sample Ref	FI	Location	Description	Qty	Analysis Result	Total M.A.S	Licensed Material Y/N
Surveyed	Ground Floor	Library. 026	No asbestos detected -		N/A		N

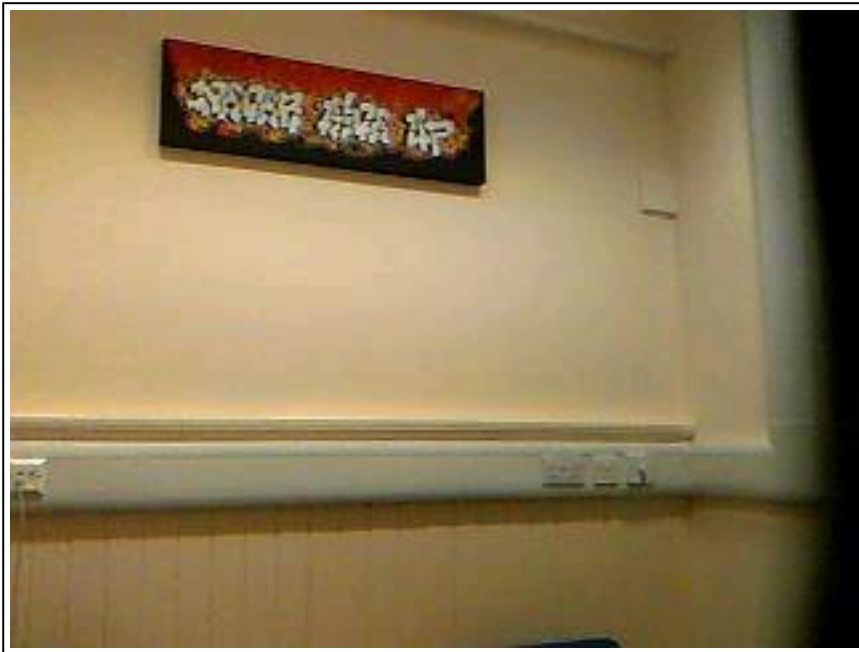
Survey Data Sheet: Conclusions & Recommendations
 Site Location: Clarence House, Civic Campus, Euclid Street, Swindon, SN1 2SG
 Building Designation: 01
 Unique item Number: 34

Sample Ref	FI	Location	Description	Qty	Analysis Result	Total M.A.S	Licensed Material Y/N
Surveyed	Ground Floor	Meeting Room. 027	No asbestos detected -		N/A		N

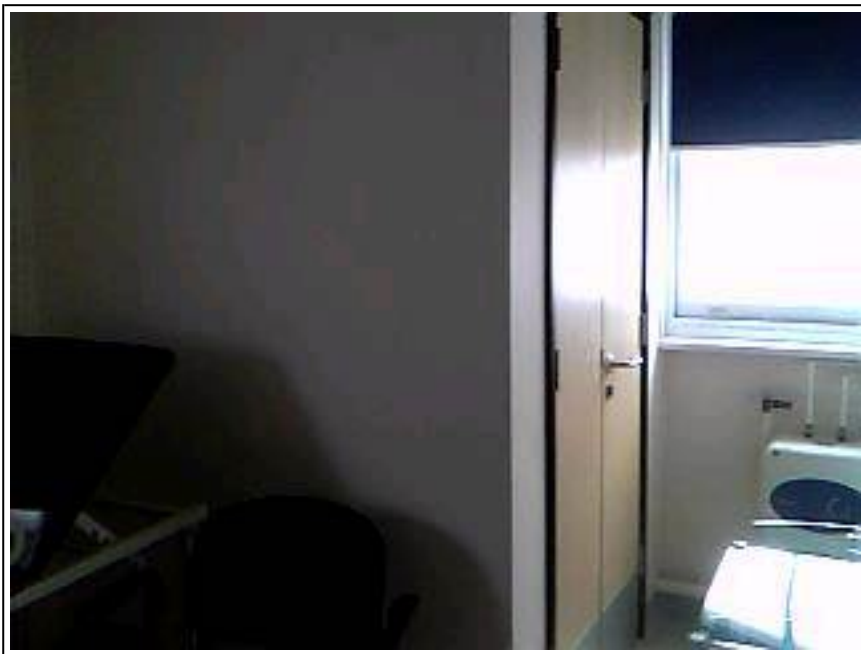
Survey Data Sheet: Conclusions & Recommendations
 Site Location: Clarence House, Civic Campus, Euclid Street, Swindon, SN1 2SG
 Building Designation: 01
 Unique item Number: 35

Sample Ref	FI	Location	Description	Qty	Analysis Result	Total M.A.S	Licensed Material Y/N
Surveyed	Ground Floor	Medical Room. 028	No asbestos detected -		N/A		N

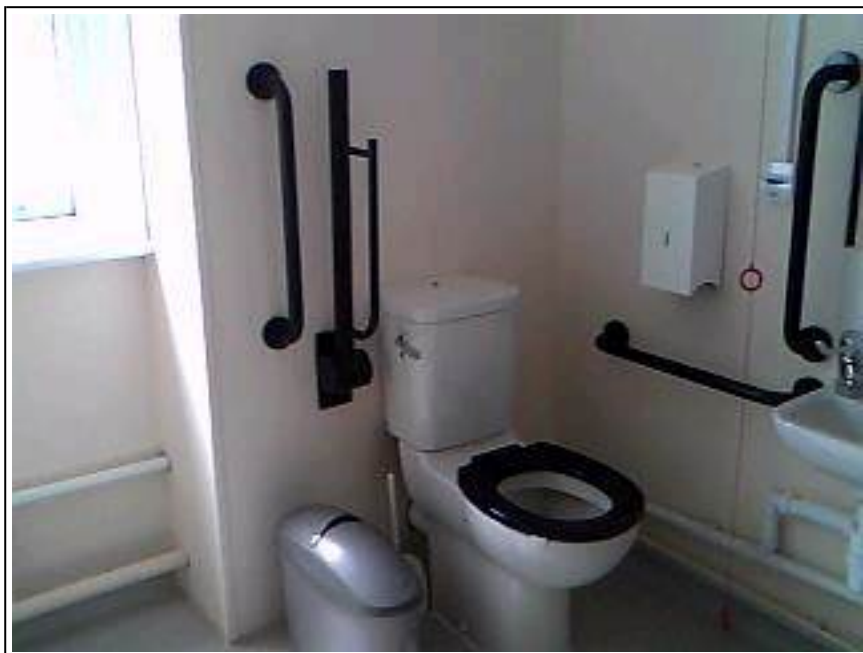
Survey Data Sheet: Conclusions & Recommendations
 Site Location: Clarence House, Civic Campus, Euclid Street, Swindon, SN1 2SG
 Building Designation: 01
 Unique item Number: 36

Sample Ref	FI	Location	Description	Qty	Analysis Result	Total M.A.S	Licensed Material Y/N
Surveyed	Ground Floor	Disabled Toilet. 029	No asbestos detected -		N/A		N

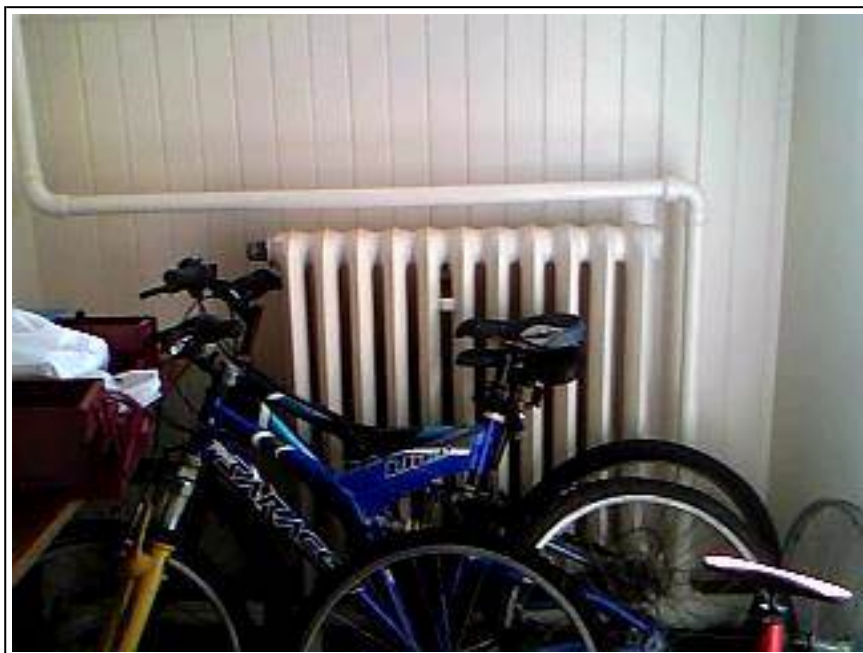
Survey Data Sheet: Conclusions & Recommendations
 Site Location: Clarence House, Civic Campus, Euclid Street, Swindon, SN1 2SG
 Building Designation: 01
 Unique item Number: 37

Sample Ref	Fl	Location	Description	Qty	Analysis Result	Total M.A.S	Licensed Material Y/N
Surveyed	Ground Floor	Quick Meet-Up Room. 030	No asbestos detected -		N/A		N

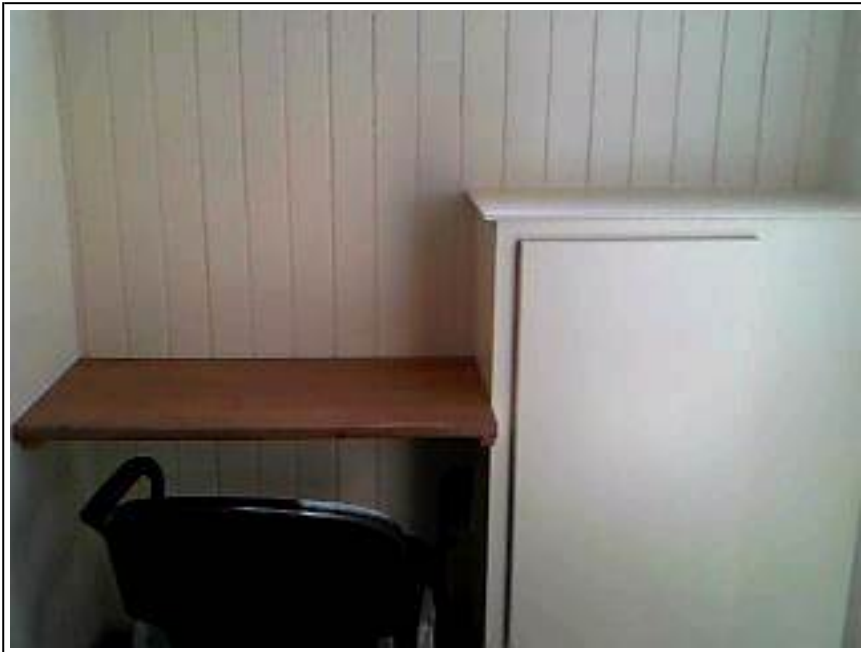
Survey Data Sheet: Conclusions & Recommendations
 Site Location: Clarence House, Civic Campus, Euclid Street, Swindon, SN1 2SG
 Building Designation: 01
 Unique item Number: 38

Sample Ref	Fl	Location	Description	Qty	Analysis Result	Total M.A.S	Licensed Material Y/N
Surveyed	Ground Floor	Quick Meet-Up Room. 031	No asbestos detected -		N/A		N

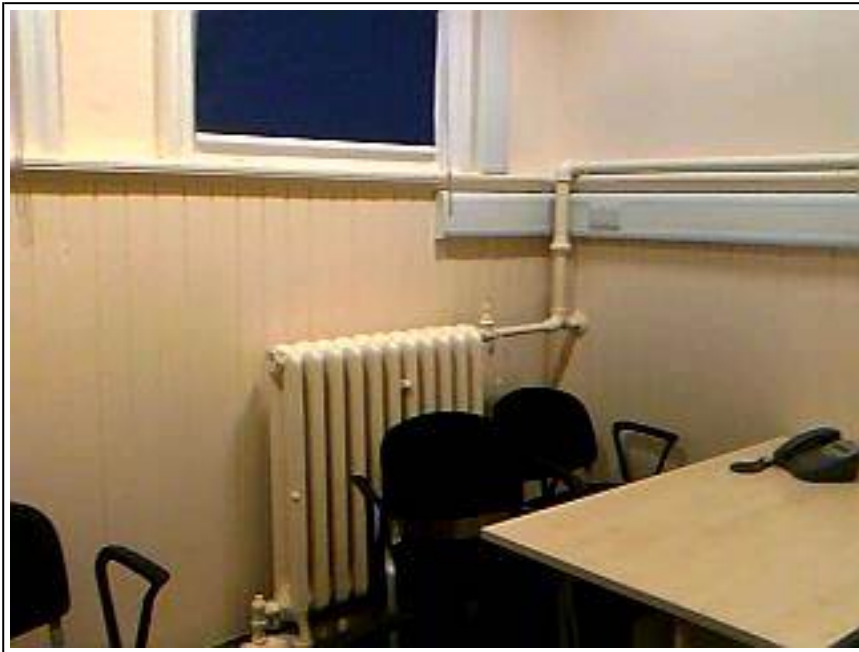
Survey Data Sheet: Conclusions & Recommendations
 Site Location: Clarence House, Civic Campus, Euclid Street, Swindon, SN1 2SG
 Building Designation: 01
 Unique item Number: 39

Sample Ref	FI	Location	Description	Qty	Analysis Result	Total M.A.S	Licensed Material Y/N
Surveyed	Ground Floor	Meeting Room. 032	No asbestos detected -		N/A		N

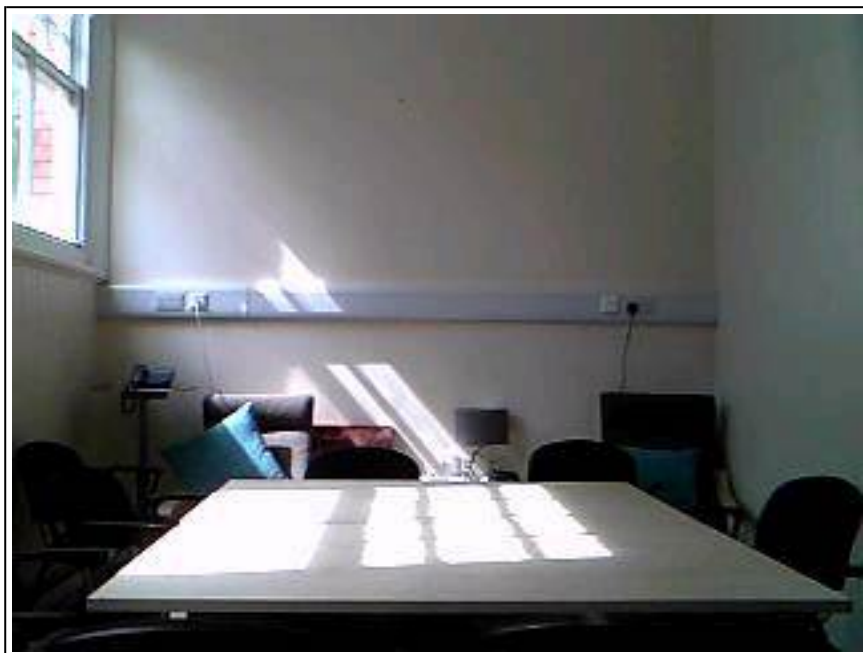
Survey Data Sheet: Conclusions & Recommendations
 Site Location: Clarence House, Civic Campus, Euclid Street, Swindon, SN1 2SG
 Building Designation: 01
 Unique item Number: 41

Sample Ref	FI	Location	Description	Qty	Analysis Result	Total M.A.S	Licensed Material Y/N
Surveyed	Ground Floor	Meeting Room. 034	No asbestos detected -		N/A		N

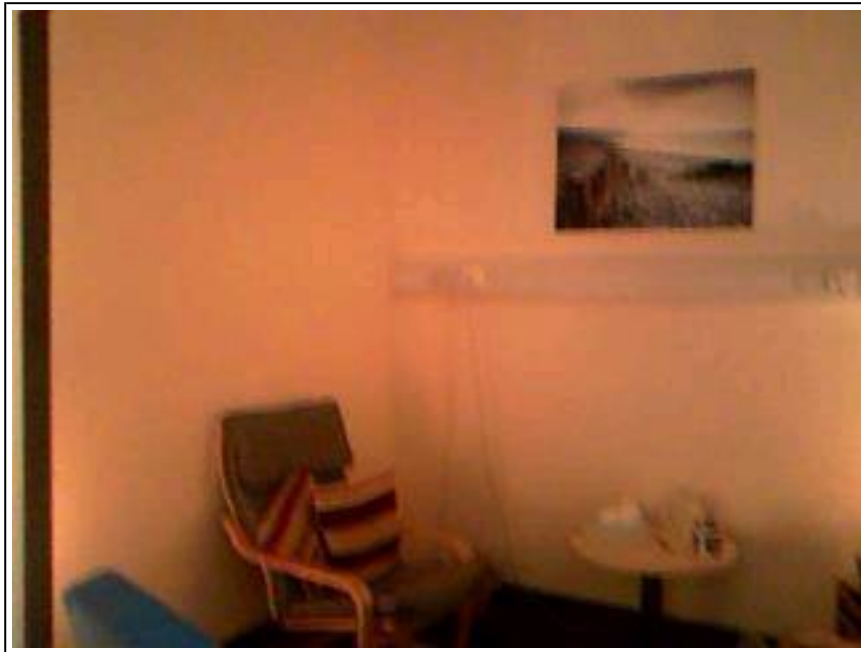
Survey Data Sheet: Conclusions & Recommendations
 Site Location: Clarence House, Civic Campus, Euclid Street, Swindon, SN1 2SG
 Building Designation: 01
 Unique item Number: 42

Sample Ref	FI	Location	Description	Qty	Analysis Result	Total M.A.S	Licensed Material Y/N
Surveyed	Ground Floor	Meeting Room. 035	No asbestos detected -		N/A		N

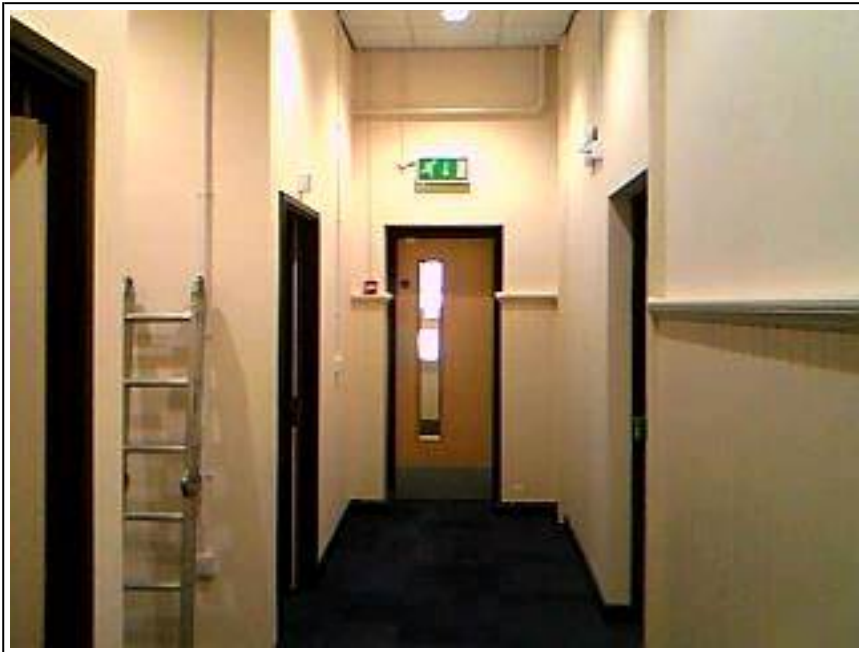
Survey Data Sheet: Conclusions & Recommendations
 Site Location: Clarence House, Civic Campus, Euclid Street, Swindon, SN1 2SG
 Building Designation: 01
 Unique item Number: 44

Sample Ref	FI	Location	Description	Qty	Analysis Result	Total M.A.S	Licensed Material Y/N
Surveyed	Ground Floor	Corridor. 037	No asbestos detected -		N/A		N

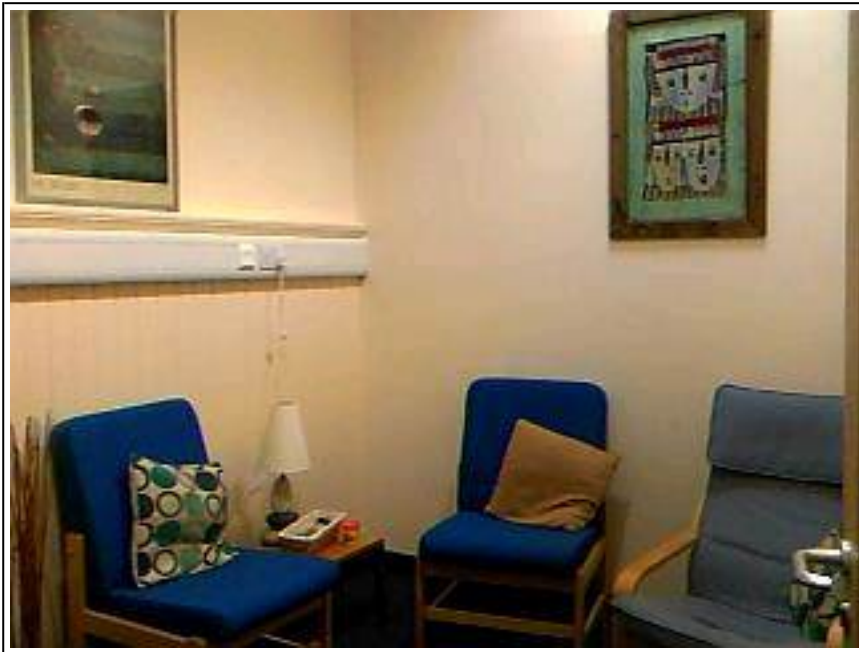
Survey Data Sheet: Conclusions & Recommendations
 Site Location: Clarence House, Civic Campus, Euclid Street, Swindon, SN1 2SG
 Building Designation: 01
 Unique item Number: 45

Sample Ref	FI	Location	Description	Qty	Analysis Result	Total M.A.S	Licensed Material Y/N
Surveyed	Ground Floor	Meeting room. 038	No asbestos detected -		N/A		N

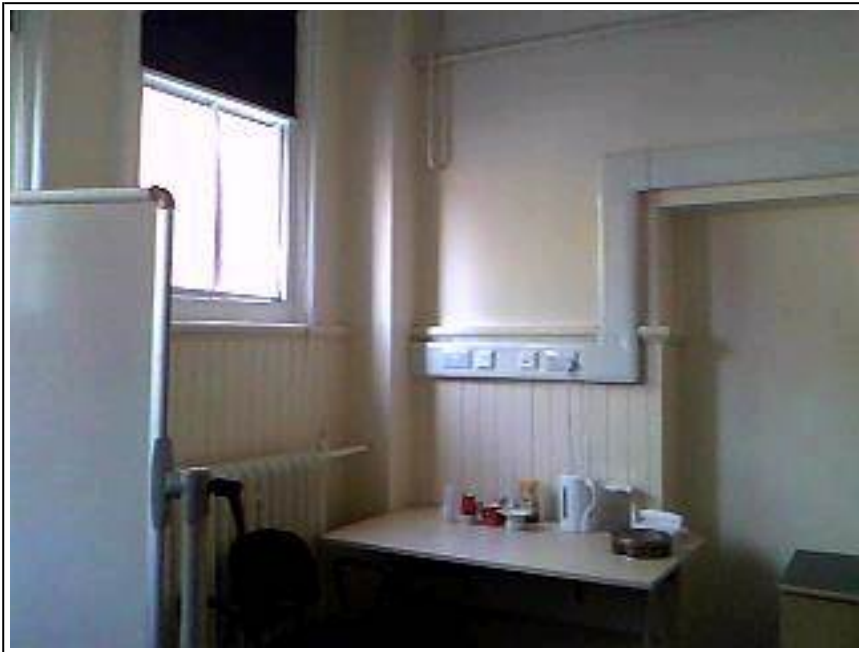
Survey Data Sheet: Conclusions & Recommendations
 Site Location: Clarence House, Civic Campus, Euclid Street, Swindon, SN1 2SG
 Building Designation: 01
 Unique item Number: 46

Sample Ref	FI	Location	Description	Qty	Analysis Result	Total M.A.S	Licensed Material Y/N
Surveyed	Ground Floor	Meeting room. 039	No asbestos detected -		N/A		N

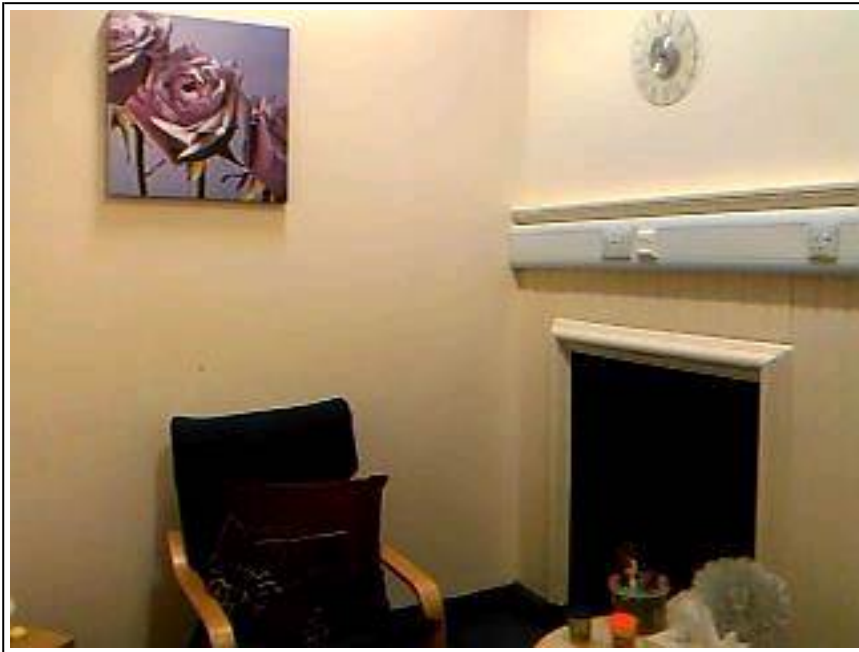
Survey Data Sheet: Conclusions & Recommendations
 Site Location: Clarence House, Civic Campus, Euclid Street, Swindon, SN1 2SG
 Building Designation: 01
 Unique item Number: 47

Sample Ref	FI	Location	Description	Qty	Analysis Result	Total M.A.S	Licensed Material Y/N
Surveyed	Ground Floor	Meeting room. 040	No asbestos detected -		N/A		N

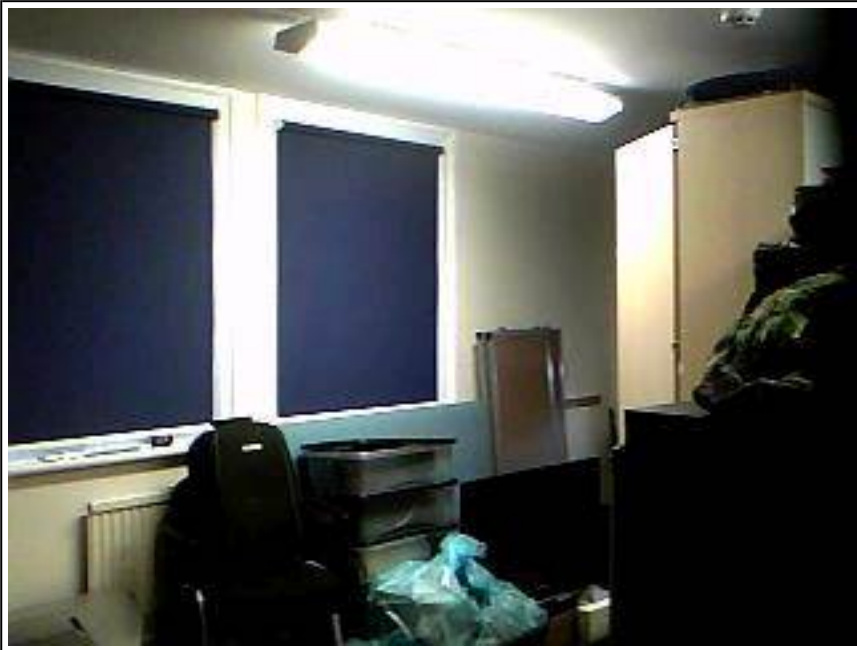
Survey Data Sheet: Conclusions & Recommendations
 Site Location: Clarence House, Civic Campus, Euclid Street, Swindon, SN1 2SG
 Building Designation: 01
 Unique item Number: 49

Sample Ref	FI	Location	Description	Qty	Analysis Result	Total M.A.S	Licensed Material Y/N
Surveyed	Ground Floor	Store room. 042	No asbestos detected -		N/A		N

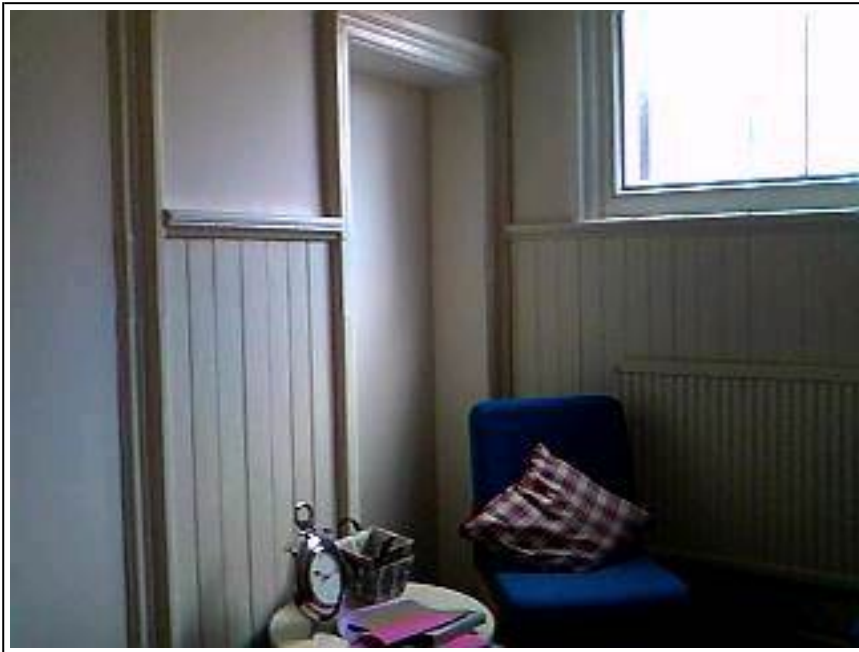
Survey Data Sheet: Conclusions & Recommendations
 Site Location: Clarence House, Civic Campus, Euclid Street, Swindon, SN1 2SG
 Building Designation: 01
 Unique item Number: 50

Sample Ref	FI	Location	Description	Qty	Analysis Result	Total M.A.S	Licensed Material Y/N
Surveyed	Ground Floor	Meeting room. 043	No asbestos detected -		N/A		N

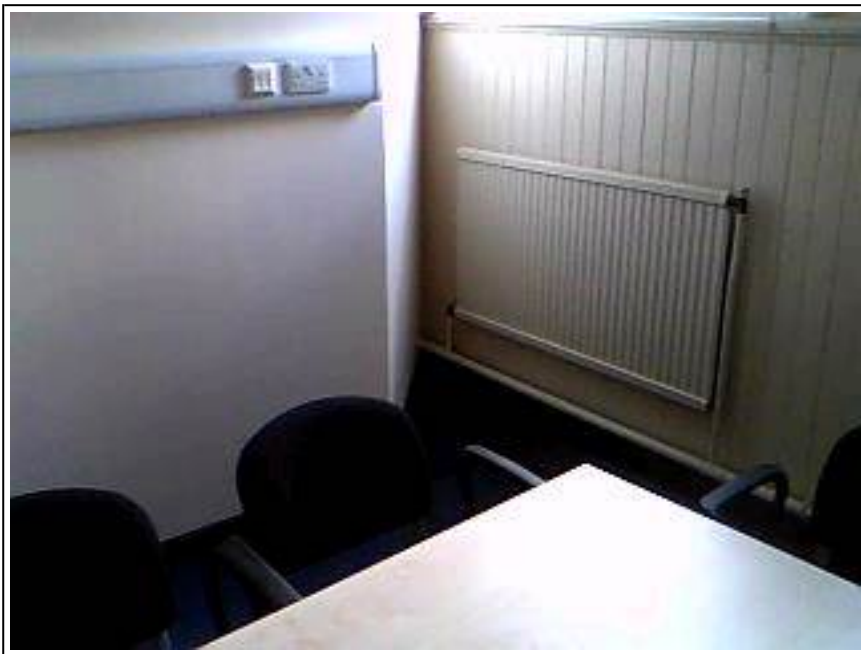
Survey Data Sheet: Conclusions & Recommendations
 Site Location: Clarence House, Civic Campus, Euclid Street, Swindon, SN1 2SG
 Building Designation: 01
 Unique item Number: 51

Sample Ref	FI	Location	Description	Qty	Analysis Result	Total M.A.S	Licensed Material Y/N
Surveyed	Ground Floor	Meeting room. 044	No asbestos detected -		N/A		N
