Asbestos Management Survey Report

Clarence House, Civic Campus, Euclid Street, Swindon, SN1 2SG

Executive Summary

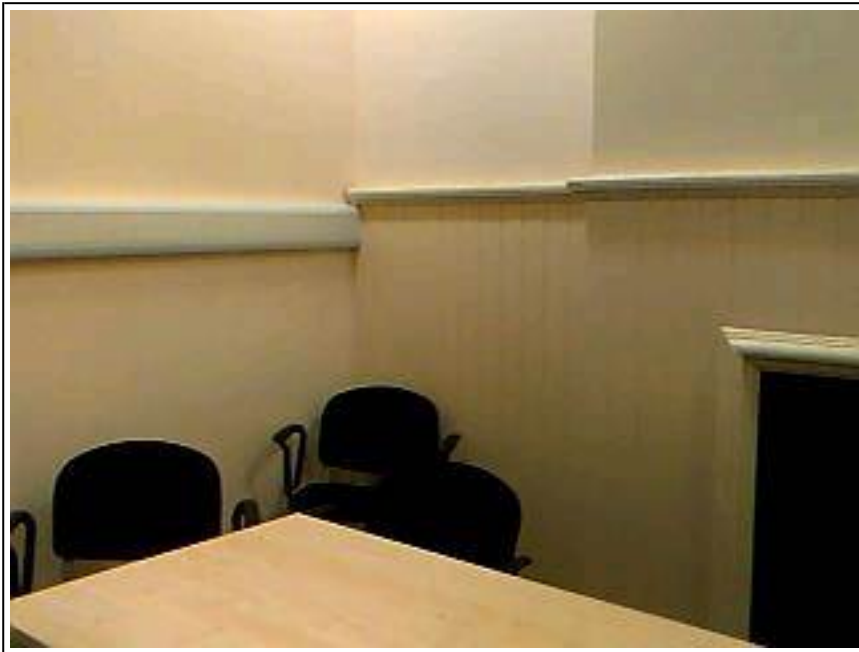
Survey Data Sheet: Conclusions & Recommendations
 Site Location: Clarence House, Civic Campus, Euclid Street, Swindon, SN1 2SG
 Building Designation: 01
 Unique item Number: 52

Sample Ref	FI	Location	Description	Qty	Analysis Result	Total M.A.S	Licensed Material Y/N
Surveyed	Ground Floor	Meeting room. 045	No asbestos detected -		N/A		N

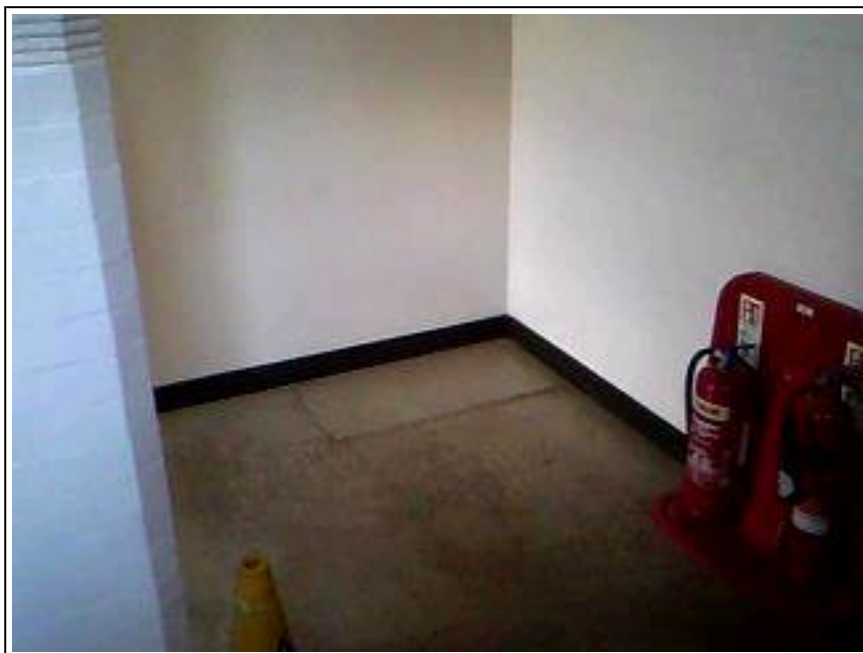
Survey Data Sheet: Conclusions & Recommendations
 Site Location: Clarence House, Civic Campus, Euclid Street, Swindon, SN1 2SG
 Building Designation: 01
 Unique item Number: 53

Sample Ref	Fl	Location	Description	Qty	Analysis Result	Total M.A.S	Licensed Material Y/N
Surveyed	1st Floor	Stairs/Landing. 101	No asbestos detected -		N/A		N

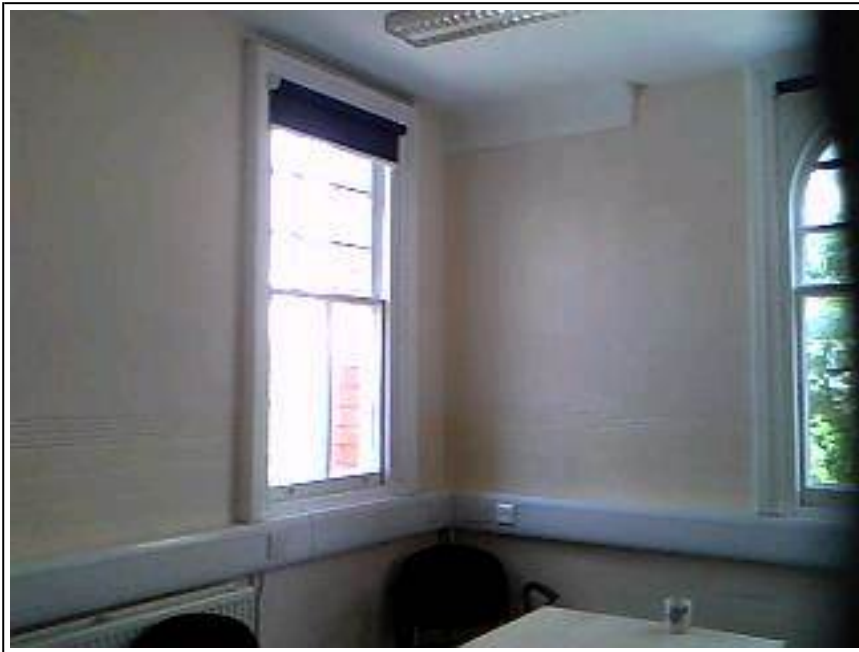
Survey Data Sheet: Conclusions & Recommendations
 Site Location: Clarence House, Civic Campus, Euclid Street, Swindon, SN1 2SG
 Building Designation: 01
 Unique item Number: 54

Sample Ref	Fl	Location	Description	Qty	Analysis Result	Total M.A.S	Licensed Material Y/N
Surveyed	1st Floor	Office. 102	No asbestos detected -		N/A		N

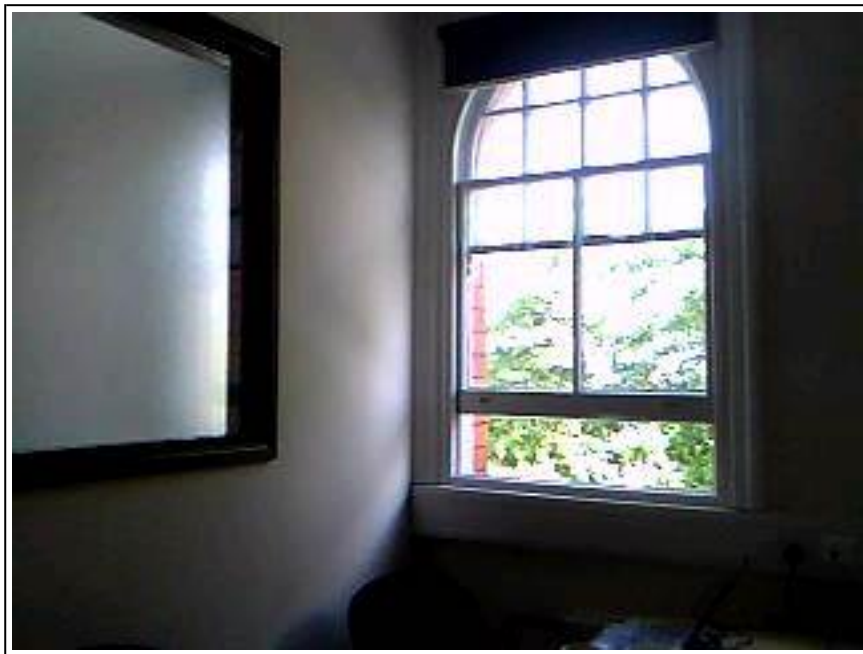
Survey Data Sheet: Conclusions & Recommendations
 Site Location: Clarence House, Civic Campus, Euclid Street, Swindon, SN1 2SG
 Building Designation: 01
 Unique item Number: 55

Sample Ref	Fl	Location	Description	Qty	Analysis Result	Total M.A.S	Licensed Material Y/N
Surveyed	1st Floor	Office. 103	No asbestos detected -		N/A		N

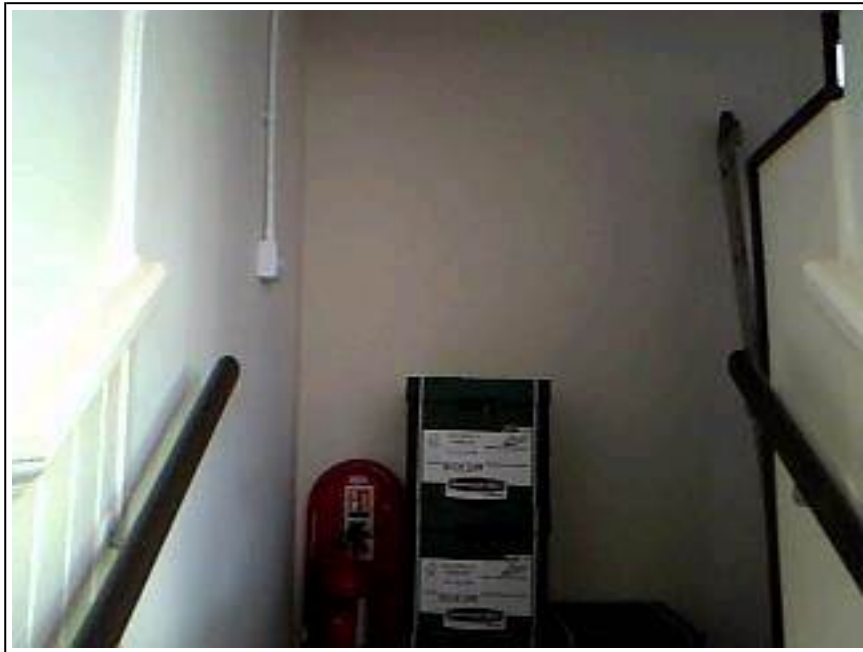
Survey Data Sheet: Conclusions & Recommendations
 Site Location: Clarence House, Civic Campus, Euclid Street, Swindon, SN1 2SG
 Building Designation: 01
 Unique item Number: 56

Sample Ref	FI	Location	Description	Qty	Analysis Result	Total M.A.S	Licensed Material Y/N
Surveyed	1st Floor	Circulation area. 104	No asbestos detected -		N/A		N

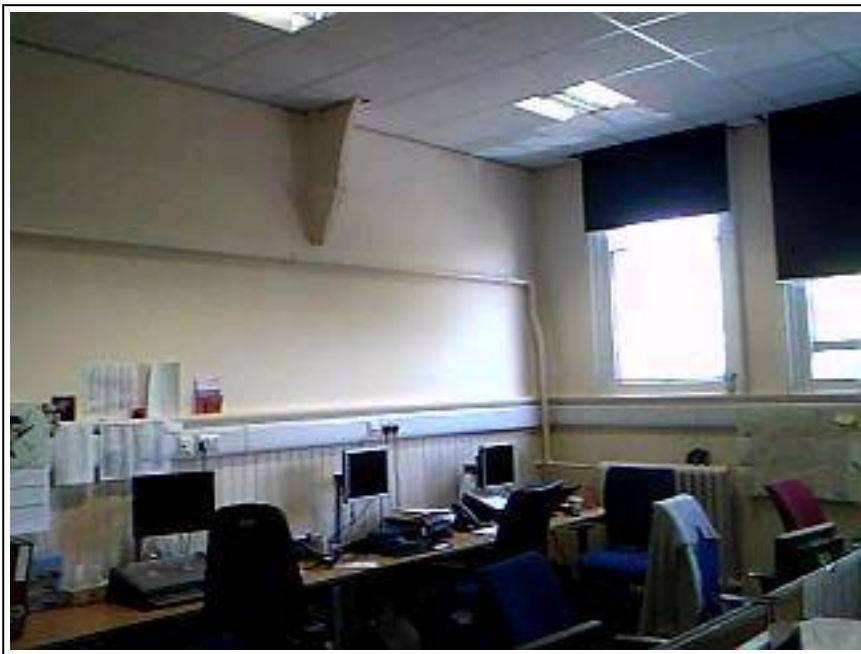
Survey Data Sheet: Conclusions & Recommendations
 Site Location: Clarence House, Civic Campus, Euclid Street, Swindon, SN1 2SG
 Building Designation: 01
 Unique item Number: 58

Sample Ref	Fl	Location	Description	Qty	Analysis Result	Total M.A.S	Licensed Material Y/N
Surveyed	1st Floor	Office. 106	No asbestos detected -		N/A		N

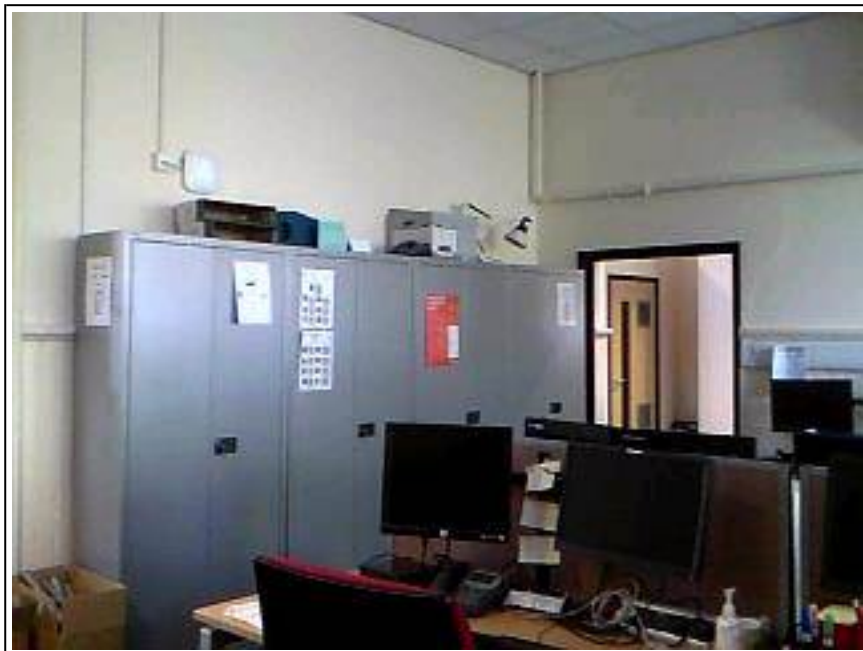
Survey Data Sheet: Conclusions & Recommendations
 Site Location: Clarence House, Civic Campus, Euclid Street, Swindon, SN1 2SG
 Building Designation: 01
 Unique item Number: 59

Sample Ref	Fl	Location	Description	Qty	Analysis Result	Total M.A.S	Licensed Material Y/N
Surveyed	1st Floor	Office. 107	No asbestos detected -		N/A		N

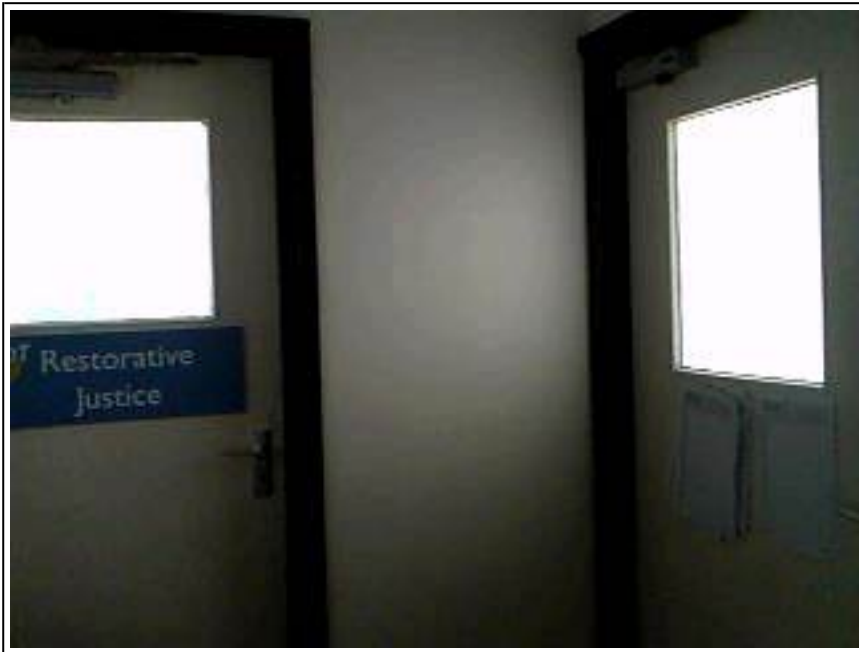
Survey Data Sheet: Conclusions & Recommendations
 Site Location: Clarence House, Civic Campus, Euclid Street, Swindon, SN1 2SG
 Building Designation: 01
 Unique item Number: 60

Sample Ref	FI	Location	Description	Qty	Analysis Result	Total M.A.S	Licensed Material Y/N
Surveyed	1st Floor	Circulation area. 108	No asbestos detected -		N/A		N

Recommended Action:	Advised Timescale for Action/Inspection:
-	N/A

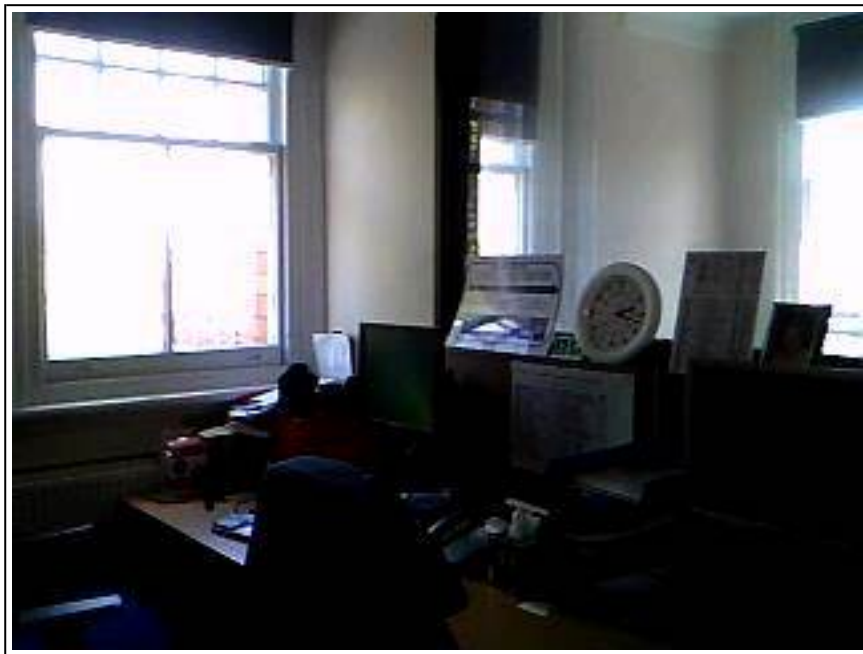
Survey Data Sheet: Conclusions & Recommendations
 Site Location: Clarence House, Civic Campus, Euclid Street, Swindon, SN1 2SG
 Building Designation: 01
 Unique item Number: 61

Sample Ref	Fl	Location	Description	Qty	Analysis Result	Total M.A.S	Licensed Material Y/N
Surveyed	1st Floor	Office. 109	No asbestos detected -		N/A		N

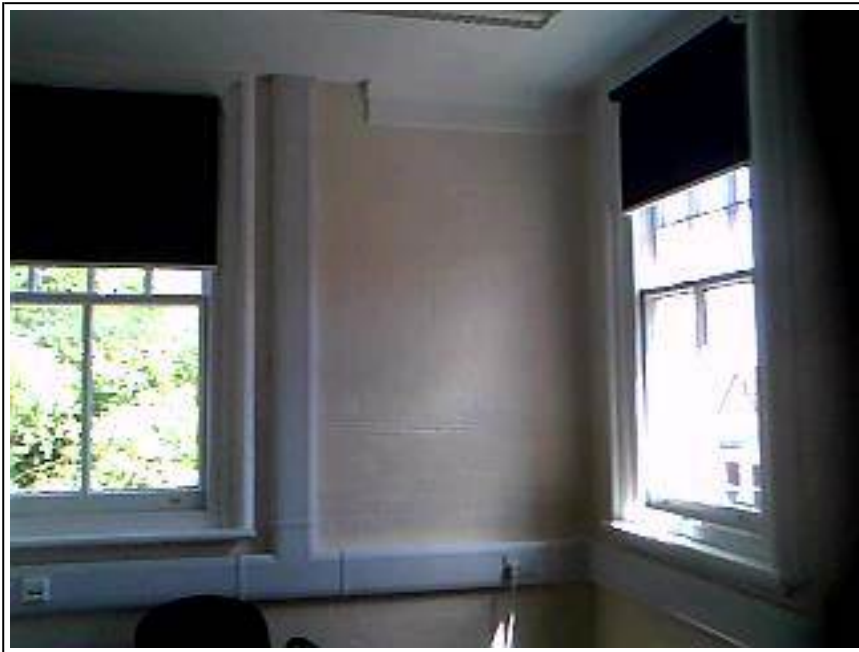
Survey Data Sheet: Conclusions & Recommendations
 Site Location: Clarence House, Civic Campus, Euclid Street, Swindon, SN1 2SG
 Building Designation: 01
 Unique item Number: 62

Sample Ref	Fl	Location	Description	Qty	Analysis Result	Total M.A.S	Licensed Material Y/N
Surveyed	1st Floor	Office. 110	No asbestos detected -		N/A		N

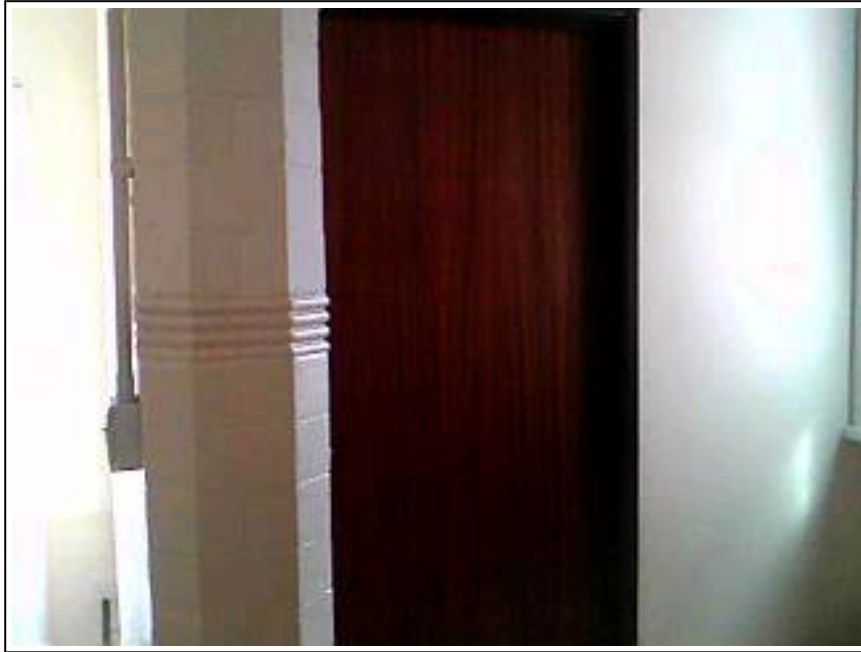
Survey Data Sheet: Conclusions & Recommendations
 Site Location: Clarence House, Civic Campus, Euclid Street, Swindon, SN1 2SG
 Building Designation: 01
 Unique item Number: 63

Sample Ref	Fl	Location	Description	Qty	Analysis Result	Total M.A.S	Licensed Material Y/N
Surveyed	1st Floor	Stairs/Landing. 111	No asbestos detected -		N/A		N

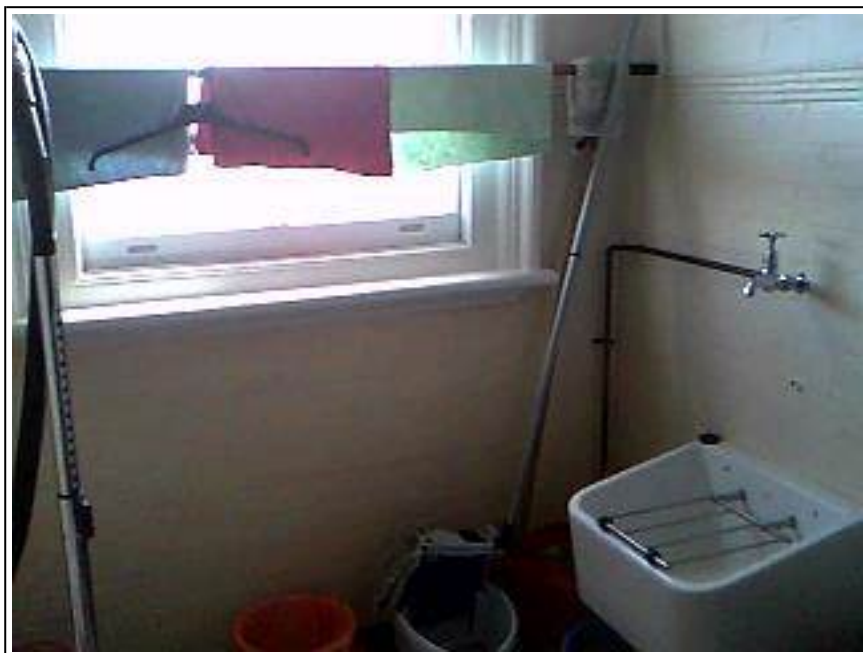
Survey Data Sheet: Conclusions & Recommendations
 Site Location: Clarence House, Civic Campus, Euclid Street, Swindon, SN1 2SG
 Building Designation: 01
 Unique item Number: 64

Sample Ref	Fl	Location	Description	Qty	Analysis Result	Total M.A.S	Licensed Material Y/N
Surveyed	1st Floor	Medical room. 112	No asbestos detected -		N/A		N

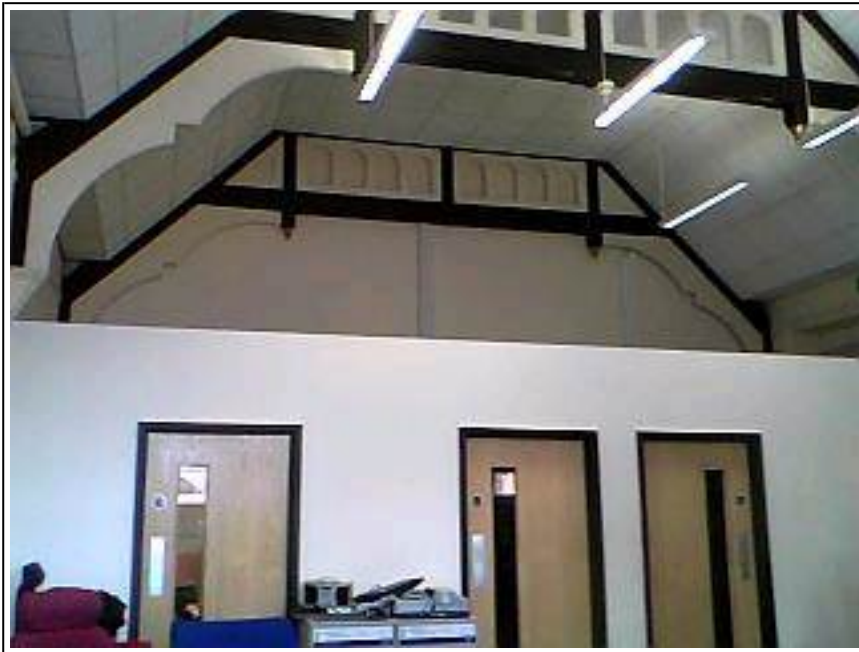
Survey Data Sheet: Conclusions & Recommendations
 Site Location: Clarence House, Civic Campus, Euclid Street, Swindon, SN1 2SG
 Building Designation: 01
 Unique item Number: 65

Sample Ref	Fl	Location	Description	Qty	Analysis Result	Total M.A.S	Licensed Material Y/N
Surveyed	1st Floor	Open plan office/kitchen. 113	No asbestos detected -		N/A		N

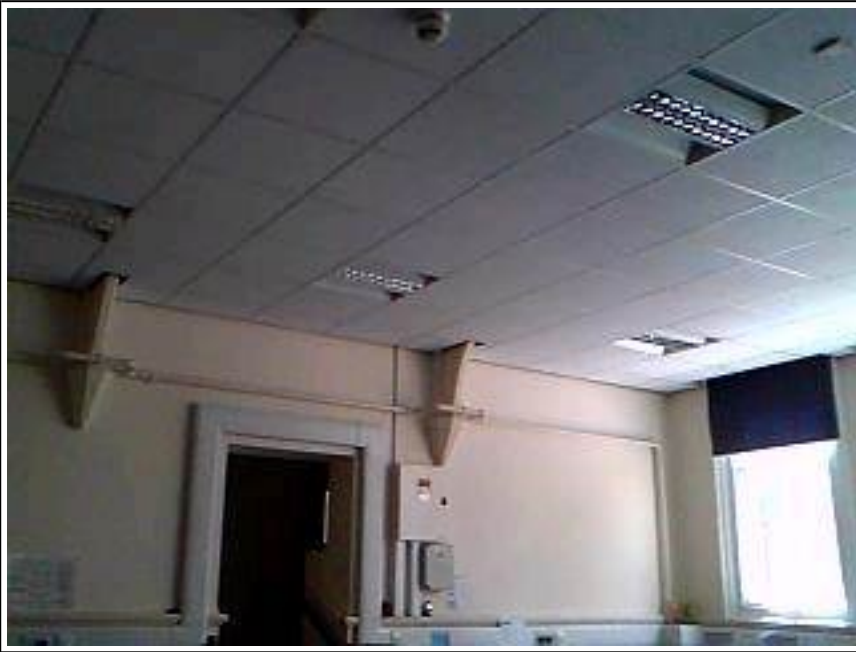
Survey Data Sheet: Conclusions & Recommendations
 Site Location: Clarence House, Civic Campus, Euclid Street, Swindon, SN1 2SG
 Building Designation: 01
 Unique item Number: 66

Sample Ref	Fl	Location	Description	Qty	Analysis Result	Total M.A.S	Licensed Material Y/N
Surveyed	1st Floor	Office. 114	No asbestos detected -		N/A		N

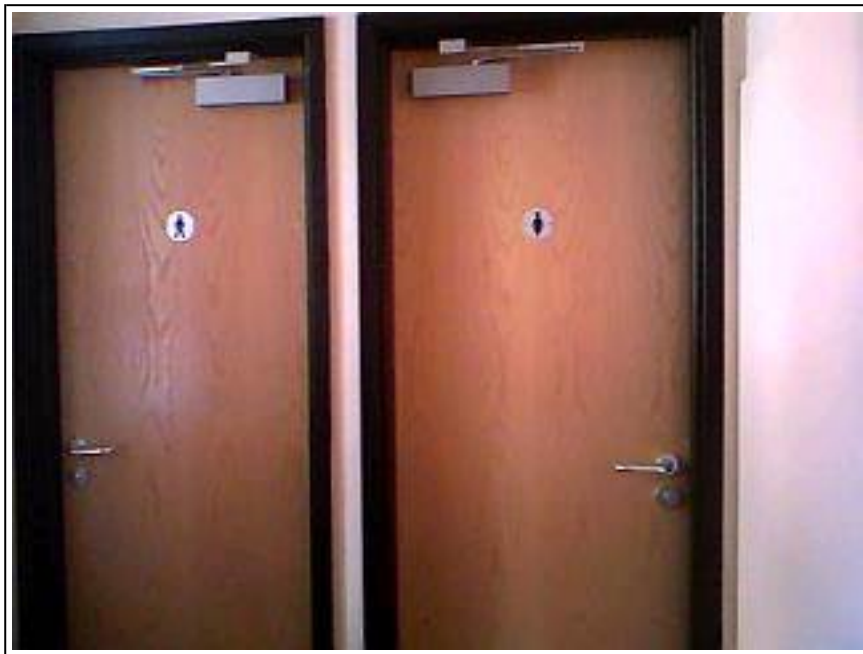
Survey Data Sheet: Conclusions & Recommendations
 Site Location: Clarence House, Civic Campus, Euclid Street, Swindon, SN1 2SG
 Building Designation: 01
 Unique item Number: 67

Sample Ref	Fl	Location	Description	Qty	Analysis Result	Total M.A.S	Licensed Material Y/N
Surveyed	1st Floor	Stairs/Landing. 115	No asbestos detected -		N/A		N

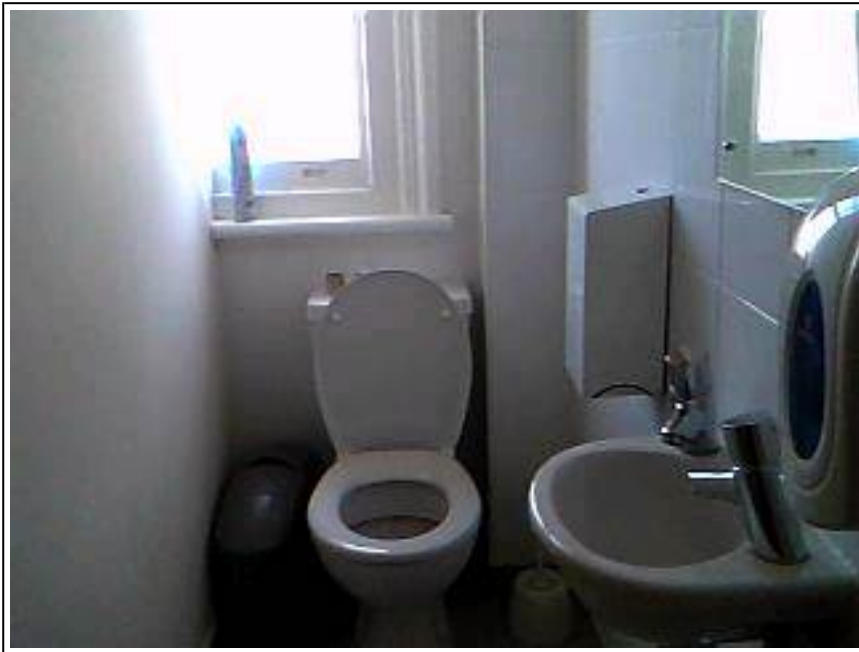
Survey Data Sheet: Conclusions & Recommendations
 Site Location: Clarence House, Civic Campus, Euclid Street, Swindon, SN1 2SG
 Building Designation: 01
 Unique item Number: 68

Sample Ref	Fl	Location	Description	Qty	Analysis Result	Total M.A.S	Licensed Material Y/N
Surveyed	1st Floor	Female W/C. 116	No asbestos detected -		N/A		N

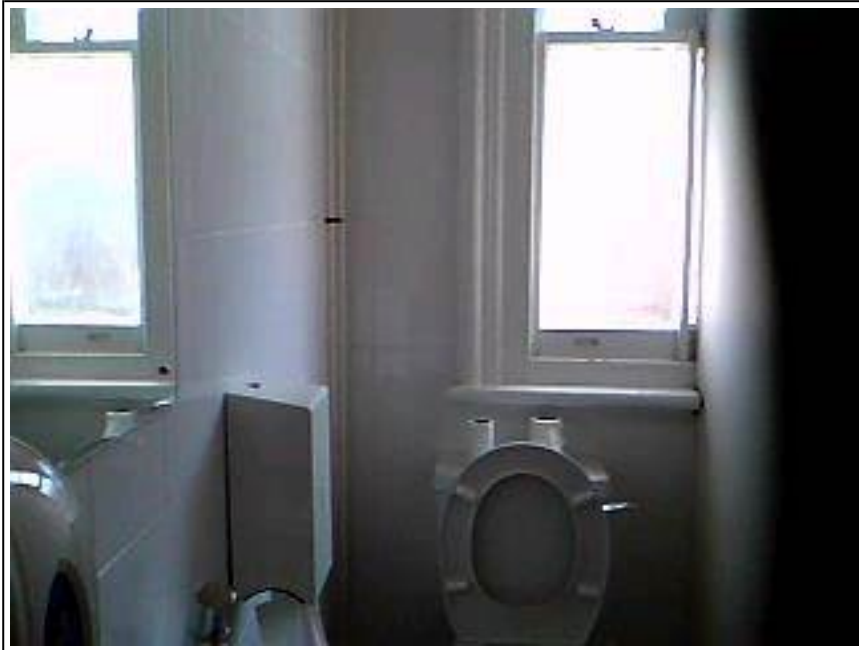
Survey Data Sheet: Conclusions & Recommendations
 Site Location: Clarence House, Civic Campus, Euclid Street, Swindon, SN1 2SG
 Building Designation: 01
 Unique item Number: 69

Sample Ref	Fl	Location	Description	Qty	Analysis Result	Total M.A.S	Licensed Material Y/N
Surveyed	1st Floor	Male W/C. 117	No asbestos detected -		N/A		N

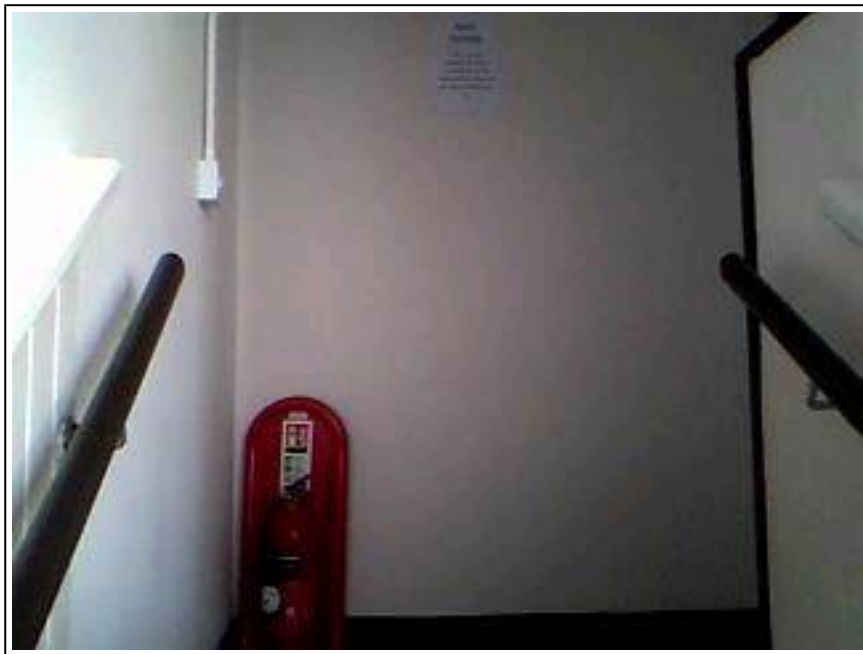
Survey Data Sheet: Conclusions & Recommendations
 Site Location: Clarence House, Civic Campus, Euclid Street, Swindon, SN1 2SG
 Building Designation: 01
 Unique item Number: 70

Sample Ref	FI	Location	Description	Qty	Analysis Result	Total M.A.S	Licensed Material Y/N
Surveyed	1st Floor	Circulation area. 118	No asbestos detected -		N/A		N

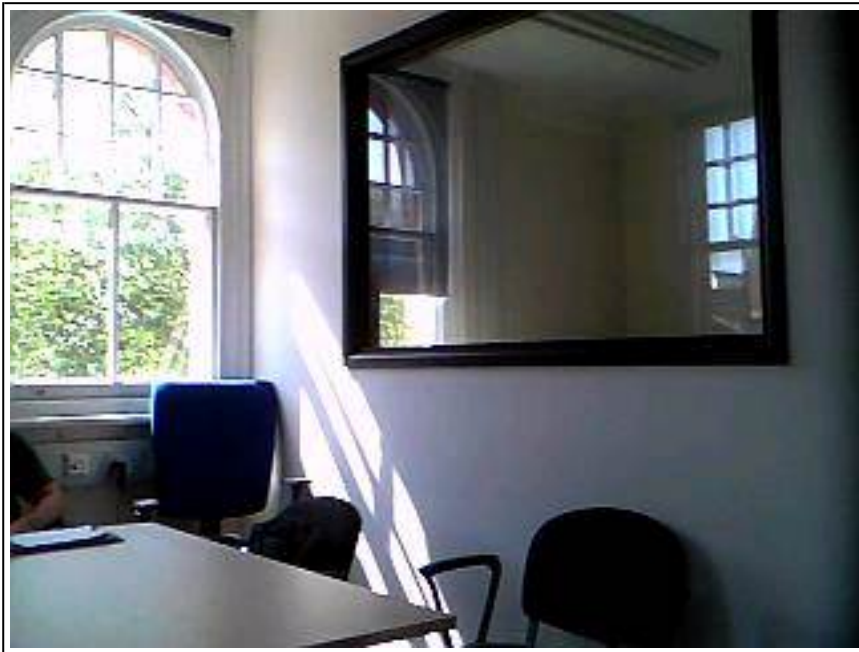
Survey Data Sheet: Conclusions & Recommendations
 Site Location: Clarence House, Civic Campus, Euclid Street, Swindon, SN1 2SG
 Building Designation: 01
 Unique item Number: 71

Sample Ref	Fl	Location	Description	Qty	Analysis Result	Total M.A.S	Licensed Material Y/N
Surveyed	1st Floor	Office. 119	No asbestos detected -		N/A		N

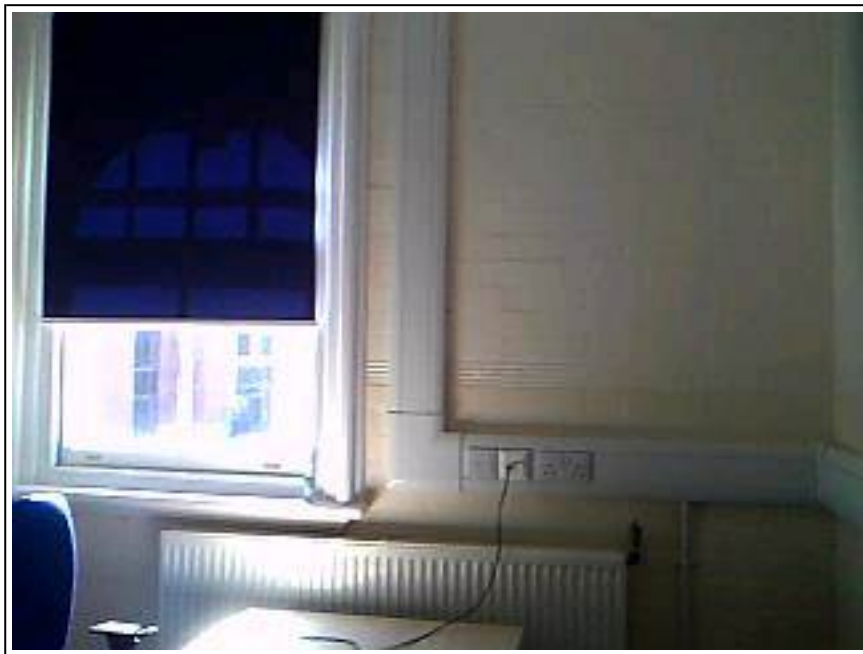
Survey Data Sheet: Conclusions & Recommendations
 Site Location: Clarence House, Civic Campus, Euclid Street, Swindon, SN1 2SG
 Building Designation: 01
 Unique item Number: 72

Sample Ref	Fl	Location	Description	Qty	Analysis Result	Total M.A.S	Licensed Material Y/N
Surveyed	1st Floor	Office. 120	No asbestos detected -		N/A		N

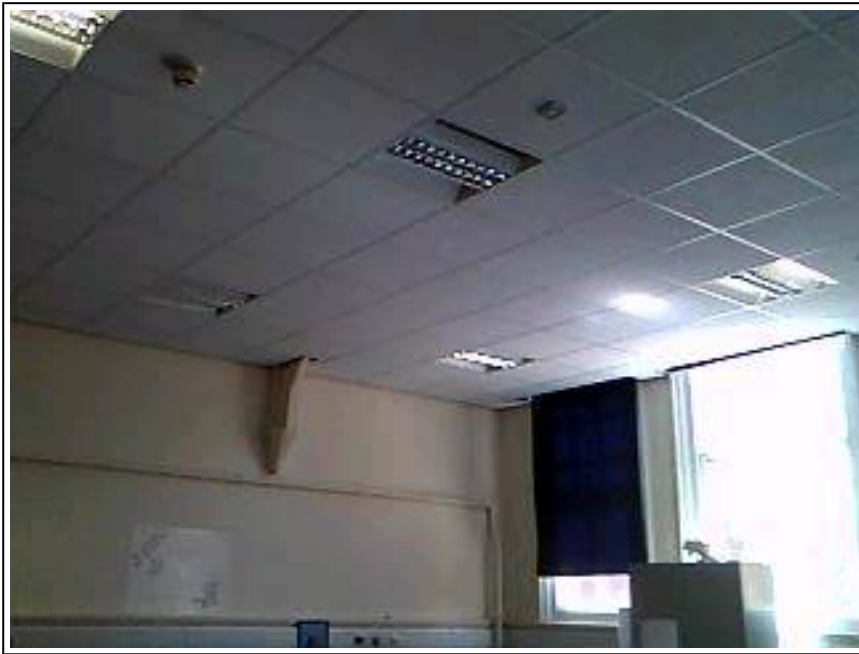
Survey Data Sheet: Conclusions & Recommendations
 Site Location: Clarence House, Civic Campus, Euclid Street, Swindon, SN1 2SG
 Building Designation: 01
 Unique item Number: 73

Sample Ref	Fl	Location	Description	Qty	Analysis Result	Total M.A.S	Licensed Material Y/N
Surveyed	1st Floor	Office. 121	No asbestos detected -		N/A		N

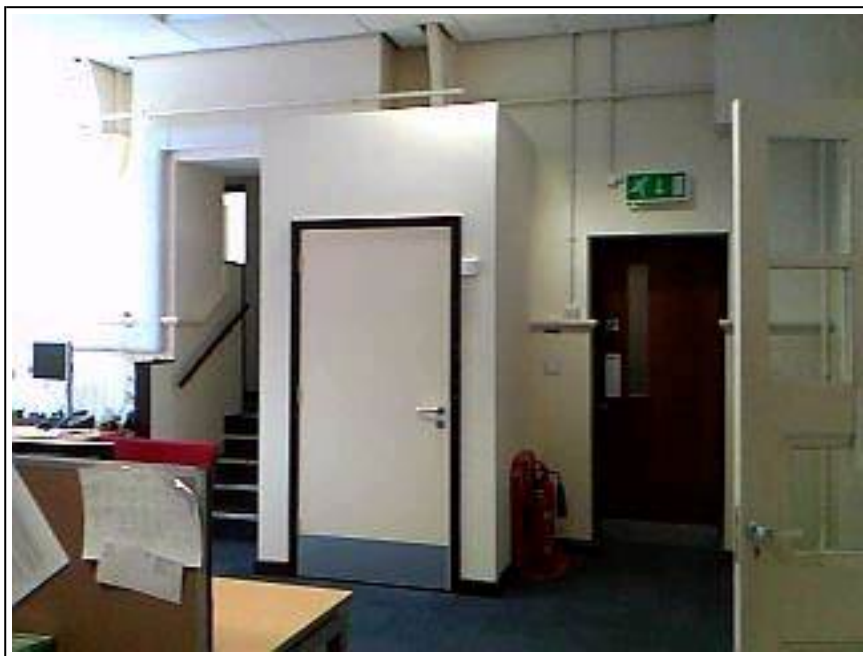
Survey Data Sheet: Conclusions & Recommendations
 Site Location: Clarence House, Civic Campus, Euclid Street, Swindon, SN1 2SG
 Building Designation: 01
 Unique item Number: 74

Sample Ref	Fl	Location	Description	Qty	Analysis Result	Total M.A.S	Licensed Material Y/N
Surveyed	1st Floor	Office. 122	No asbestos detected -		N/A		N

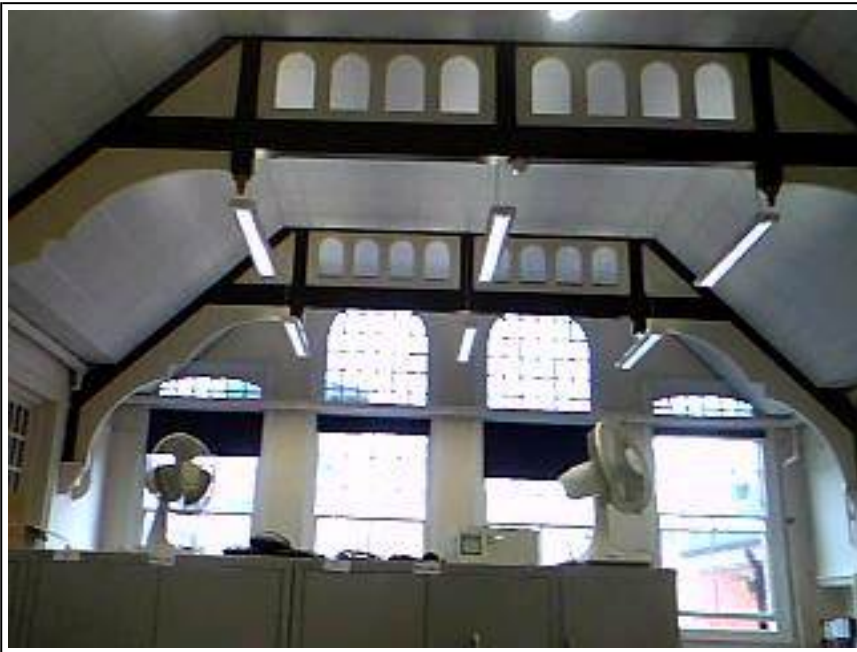
Survey Data Sheet: Conclusions & Recommendations
 Site Location: Clarence House, Civic Campus, Euclid Street, Swindon, SN1 2SG
 Building Designation: 01
 Unique item Number: 75

Sample Ref	Fl	Location	Description	Qty	Analysis Result	Total M.A.S	Licensed Material Y/N
Surveyed	1st Floor	Office. 123	No asbestos detected -		N/A		N

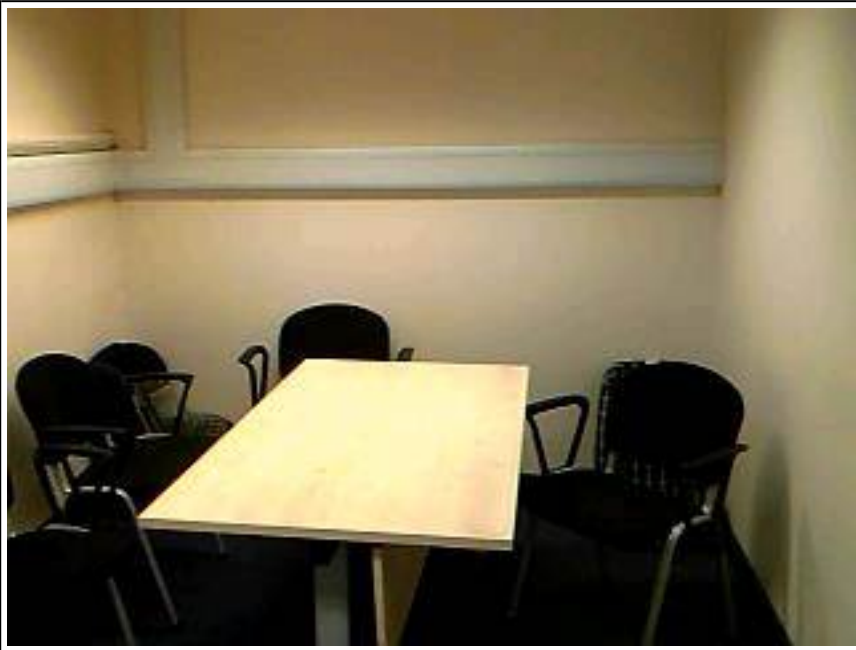
Survey Data Sheet: Conclusions & Recommendations
 Site Location: Clarence House, Civic Campus, Euclid Street, Swindon, SN1 2SG
 Building Designation: 01
 Unique item Number: 76

Sample Ref	FI	Location	Description	Qty	Analysis Result	Total M.A.S	Licensed Material Y/N
Surveyed	1st Floor	Meeting Room. 124	No asbestos detected -		N/A		N

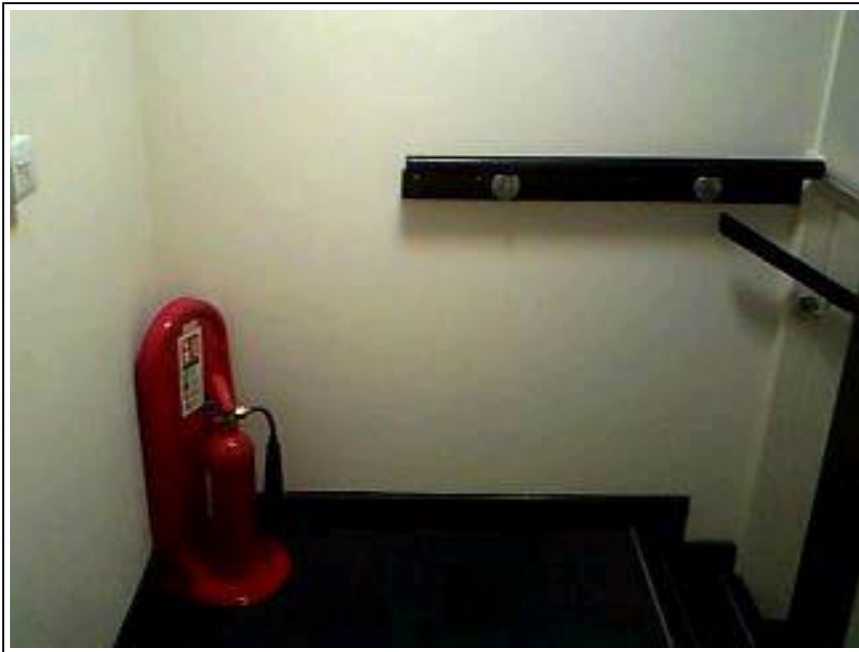
Survey Data Sheet: Conclusions & Recommendations
 Site Location: Clarence House, Civic Campus, Euclid Street, Swindon, SN1 2SG
 Building Designation: 01
 Unique item Number: 77

Sample Ref	Fl	Location	Description	Qty	Analysis Result	Total M.A.S	Licensed Material Y/N
Surveyed	1st Floor	Circulation. 125	No asbestos detected -		N/A		N

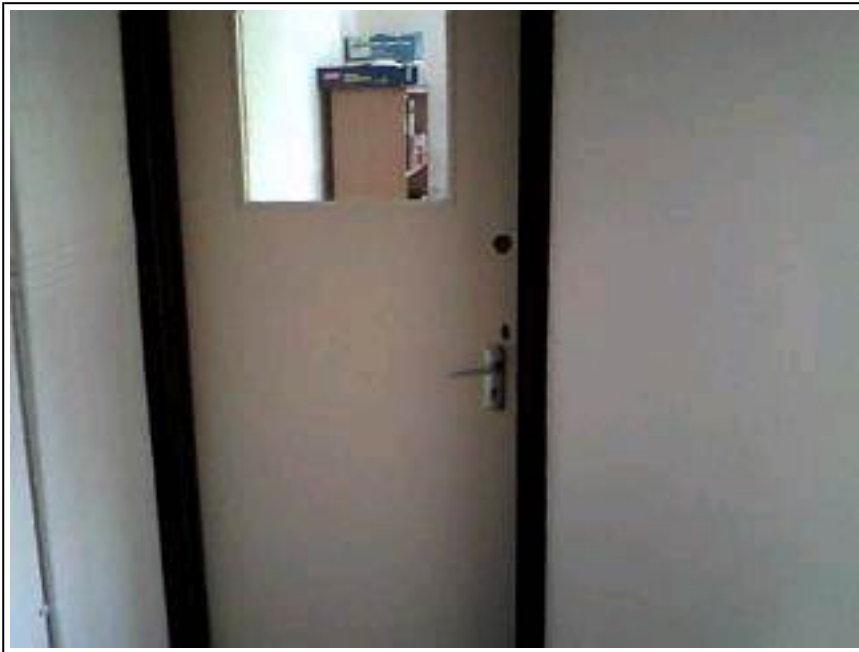
Survey Data Sheet: Conclusions & Recommendations
 Site Location: Clarence House, Civic Campus, Euclid Street, Swindon, SN1 2SG
 Building Designation: 01
 Unique item Number: 78

Sample Ref	FI	Location	Description	Qty	Analysis Result	Total M.A.S	Licensed Material Y/N
Surveyed	1st Floor	Store. 126	No asbestos detected -		N/A		N

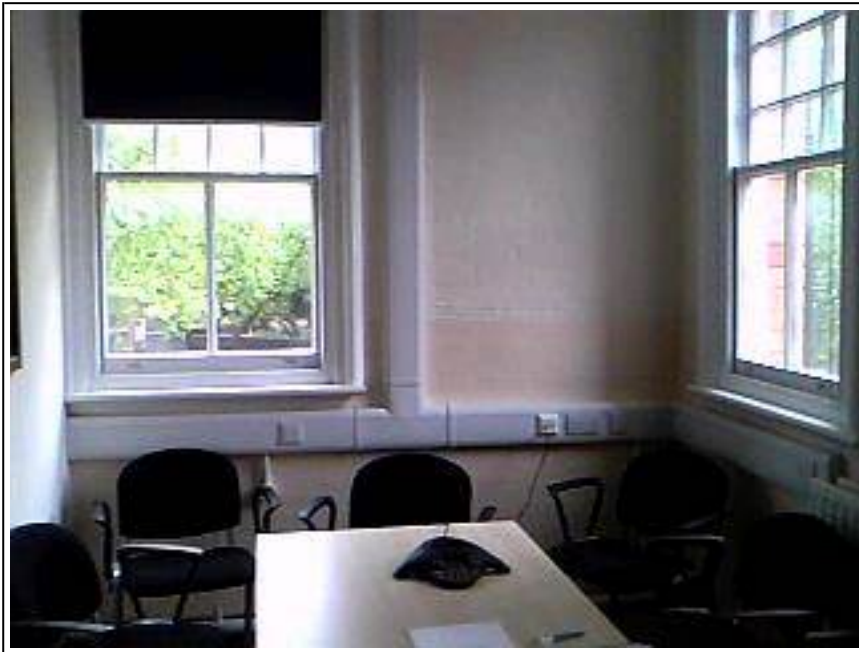
Survey Data Sheet: Conclusions & Recommendations
 Site Location: Clarence House, Civic Campus, Euclid Street, Swindon, SN1 2SG
 Building Designation: 01
 Unique item Number: 79

Sample Ref	Fl	Location	Description	Qty	Analysis Result	Total M.A.S	Licensed Material Y/N
Surveyed	1st Floor	Office. 127	No asbestos detected -		N/A		N

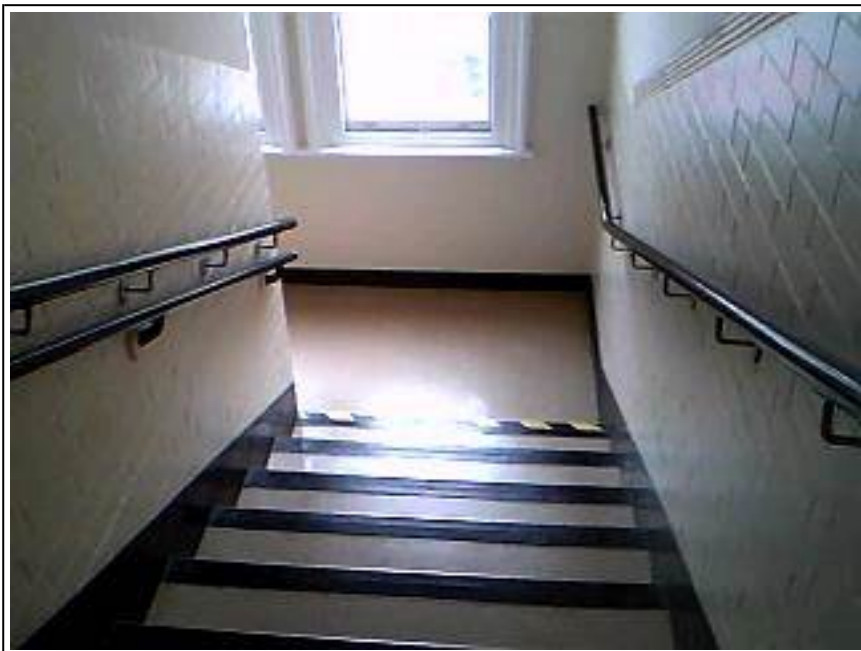
Survey Data Sheet: Conclusions & Recommendations
 Site Location: Clarence House, Civic Campus, Euclid Street, Swindon, SN1 2SG
 Building Designation: 01
 Unique item Number: 80

Sample Ref	FI	Location	Description	Qty	Analysis Result	Total M.A.S	Licensed Material Y/N
Surveyed	1st Floor	Stairs/Landing. 128	No asbestos detected -		N/A		N

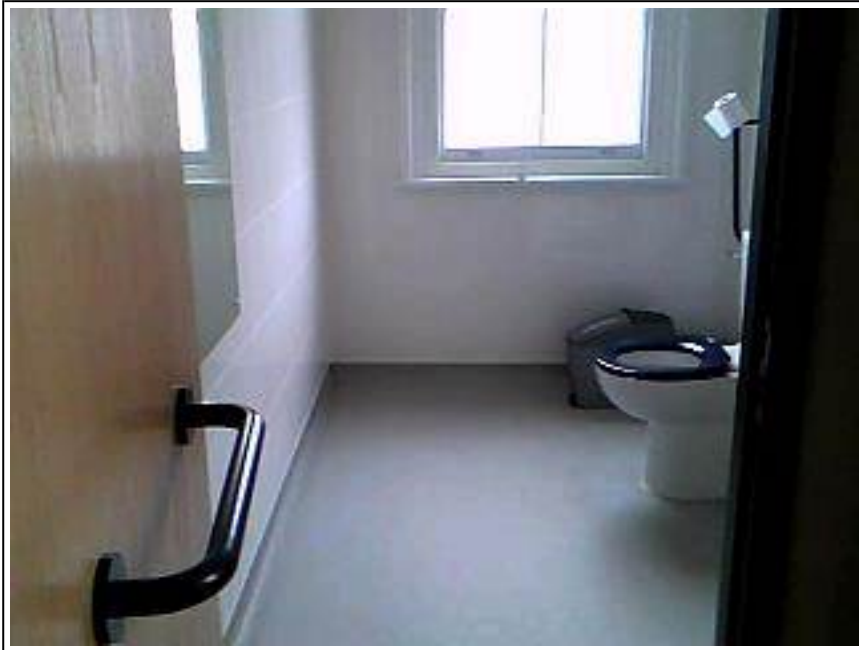
Survey Data Sheet: Conclusions & Recommendations
 Site Location: Clarence House, Civic Campus, Euclid Street, Swindon, SN1 2SG
 Building Designation: 01
 Unique item Number: 81

Sample Ref	FI	Location	Description	Qty	Analysis Result	Total M.A.S	Licensed Material Y/N
Surveyed	1st Floor	Disabled W/C. 129	No asbestos detected -		N/A		N

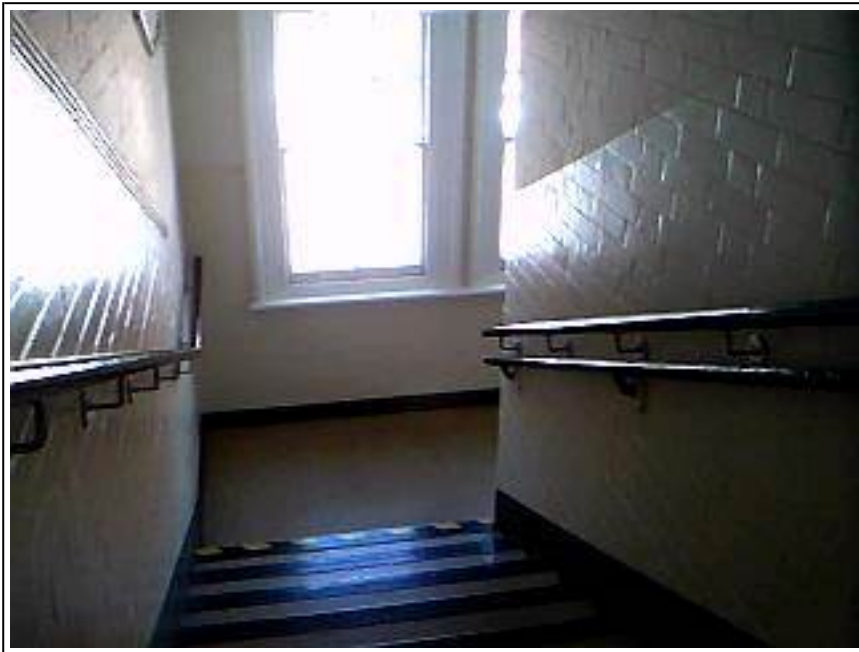
Survey Data Sheet: Conclusions & Recommendations
 Site Location: Clarence House, Civic Campus, Euclid Street, Swindon, SN1 2SG
 Building Designation: 01
 Unique item Number: 82

Sample Ref	FI	Location	Description	Qty	Analysis Result	Total M.A.S	Licensed Material Y/N
Surveyed	Mezzanine	Stairs/Landing. M01	No asbestos detected -		N/A		N

Recommended Action:	Advised Timescale for Action/Inspection:
-	N/A

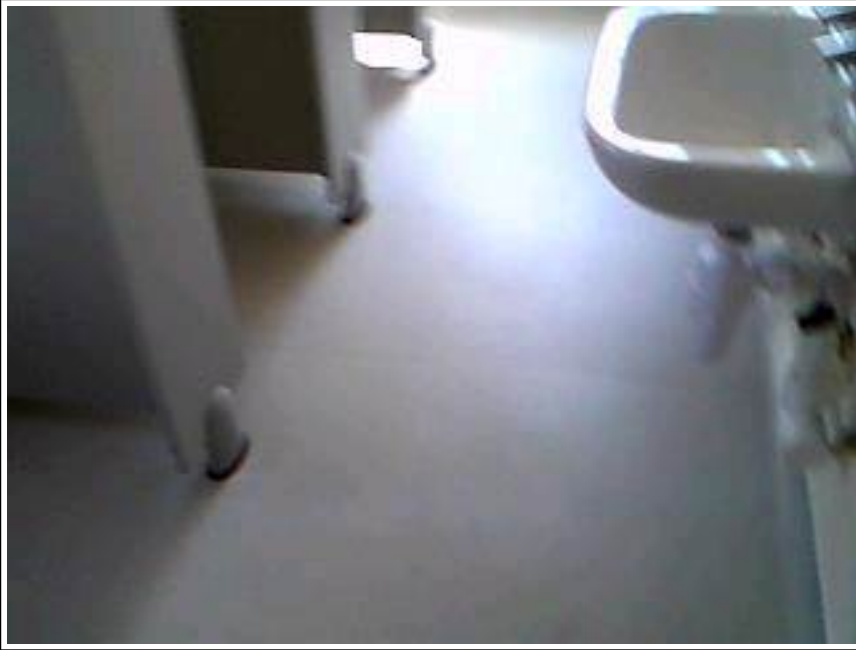
Survey Data Sheet: Conclusions & Recommendations
 Site Location: Clarence House, Civic Campus, Euclid Street, Swindon, SN1 2SG
 Building Designation: 01
 Unique item Number: 84

Sample Ref	FI	Location	Description	Qty	Analysis Result	Total M.A.S	Licensed Material Y/N
Surveyed	Mezzanine	Female W/C. M03	No asbestos detected -		N/A		N

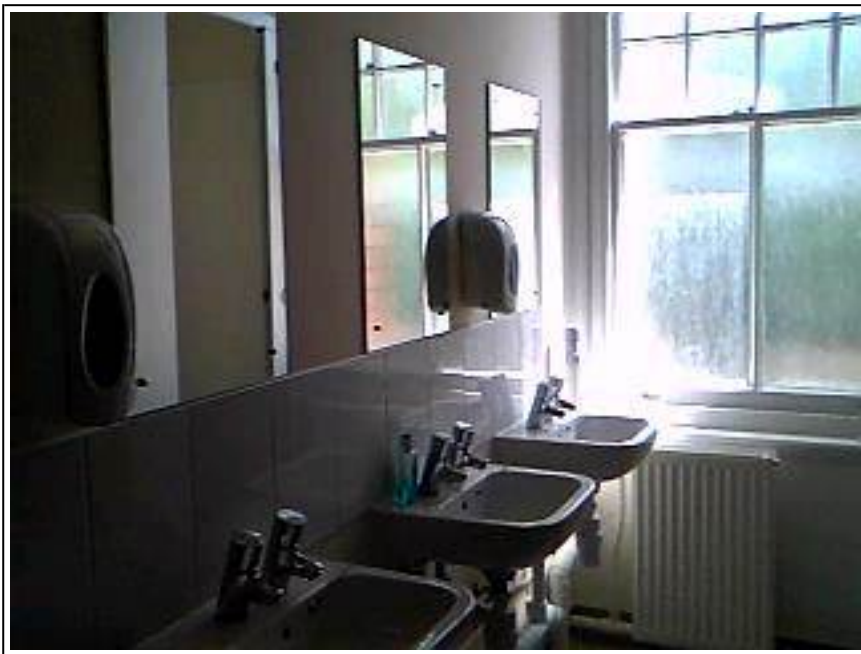
Survey Data Sheet: Conclusions & Recommendations
 Site Location: Clarence House, Civic Campus, Euclid Street, Swindon, SN1 2SG
 Building Designation: 01
 Unique item Number: 85

Sample Ref	FI	Location	Description	Qty	Analysis Result	Total M.A.S	Licensed Material Y/N
Surveyed	Mezzanine	Male W/C. M04	No asbestos detected -		N/A		N

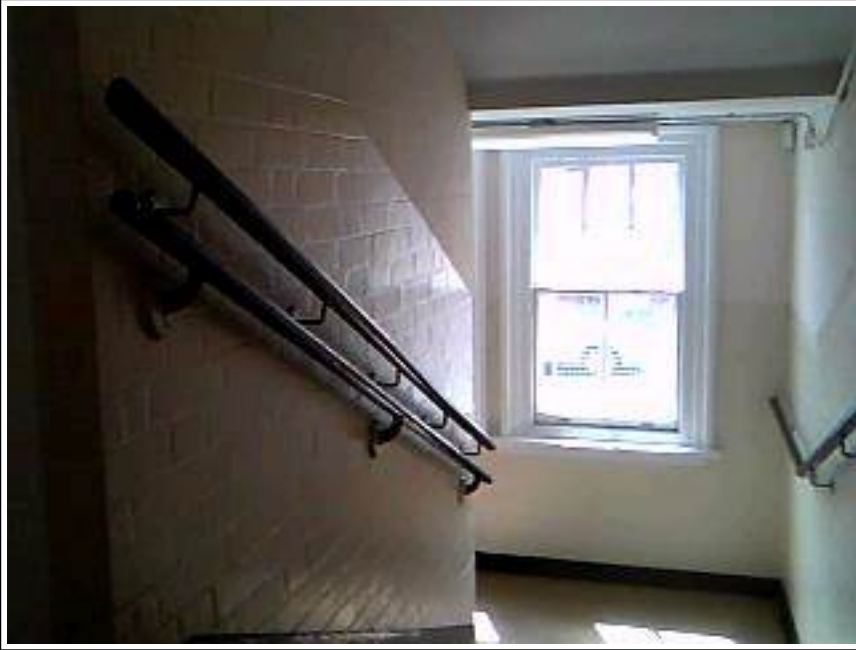
Survey Data Sheet: Conclusions & Recommendations
 Site Location: Clarence House, Civic Campus, Euclid Street, Swindon, SN1 2SG
 Building Designation: 01
 Unique item Number: 86

Sample Ref	FI	Location	Description	Qty	Analysis Result	Total M.A.S	Licensed Material Y/N
Surveyed	Mezzanine	Stairs/Landing. M05	No asbestos detected -		N/A		N

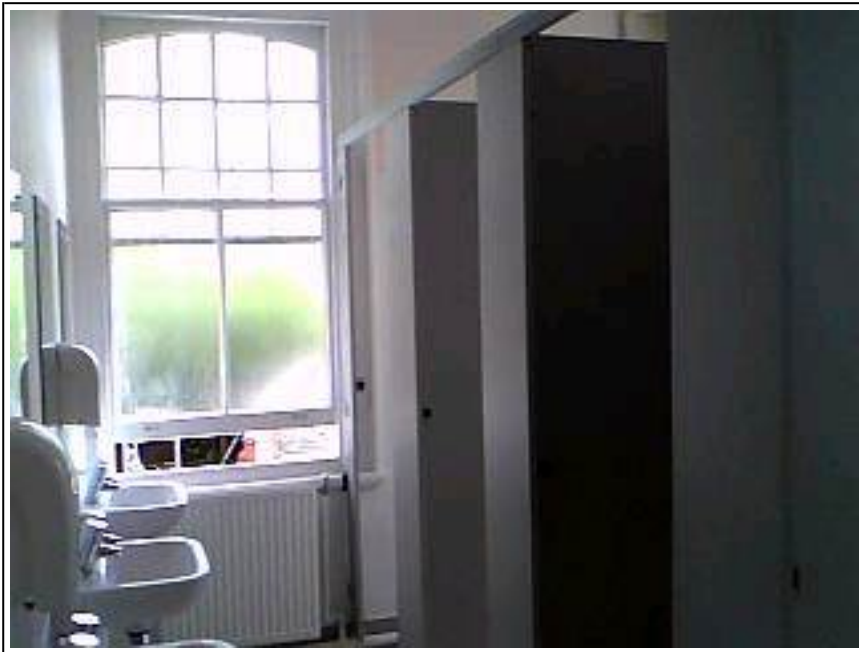
Survey Data Sheet: Conclusions & Recommendations
 Site Location: Clarence House, Civic Campus, Euclid Street, Swindon, SN1 2SG
 Building Designation: 01
 Unique item Number: 88

Sample Ref	FI	Location	Description	Qty	Analysis Result	Total M.A.S	Licensed Material Y/N
Surveyed	Mezzanine	Female W/C. M07	No asbestos detected -		N/A		N

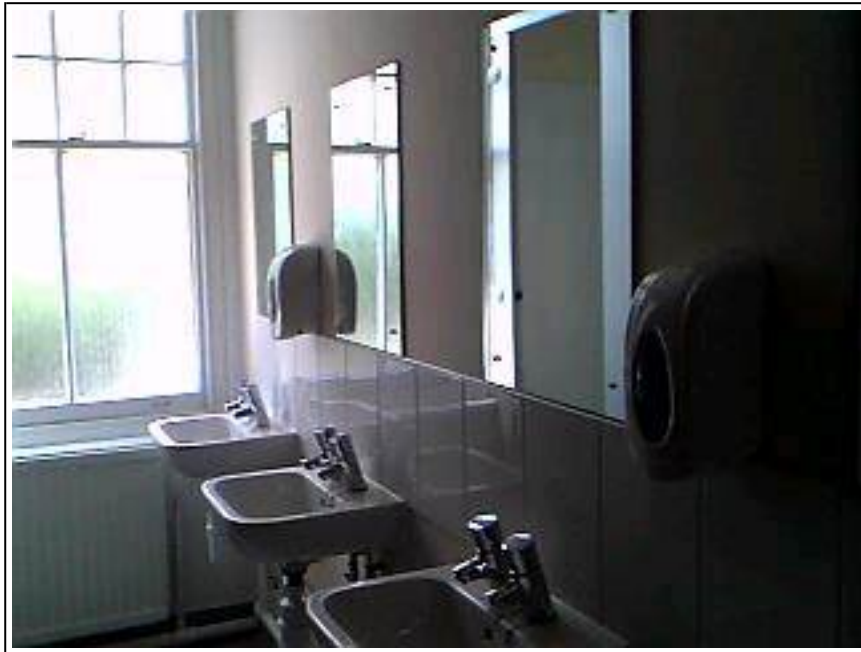
Survey Data Sheet: Conclusions & Recommendations
 Site Location: Clarence House, Civic Campus, Euclid Street, Swindon, SN1 2SG
 Building Designation: 01
 Unique item Number: 89

Sample Ref	FI	Location	Description	Qty	Analysis Result	Total M.A.S	Licensed Material Y/N
Surveyed	Mezzanine	Male W/C. M08	No asbestos detected -		N/A		N
