Asbestos Management Survey Report

Clarence House, Civic Campus, Euclid Street, Swindon, SN1 2SG

Executive Summary

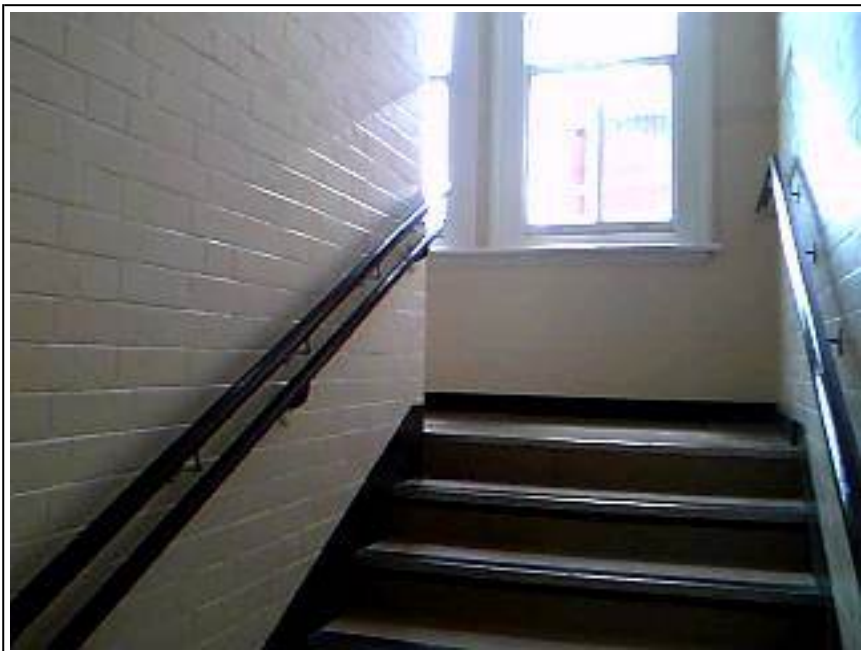
Survey Data Sheet: Conclusions & Recommendations
 Site Location: Clarence House, Civic Campus, Euclid Street, Swindon, SN1 2SG
 Building Designation: 01
 Unique item Number: 90

Sample Ref	FI	Location	Description	Qty	Analysis Result	Total M.A.S	Licensed Material Y/N
Surveyed	Mezzanine	Stairs/Landing. M09	No asbestos detected -		N/A		N

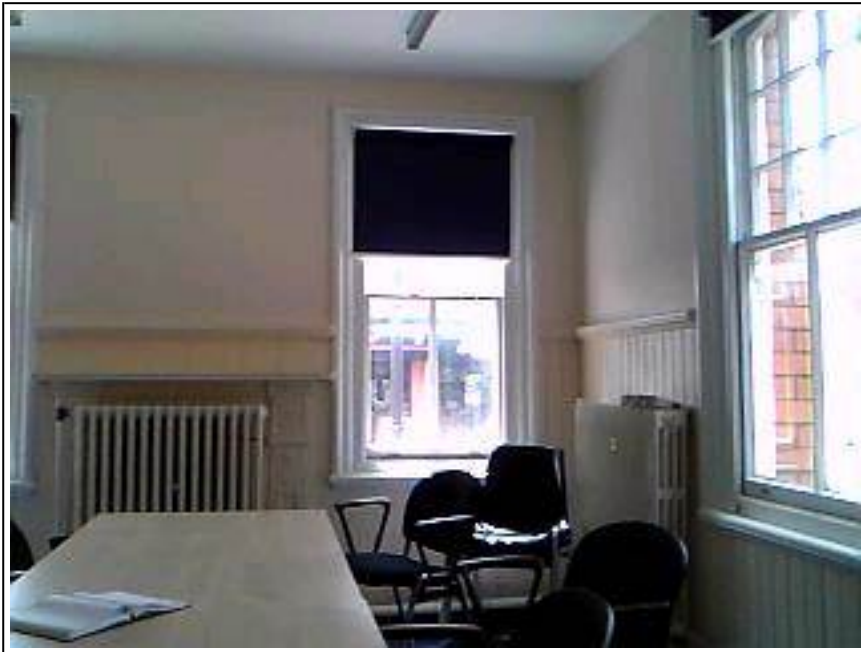
Survey Data Sheet: Conclusions & Recommendations
 Site Location: Clarence House, Civic Campus, Euclid Street, Swindon, SN1 2SG
 Building Designation: 01
 Unique item Number: 91

Sample Ref	Fl	Location	Description	Qty	Analysis Result	Total M.A.S	Licensed Material Y/N
Surveyed	Mezzanine	Conference Room. M10	No asbestos detected -		N/A		N

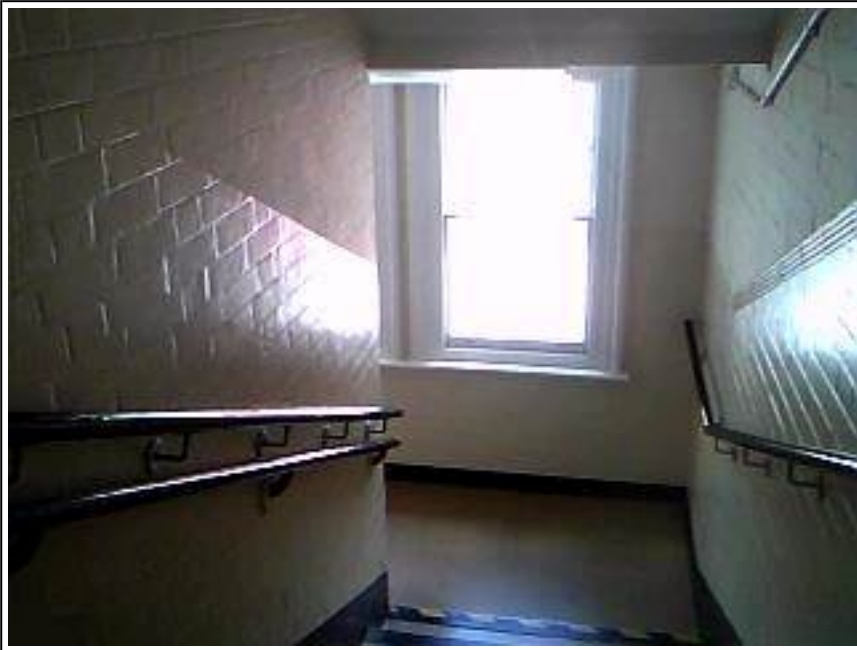
Survey Data Sheet: Conclusions & Recommendations
 Site Location: Clarence House, Civic Campus, Euclid Street, Swindon, SN1 2SG
 Building Designation: 01
 Unique item Number: 92

Sample Ref	FI	Location	Description	Qty	Analysis Result	Total M.A.S	Licensed Material Y/N
Surveyed	Mezzanine	Stairs/Landing. M11	No asbestos detected -		N/A		N

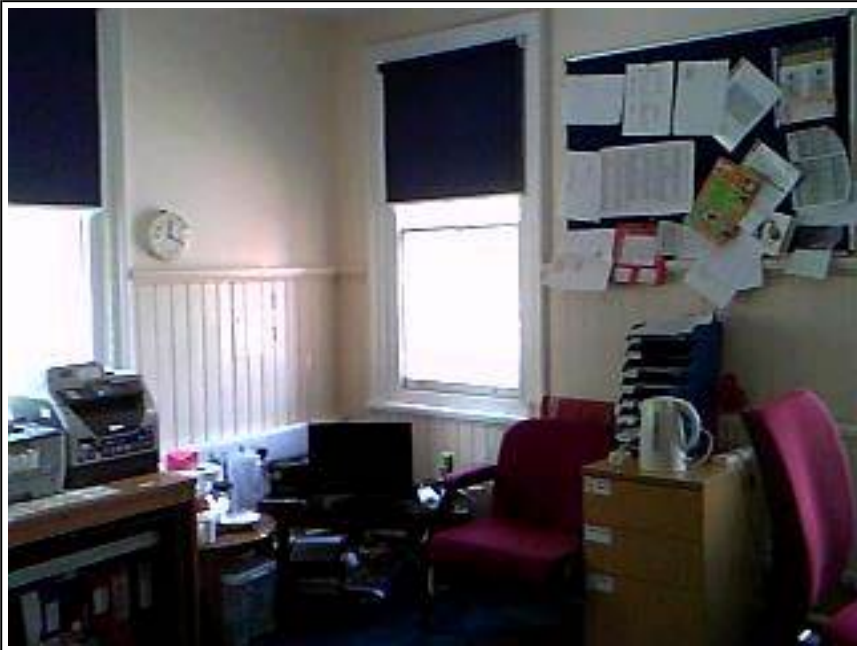
Survey Data Sheet: Conclusions & Recommendations
 Site Location: Clarence House, Civic Campus, Euclid Street, Swindon, SN1 2SG
 Building Designation: 01
 Unique item Number: 93

Sample Ref	Fl	Location	Description	Qty	Analysis Result	Total M.A.S	Licensed Material Y/N
Surveyed	Mezzanine	Office. M12	No asbestos detected -		N/A		N

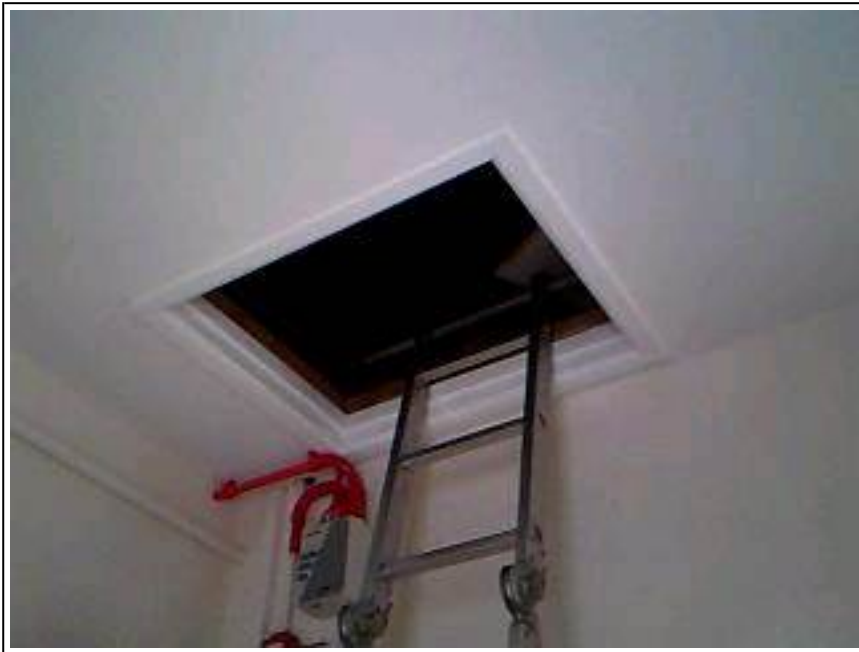
Survey Data Sheet: Conclusions & Recommendations
 Site Location: Clarence House, Civic Campus, Euclid Street, Swindon, SN1 2SG
 Building Designation: 01
 Unique item Number: 94

Sample Ref	FI	Location	Description	Qty	Analysis Result	Total M.A.S	Licensed Material Y/N
Surveyed	Roof Void	Attic. A01	No asbestos detected -		N/A		N

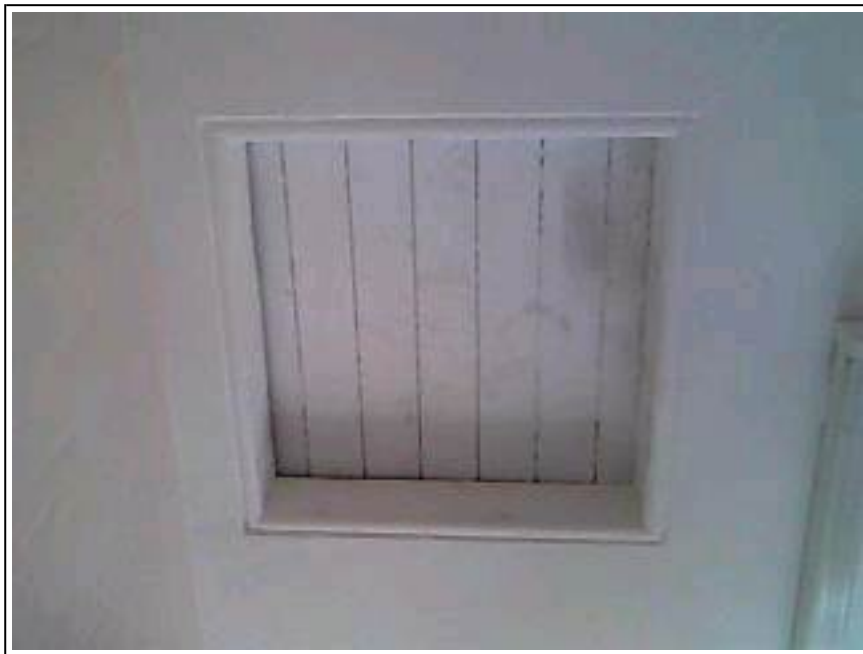
Survey Data Sheet: Conclusions & Recommendations
 Site Location: Clarence House, Civic Campus, Euclid Street, Swindon, SN1 2SG
 Building Designation: 01
 Unique item Number: 95

Sample Ref	FI	Location	Description	Qty	Analysis Result	Total M.A.S	Licensed Material Y/N
Surveyed	Roof Void	Attic. A02	No asbestos detected -		N/A		N

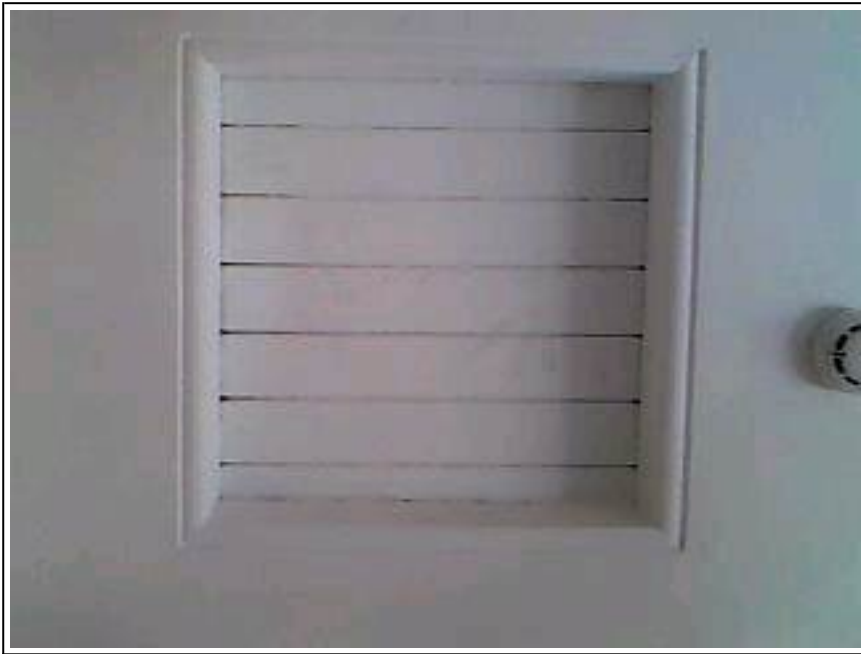
Survey Data Sheet: Conclusions & Recommendations
 Site Location: Clarence House, Civic Campus, Euclid Street, Swindon, SN1 2SG
 Building Designation: 01
 Unique item Number: 96

Sample Ref	FI	Location	Description	Qty	Analysis Result	Total M.A.S	Licensed Material Y/N
Surveyed	Roof Void	Attic. A03	No asbestos detected -		N/A		N

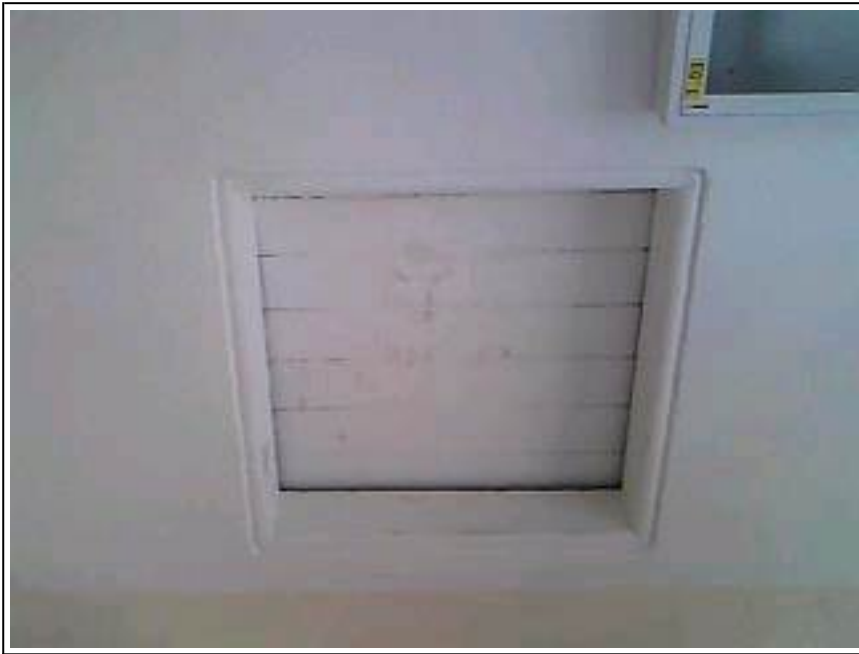
Survey Data Sheet: Conclusions & Recommendations
 Site Location: Clarence House, Civic Campus, Euclid Street, Swindon, SN1 2SG
 Building Designation: 01
 Unique item Number: 97

Sample Ref	FI	Location	Description	Qty	Analysis Result	Total M.A.S	Licensed Material Y/N
Surveyed	Roof Void	Attic. A04	No asbestos detected -		N/A		N

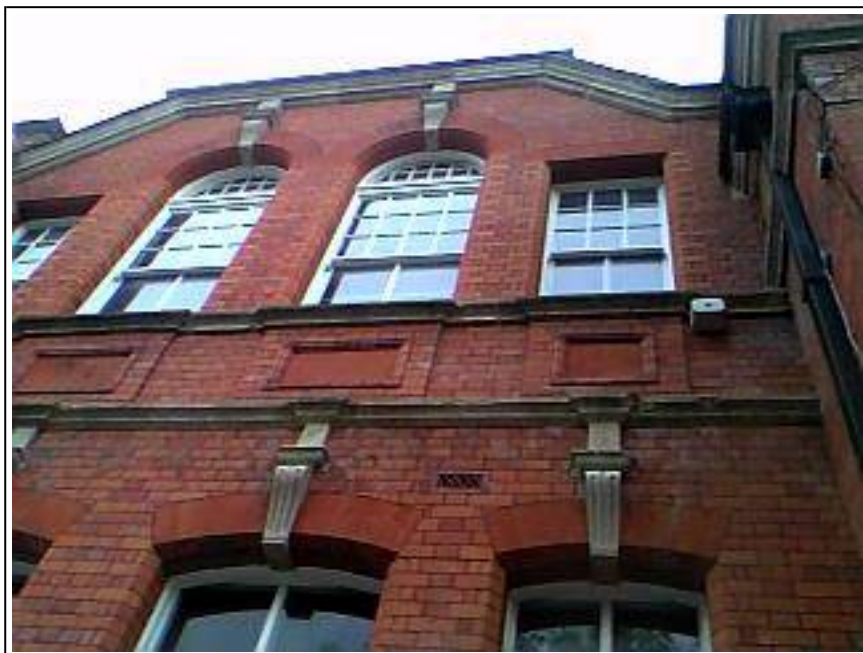
Survey Data Sheet: Conclusions & Recommendations
 Site Location: Clarence House, Civic Campus, Euclid Street, Swindon, SN1 2SG
 Building Designation: 01
 Unique item Number: 98

Sample Ref	Fl	Location	Description	Qty	Analysis Result	Total M.A.S	Licensed Material Y/N
SAS 7702/15	External	External	Roof - Undercloak - Asbestos Cement	4lm	Chrysotile	3	N

Product Type	Extent of Damage	Surface Treatment	Asbestos Type	Total M.A.S	Accessibility/Vulnerability	Combined Total for Advised Timescale
1	0	1	1	3	0	3

This material may remain in situ and be managed accordingly. Undertake continued regular recorded inspections on the condition of the material as dictated in the asbestos register and management plan. No drilling, cutting or any abrasive actions should take place on this material.
