Report of 'Type 2' Asbestos Survey
At
Lydiard House
Lydiard Tregoze
Swindon
For
Swindon Borough Council

On
Tuesday 12th December 2006
Project Ref: J10943
UPRN: 10004843255

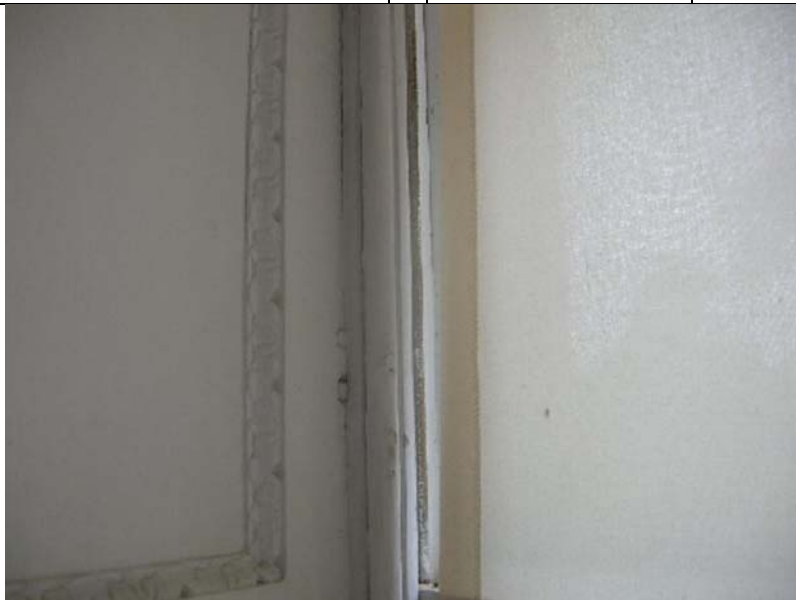
Swindon Borough Council			
Project Ref	J10943	Building	00 Main Building
Site	Lydiard House Lydiard Tregoze Swindon	Floor	00 Ground
Location	ENS1984	Description	Sash cord to state room
Room/Area	B004 State Room	Site Code/UPRN	10004843255

Last Inspection Date	- 25 May 2007	Certificate N^o	- C15751
Next Inspection Date	- N/A	Sample N^o	- B50
Survey Type	- Type 2	Photograph N^o	- 15

Position	- Internal (Occupied)	Damage Risk	- Low
Asbestos Type	- No Asbestos Detected	HSE Notifiable	- No
Product Type	- Rope

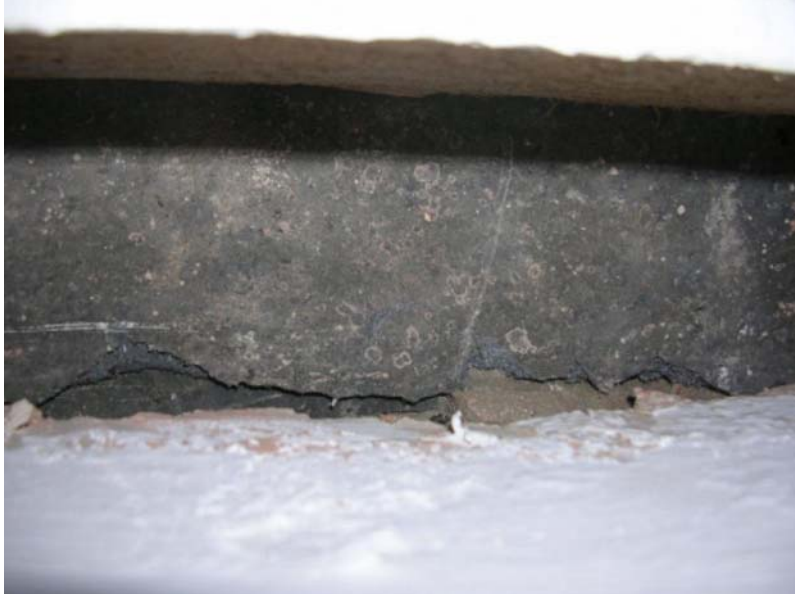
- 9.3.3 Within the B008 circ there was a cement panel to the underside of the cupboard. A sample of the cement was collected (Sample Number B29) and the sample was found to contain Chrysotile (White) asbestos. The asbestos cement was medium damaged and was in an unsealed condition. The asbestos containing cement should be removed or repaired utilising a suitable non asbestos substitute. If repaired, it should be managed accordingly. Although not a requirement, it may be prudent to consider encapsulation/re-encapsulation and or labelling where practicable to do so.

Swindon Borough Council			
Project Ref	J10943	Building	00 Main Building
Site	Lydiard House Lydiard Tregoze Swindon	Floor	00 Ground
Location	Ens0375	Description	Cement panel to underside of cupboard
Room/Area	B008 Corridor	Site Code/UPRN	10004843255

Last Inspection Date	- 19 Dec 2006	Certificate N°	- C15751
Next Inspection Date	- N/A	Sample N°	- B29
Survey Type	- Type 2	Photograph N°	- 42 & 43

Position	- Internal (Occupied)	Damage Risk	- Low
Asbestos Type	- Chrysotile	HSE Notifiable	- No
Product Type	- Cement

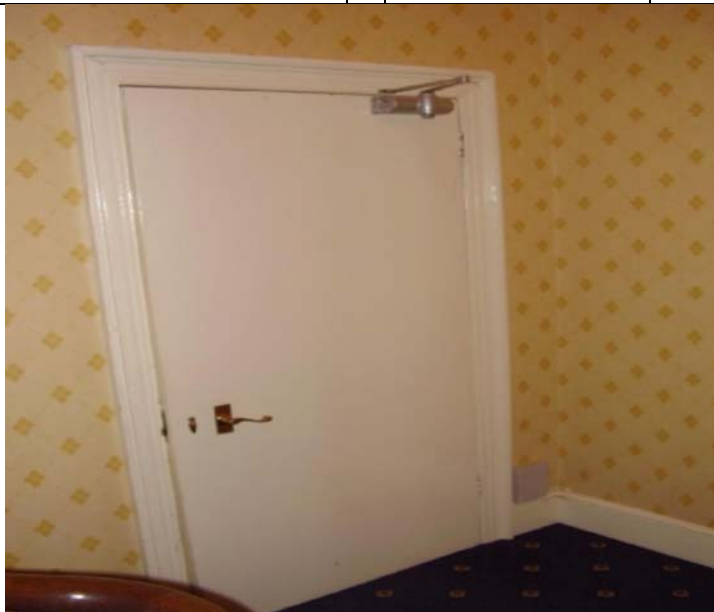
- 9.3.1 Within the B008 circ there was an insulating board panel to the rear of the door leading to B006 circ. A sample of the insulating board was collected (Sample Number B14) and the sample was found to contain Amosite (Brown) asbestos. The asbestos insulating board was low damaged and the exposed face was in a sealed condition. If left undisturbed the asbestos insulating board does not require removal, however, should be managed accordingly. Although not a requirement it may be prudent to consider re-encapsulation and or labelling where practicable to do so.

Swindon Borough Council			
Project Ref	J10943	Building	00 Main Building
Site	Lydiard House Lydiard Tregoze Swindon	Floor	00 Ground
Location	ENS173	Description	Panel to rear of door leading into B006 circ
Room/Area	B008 Circ	Site Code/UPRN	10004843255

Last Inspection Date	- 14 Dec 2006	Certificate N°	- C15751
Next Inspection Date	- 14 Dec 2007	Sample N°	- B14
Survey Type	- Type 2	Photograph N°	- 16

Position	- Internal (Occupied)	Damage Risk	- Medium
Asbestos Type	- Amosite	HSE Notifiable	- Yes
Product Type	- Insulating Board

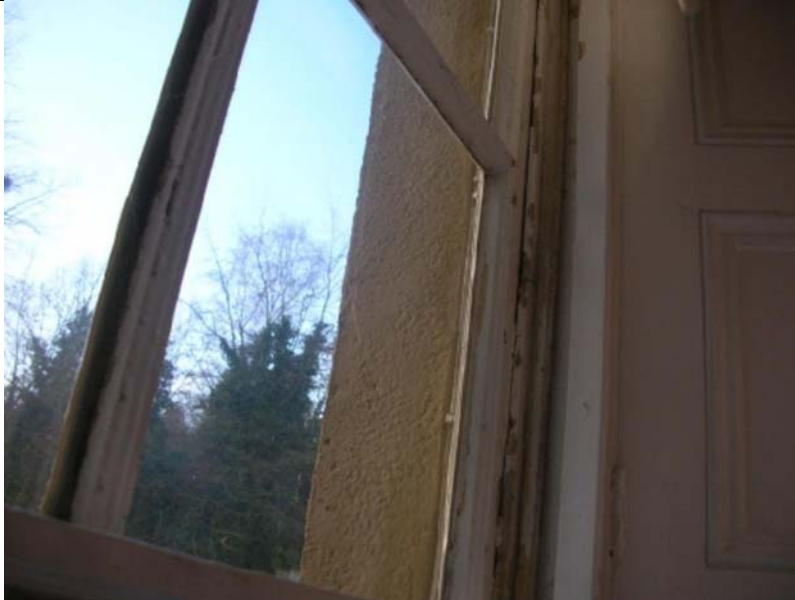
Swindon Borough Council			
Project Ref	J10943	Building	00 Main Building
Site	Lydiard House Lydiard Tregoze Swindon	Floor	00 Ground
Location	Loc0219	Description	Sash cord to window frame
Room/Area	B014 Office	Site Code/UPRN	10004843255

Last Inspection Date	- 21 Dec 2006	Certificate N^o.	- C15751
Next Inspection Date	- N/A	Sample N^o.	- Ref B18
Survey Type	- Type 2	Photograph N^o.	- 41

Position	- Internal (Occupied)	Damage Risk	- Low
Asbestos Type	- No Asbestos Detected	HSE Notifiable	- No
Product Type	- Rope

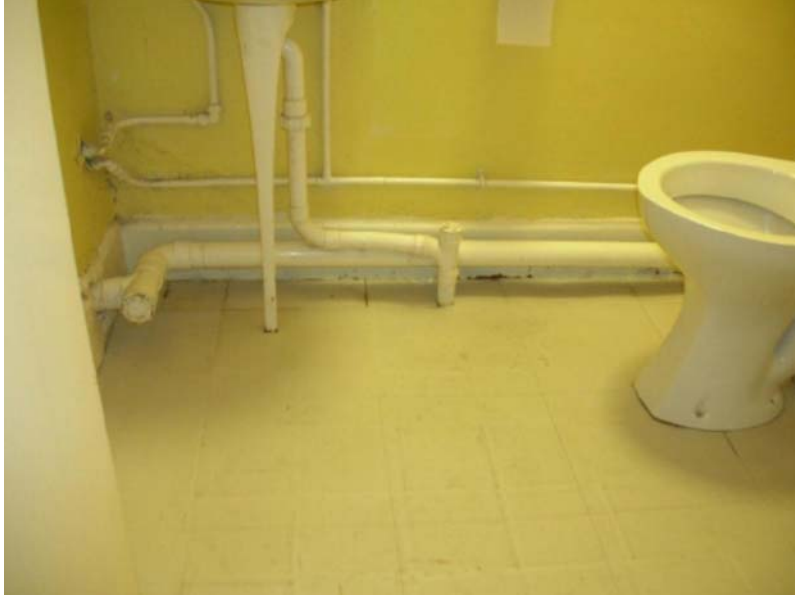
Swindon Borough Council			
Project Ref	J10943	Building	00 Main Building
Site	Lydiard House Lydiard Tregoze Swindon	Floor	00 Ground
Location	Loc0136	Description	Vinyl floor covering
Room/Area	B015 Staff WC	Site Code/UPRN	10004843255

Last Inspection Date	- 20 Dec 2006	Certificate N°	- C15751
Next Inspection Date	- N/A	Sample N°	- B34
Survey Type	- Type 2	Photograph N°	- 50

Position	- Internal (Occupied)	Damage Risk	- Low
Asbestos Type	- No Asbestos Detected	HSE Notifiable	- No
Product Type	- Vinyl

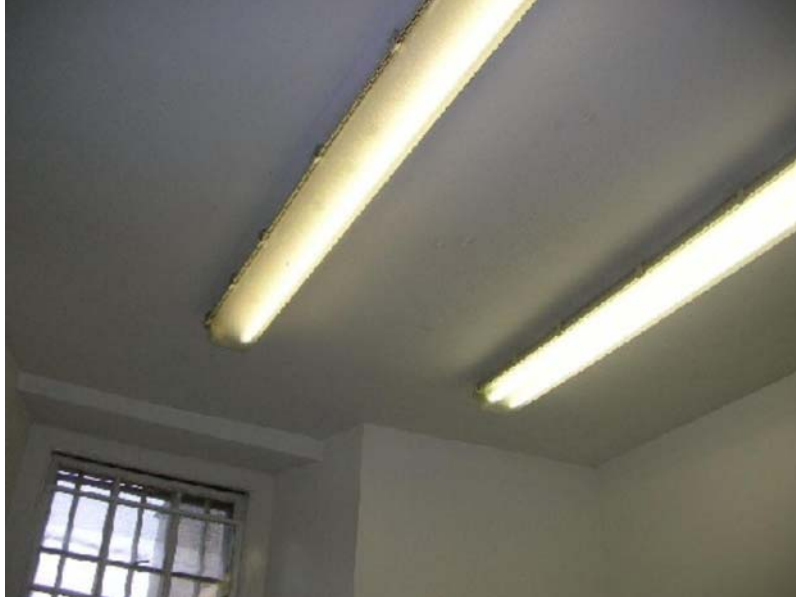
Swindon Borough Council			
Project Ref	J10943	Building	00 Main Building
Site	Lydiard House Lydiard Tregoze Swindon	Floor	00 Ground
Location	ENS1981	Description	Lining to store ceiling
Room/Area	B016 Store	Site Code/UPRN	10004843255

Last Inspection Date	- 25 May 2007	Certificate N°	- C15751
Next Inspection Date	- N/A	Sample N°	- Ref B49
Survey Type	- Type 2	Photograph N°	- 12

Position	- Internal (Occupied)	Damage Risk	- Low
Asbestos Type	- No Asbestos Detected	HSE Notifiable	- No
Product Type	- Textured Coating

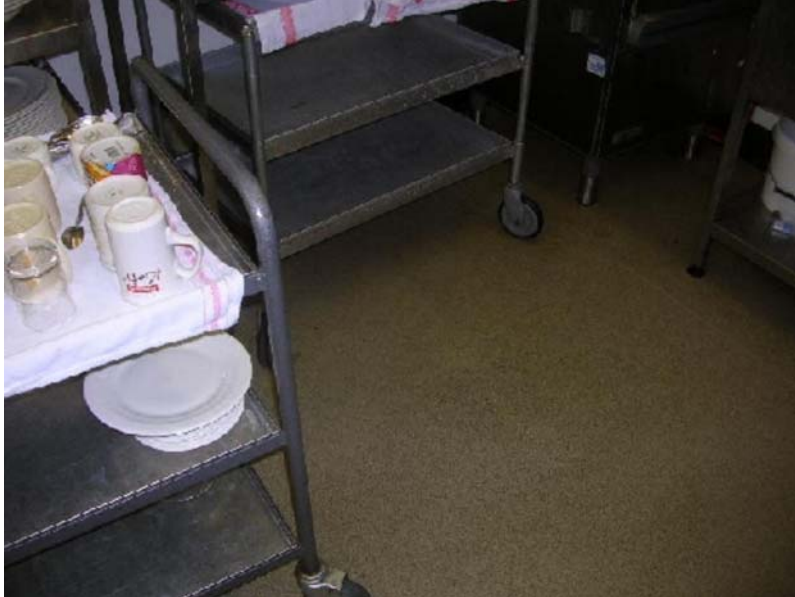
Swindon Borough Council			
Project Ref	J10943	Building	00 Main Building
Site	Lydiard House Lydiard Tregoze Swindon	Floor	00 Ground
Location	ENS1982	Description	Floor covering to store
Room/Area	B016 Store	Site Code/UPRN	10004843255

Last Inspection Date	- 25 May 2007	Certificate N°	- C15751
Next Inspection Date	- N/A	Sample N°	- Ref B47
Survey Type	- Type 2	Photograph N°	- 13

Position	- Internal (Occupied)	Damage Risk	- Low
Asbestos Type	- No Asbestos Detected	HSE Notifiable	- No
Product Type	- Vinyl

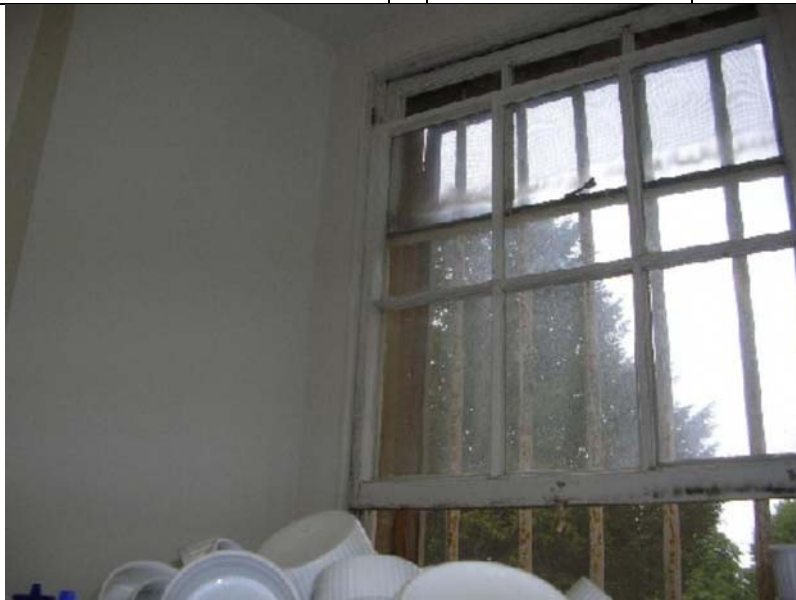
Swindon Borough Council			
Project Ref	J10943	Building	00 Main Building
Site	Lydiard House Lydiard Tregoze Swindon	Floor	00 Ground
Location	ENS1983	Description	Sash cord to store window
Room/Area	B016 Store	Site Code/UPRN	10004843255

Last Inspection Date	- 25 May 2007	Certificate N°	- C15751
Next Inspection Date	- N/A	Sample N°	- Ref B45
Survey Type	- Type 2	Photograph N°	- 14

Position	- Internal (Occupied)	Damage Risk	- Low
Asbestos Type	- No Asbestos Detected	HSE Notifiable	- No
Product Type	- Rope

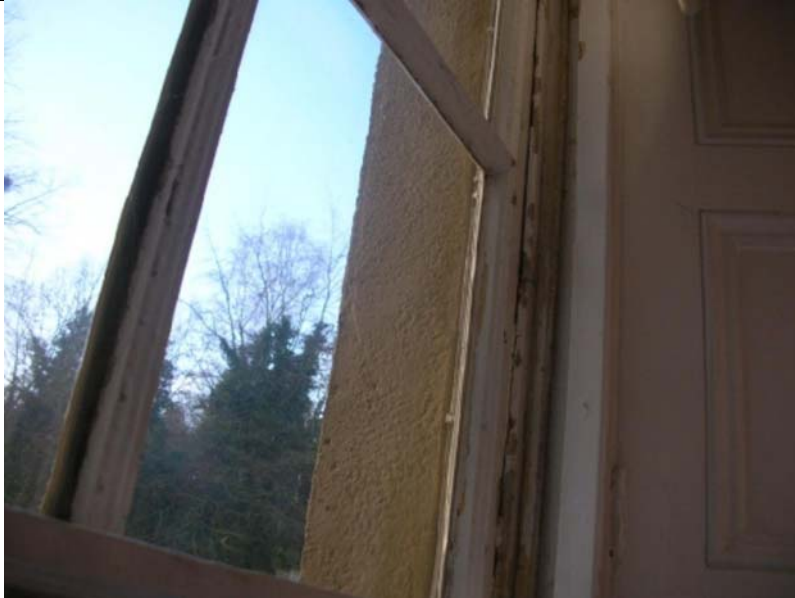
Swindon Borough Council			
Project Ref	J10943	Building	00 Main Building
Site	Lydiard House Lydiard Tregoze Swindon	Floor	00 Ground
Location	Loc0119	Description	Sash cord to windows
Room/Area	B018 Dining Room	Site Code/UPRN	10004843255

Last Inspection Date	- 20 Dec 2006	Certificate N°	- C15751
Next Inspection Date	- N/A	Sample N°	- Ref B18
Survey Type	- Type 2	Photograph N°	- 46

Position	- Internal (Occupied)	Damage Risk	- Low
Asbestos Type	- No Asbestos Detected	HSE Notifiable	- No
Product Type	- Rope

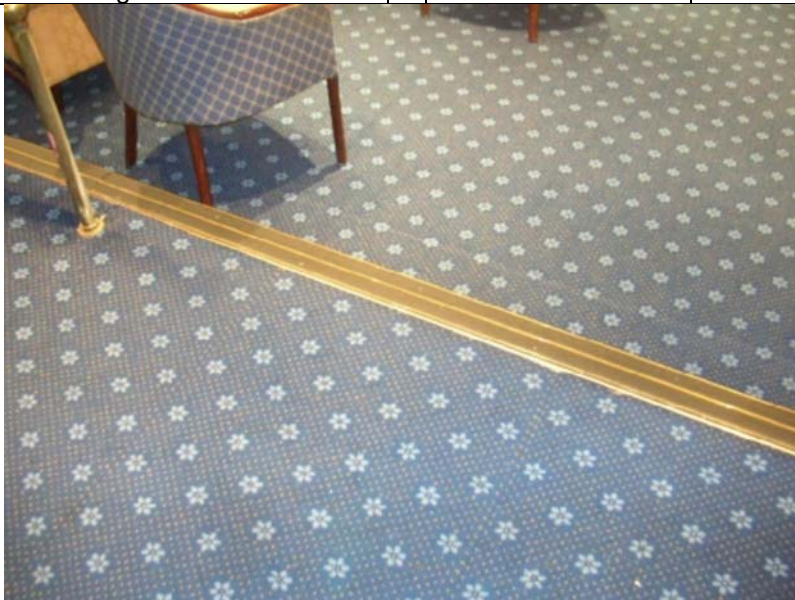
Swindon Borough Council			
Project Ref	J10943	Building	00 Main Building
Site	Lydiard House Lydiard Tregoze Swindon	Floor	00 Ground
Location	Loc0121	Description	Resin stair nosing to floor
Room/Area	B022 Lounge	Site Code/UPRN	10004843255

Last Inspection Date	- 20 Dec 2006	Certificate N°	- C15751
Next Inspection Date	- N/A	Sample N°	- B31
Survey Type	- Type 2	Photograph N°	- 47

Position	- Internal (Occupied)	Damage Risk	- Low
Asbestos Type	- No Asbestos Detected	HSE Notifiable	- No
Product Type	- Resin

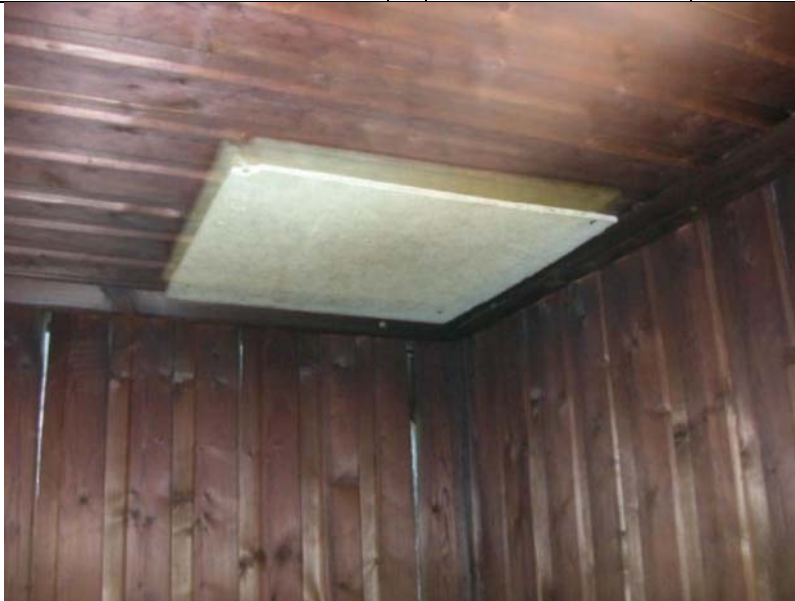
Swindon Borough Council			
Project Ref	J10943	Building	00 Main Building
Site	Lydiard House Lydiard Tregoze Swindon	Floor	00 Ground
Location	Loc0125	Description	Insulating board wall and ceiling panels
Room/Area	B029 Sauna	Site Code/UPRN	10004843255

Last Inspection Date	- 20 Dec 2006	Certificate N°	- C15751
Next Inspection Date	- N/A	Sample N°	- B32
Survey Type	- Type 2	Photograph N°	- 48

Position	- Internal (Occupied)	Damage Risk	- Low
Asbestos Type	- No Asbestos Detected	HSE Notifiable	- No
Product Type	- Insulating Board

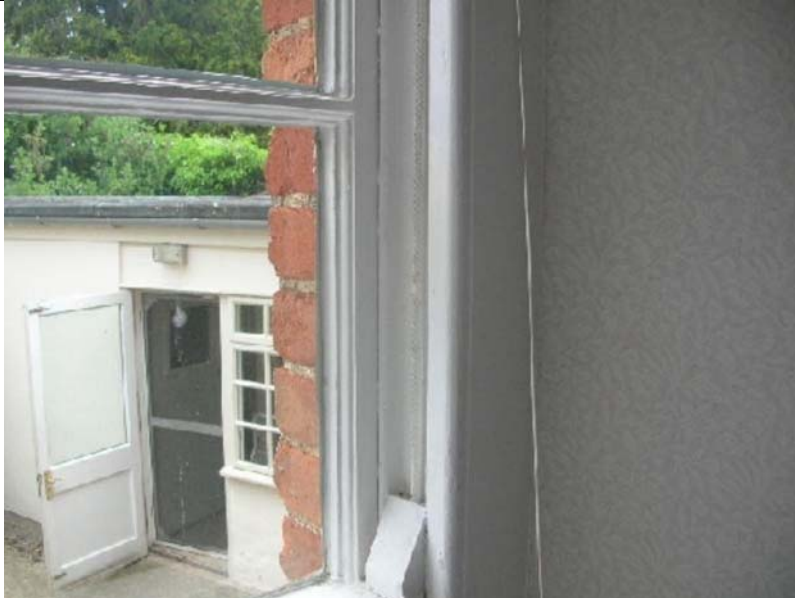
Swindon Borough Council			
Project Ref	J10943	Building	00 Main Building
Site	Lydiard House Lydiard Tregoze Swindon	Floor	00 Ground
Location	ENS1971	Description	Sash cord to stairs window
Room/Area	B062 Stairs	Site Code/UPRN	10004843255

Last Inspection Date	- 25 May 2007	Certificate N^o	- C15751
Next Inspection Date	- N/A	Sample N^o	- B45
Survey Type	- Type 2	Photograph N^o	- 02

Position	- Internal (Occupied)	Damage Risk	- Low
Asbestos Type	- No Asbestos Detected	HSE Notifiable	- No
Product Type	- Rope

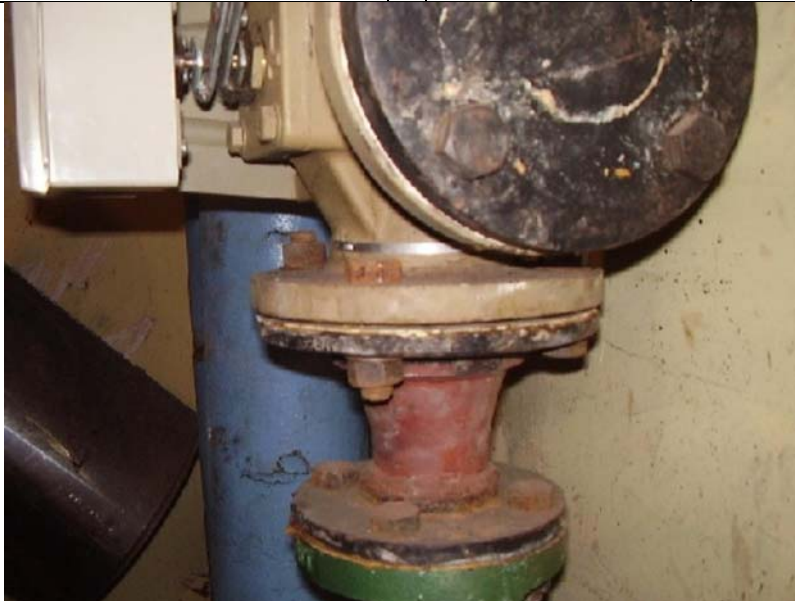
Swindon Borough Council			
Project Ref	J10943	Building	00 Main Building
Site	Lydiard House Lydiard Tregoze Swindon	Floor	00 Ground
Location	ENS0202	Description	Gasket to pipework in boiler room
Room/Area	B064 Boiler room	Site Code/UPRN	10004843255

Last Inspection Date	- 18 Dec 2006	Certificate N°	- C15751
Next Inspection Date	- N/A	Sample N°	- B25
Survey Type	- Type 2	Photograph N°	- 37

Position	- Internal (Occupied)	Damage Risk	- N/A
Asbestos Type	- No Asbestos Detected	HSE Notifiable	- No
Product Type	- Gasket

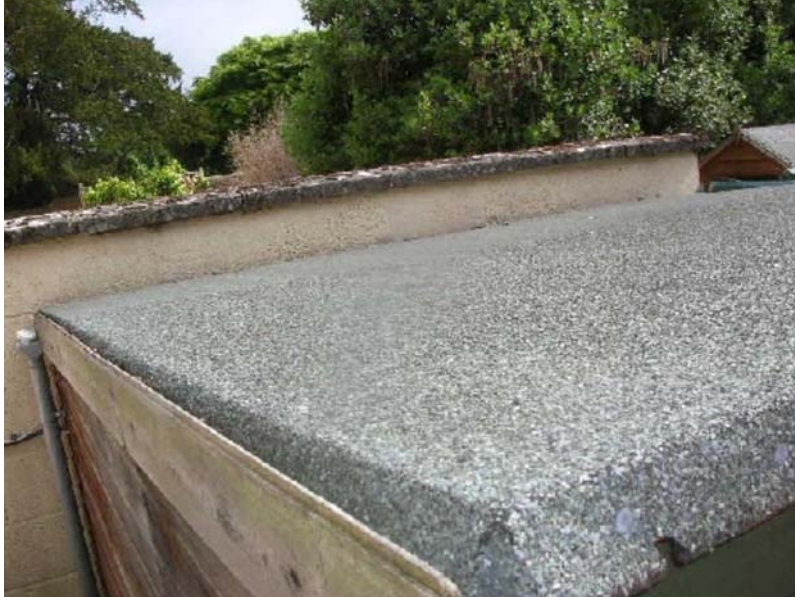
Swindon Borough Council			
Project Ref	J10943	Building	00 Main Building
Site	Lydiard House Lydiard Tregoze Swindon	Floor	00 Ground
Location	ENS1972	Description	Roof lining to yard shed
Room/Area	B065 Yard	Site Code/UPRN	10004843255

Last Inspection Date	- 25 May 2007	Certificate N^o.	- C15751
Next Inspection Date	- N/A	Sample N^o.	- B46
Survey Type	- Type 2	Photograph N^o.	- 03

Position	- External	Damage Risk	- Low
Asbestos Type	- No Asbestos Detected	HSE Notifiable	- No
Product Type	- Felt

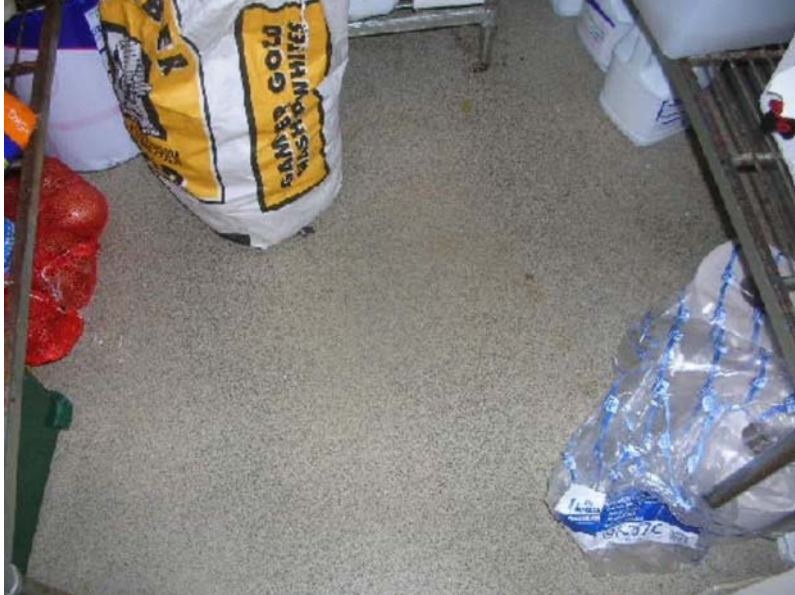
Swindon Borough Council			
Project Ref	J10943	Building	00 Main Building
Site	Lydiard House Lydiard Tregoze Swindon	Floor	00 Ground
Location	ENS1979	Description	Floor covering to salvage
Room/Area	B066 Salvage	Site Code/UPRN	10004843255

Last Inspection Date	- 25 May 2007	Certificate N°	- C15751
Next Inspection Date	- N/A	Sample N°	- Ref B47
Survey Type	- Type 2	Photograph N°	- 10

Position	- Internal (Occupied)	Damage Risk	- Low
Asbestos Type	- No Asbestos Detected	HSE Notifiable	- No
Product Type	- Vinyl

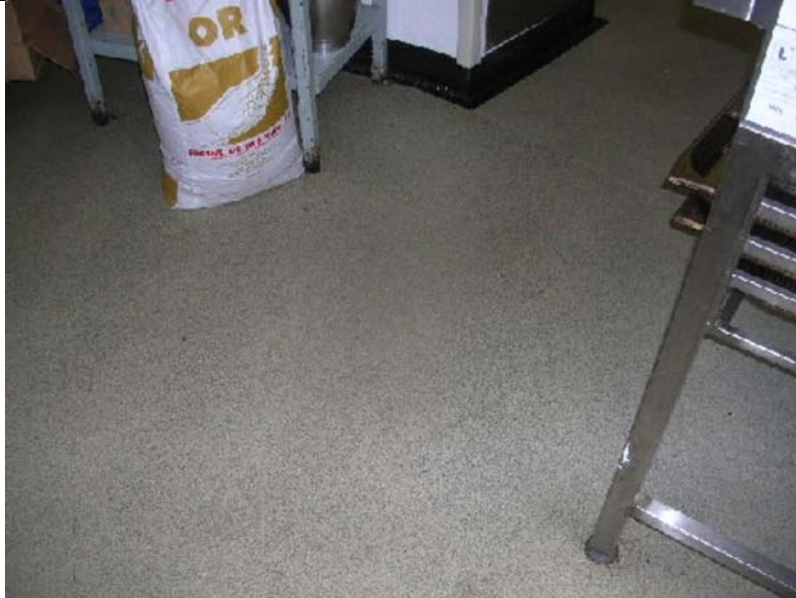
Swindon Borough Council			
Project Ref	J10943	Building	00 Main Building
Site	Lydiard House Lydiard Tregoze Swindon	Floor	00 Ground
Location	ENS1978	Description	Floor covering to laundry
Room/Area	B067 Laundry	Site Code/UPRN	10004843255

Last Inspection Date	- 25 May 2007	Certificate N°	- C15751
Next Inspection Date	- N/A	Sample N°	- Ref B47
Survey Type	- Type 2	Photograph N°	- 09

Position	- Internal (Occupied)	Damage Risk	- Low
Asbestos Type	- No Asbestos Detected	HSE Notifiable	- No
Product Type	- Vinyl

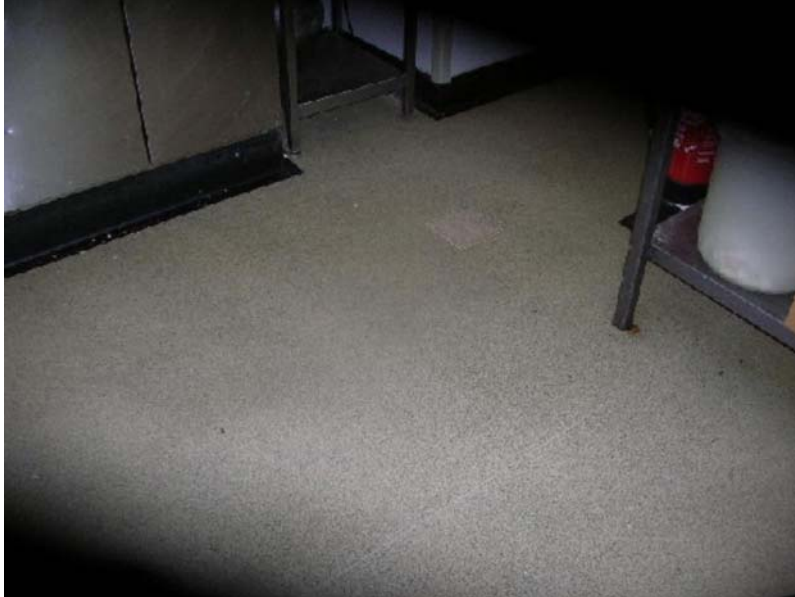
Swindon Borough Council			
Project Ref	J10943	Building	00 Main Building
Site	Lydiard House Lydiard Tregoze Swindon	Floor	00 Ground
Location	ENS1975	Description	Floor covering to kitchen
Room/Area	B068 Kitchen	Site Code/UPRN	10004843255

Last Inspection Date	- 25 May 2007	Certificate N°	- C15751
Next Inspection Date	- N/A	Sample N°	- Ref B47
Survey Type	- Type 2	Photograph N°	- 06

Position	- Internal (Occupied)	Damage Risk	- N/A
Asbestos Type	- No Asbestos Detected	HSE Notifiable	- No
Product Type	- Vinyl

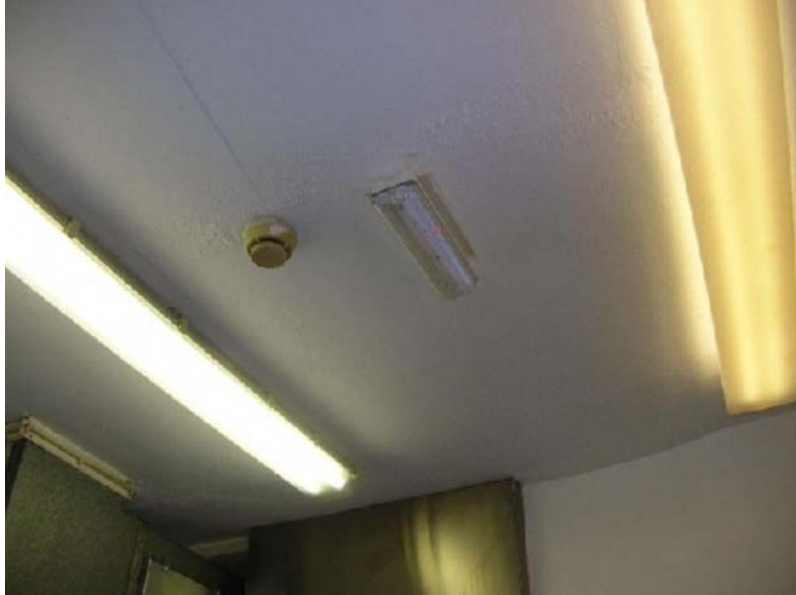
Swindon Borough Council			
Project Ref	J10943	Building	00 Main Building
Site	Lydiard House Lydiard Tregoze Swindon	Floor	00 Ground
Location	ENS1977	Description	Lining to kitchen ceiling
Room/Area	B068 Kitchen	Site Code/UPRN	10004843255

Last Inspection Date	- 25 May 2007	Certificate N^o.	- C15751
Next Inspection Date	- N/A	Sample N^o.	- B49
Survey Type	- Type 2	Photograph N^o.	- 08

Position	- Internal (Occupied)	Damage Risk	- Low
Asbestos Type	- No Asbestos Detected	HSE Notifiable	- No
Product Type	- Textured Coating

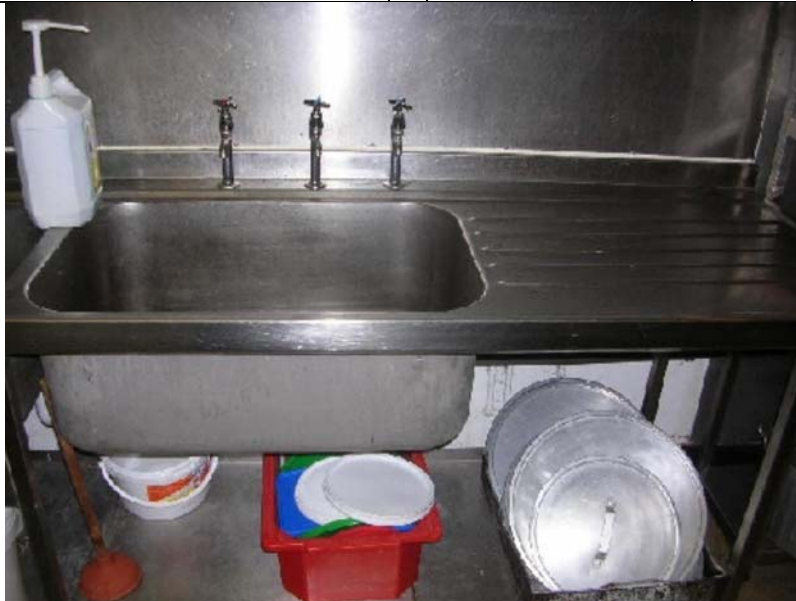
Swindon Borough Council			
Project Ref	J10943	Building	00 Main Building
Site	Lydiard House Lydiard Tregoze Swindon	Floor	00 Ground
Location	ENS1976	Description	Pad to underside of kitchen sink
Room/Area	B068 Kitchen	Site Code/UPRN	10004843255

Last Inspection Date	- 25 May 2007	Certificate N°	- C15751
Next Inspection Date	- N/A	Sample N°	- B48
Survey Type	- Type 2	Photograph N°	- 07

Position	- Internal (Occupied)	Damage Risk	- N/A
Asbestos Type	- No Asbestos Detected	HSE Notifiable	- No
Product Type	- Mastic

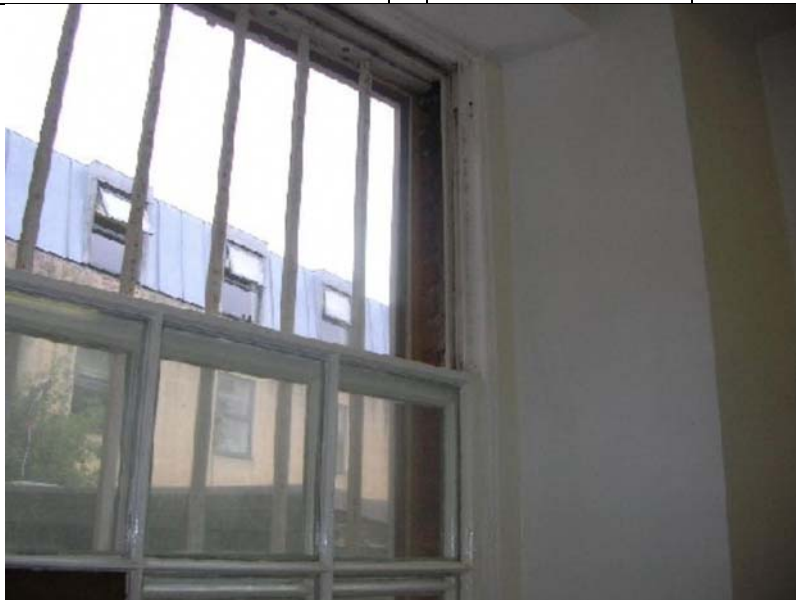
Swindon Borough Council			
Project Ref	J10943	Building	00 Main Building
Site	Lydiard House Lydiard Tregoze Swindon	Floor	00 Ground
Location	ENS1980	Description	Sash cord to kitchen window
Room/Area	B068 Kitchen	Site Code/UPRN	10004843255

Last Inspection Date	- 25 May 2007	Certificate N^o.	- C15751
Next Inspection Date	- N/A	Sample N^o.	- Ref B45
Survey Type	- Type 2	Photograph N^o.	- 11

Position	- Internal (Occupied)	Damage Risk	- Low
Asbestos Type	- No Asbestos Detected	HSE Notifiable	- No
Product Type	- Rope

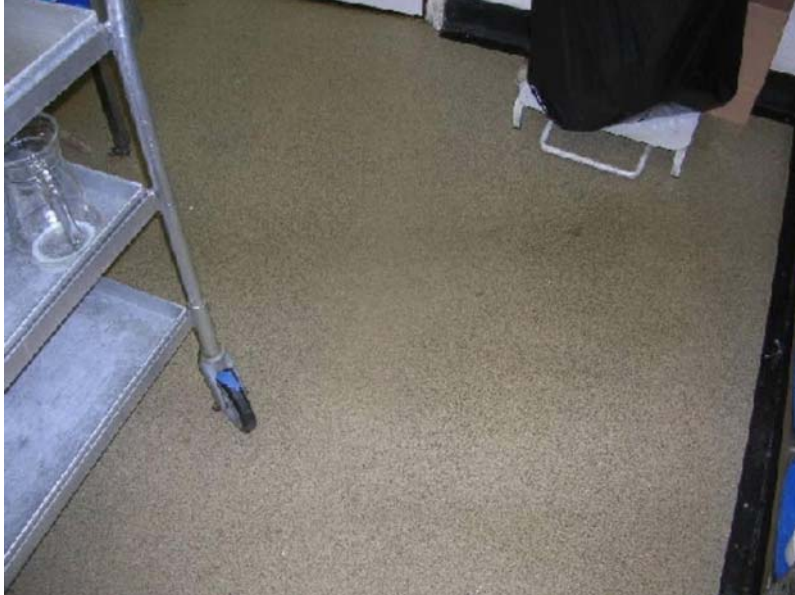
Swindon Borough Council			
Project Ref	J10943	Building	00 Main Building
Site	Lydiard House Lydiard Tregoze Swindon	Floor	00 Ground
Location	ENS1973	Description	Floor covering
Room/Area	B069 Room	Site Code/UPRN	10004843255

Last Inspection Date	- 25 May 2007	Certificate N°	- C15751
Next Inspection Date	- N/A	Sample N°	- B47
Survey Type	- Type 2	Photograph N°	- 04

Position	- Internal (Occupied)	Damage Risk	- Low
Asbestos Type	- No Asbestos Detected	HSE Notifiable	- No
Product Type	- Vinyl

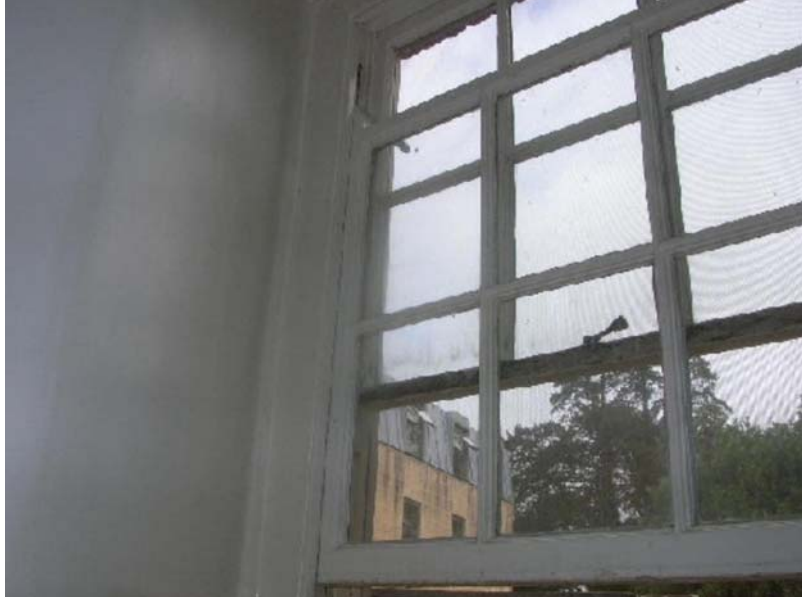
Swindon Borough Council			
Project Ref	J10943	Building	00 Main Building
Site	Lydiard House Lydiard Tregoze Swindon	Floor	00 Ground
Location	ENS1974	Description	Sah cord to window
Room/Area	B069 Room	Site Code/UPRN	10004843255

Last Inspection Date	- 25 May 2007	Certificate N°	- C15751
Next Inspection Date	- N/A	Sample N°	- Ref B45
Survey Type	- Type 2	Photograph N°	- 05

Position	- Internal (Occupied)	Damage Risk	- Low
Asbestos Type	- No Asbestos Detected	HSE Notifiable	- No
Product Type	- Rope

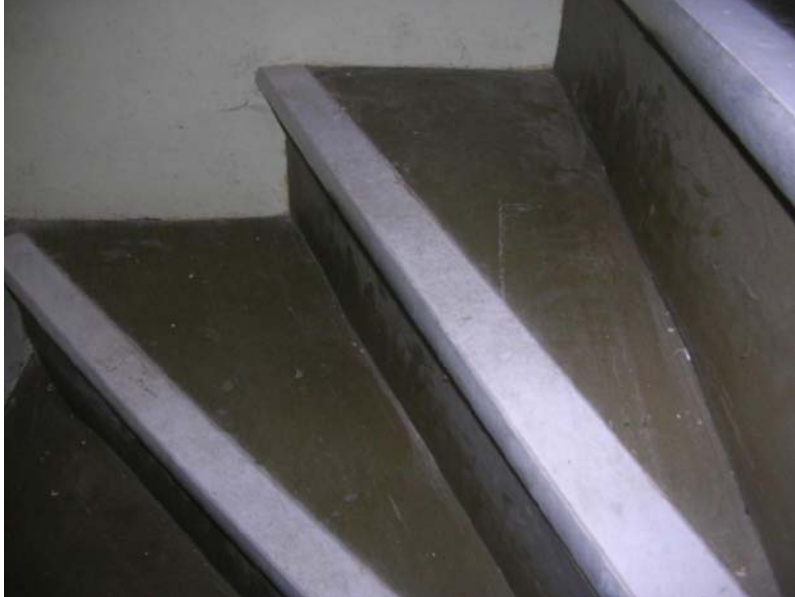
Swindon Borough Council			
Project Ref	J10943	Building	00 Main Building
Site	Lydiard House Lydiard Tregoze Swindon	Floor	00 Ground
Location	Loc0146	Description	Vinyl floor covering to stairs
Room/Area	B070 Stairs and Landing	Site Code/UPRN	10004843255

Last Inspection Date	- 20 Dec 2006	Certificate N^o	- C15751
Next Inspection Date	- 20 Dec 2007	Sample N^o	- B36
Survey Type	- Type 2	Photograph N^o	- 52

Position	- Internal (Occupied)	Damage Risk	- Low
Asbestos Type	- Chrysotile	HSE Notifiable	- No
Product Type	- Vinyl

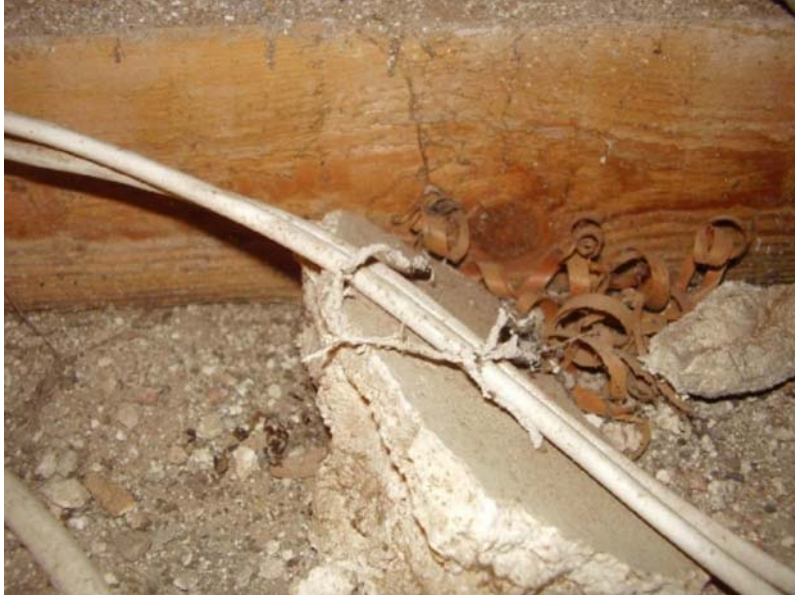
Swindon Borough Council			
Project Ref	J10943	Building	00 Main Building
Site	Lydiard House Lydiard Tregoze Swindon	Floor	00 Ground
Location	ENS166	Description	Debris within ceiling void
Room/Area	B077 Circ	Site Code/UPRN	10004843255

Last Inspection Date	- 14 Dec 2006	Certificate N°	- C15751
Next Inspection Date	- N/A	Sample N°	- B11
Survey Type	- Type 2	Photograph N°	- 13

Position	- Internal (Occupied)	Damage Risk	- Low
Asbestos Type	- No Asbestos Detected	HSE Notifiable	- No
Product Type	- Rope

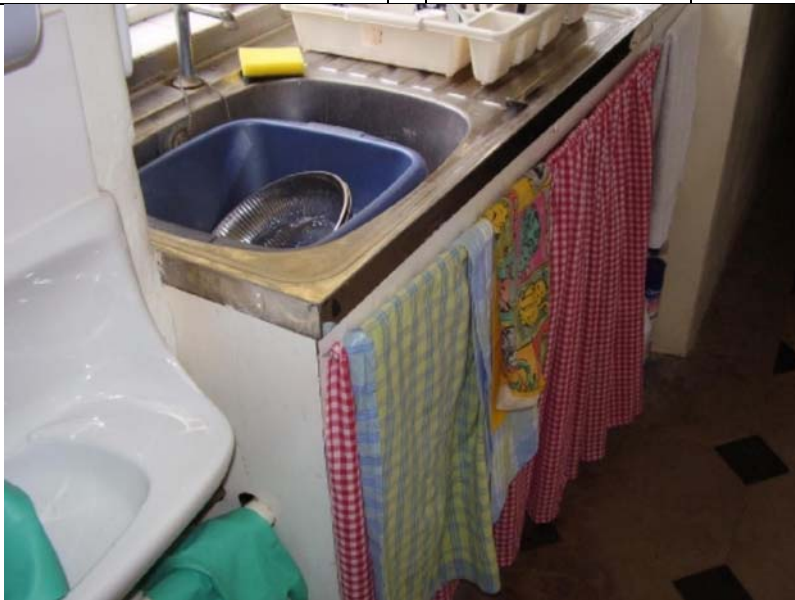
Swindon Borough Council			
Project Ref	J10943	Building	00 Main Building
Site	Lydiard House Lydiard Tregoze Swindon	Floor	00 Ground
Location	ENS165	Description	Pad to base of kitchen sink
Room/Area	B077 Circ	Site Code/UPRN	10004843255

Last Inspection Date	- 14 Dec 2006	Certificate N^o	- C15751
Next Inspection Date	- N/A	Sample N^o	- B10
Survey Type	- Type 2	Photograph N^o	- 12

Position	- Internal (Occupied)	Damage Risk	- Low
Asbestos Type	- No Asbestos Detected	HSE Notifiable	- No
Product Type	- Mastic

Amount	- < 1 Sq M	Job Status	- Surveyed
Damage Extent	- Low Damage	Material Risk	- 0
Surface Treatment	- Composite (Self Sealed)	Assessment	NO ASBESTOS DETECTED
Friability	- Low

Comments:	- Please refer to the recommendation below
Recommendations:	- No asbestos fibre was detected within the sample collected. As such the client is not required to take any further action.

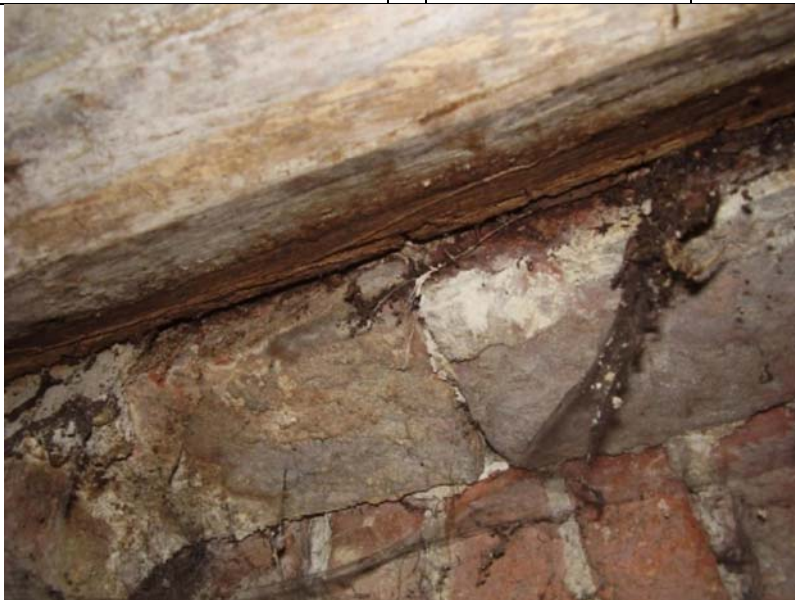
Swindon Borough Council			
Project Ref	J10943	Building	00 Main Building
Site	Lydiard House Lydiard Tregoze Swindon	Floor	00 Ground
Location	ENS170	Description	Debris above door
Room/Area	B078 Boiler	Site Code/UPRN	10004843255

Last Inspection Date	- 14 Dec 2006	Certificate N°	- C15751
Next Inspection Date	- N/A	Sample N°	- B13
Survey Type	- Type 2	Photograph N°	- 14

Position	- Internal (Occupied)	Damage Risk	- Low
Asbestos Type	- No Asbestos Detected	HSE Notifiable	- No
Product Type	- Cement

Amount	- < 1 Sq M	Job Status	- Surveyed
Damage Extent	- High Damage	Material Risk	- 0
Surface Treatment	- Unsealed Cement	Assessment	
Friability	- Low	NO ASBESTOS DETECTED

Comments:	- Please refer to the recommendation below
Recommendations:	- No asbestos fibre was detected within the sample collected. As such the client is not required to take any further action.

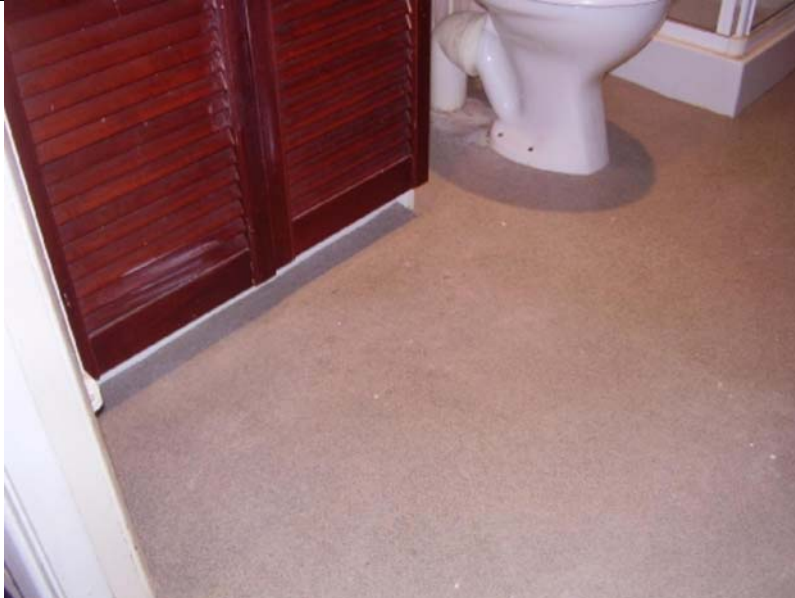
Swindon Borough Council			
Project Ref	J10943	Building	00 Main Building
Site	Lydiard House Lydiard Tregoze Swindon	Floor	01 First
Location	ENS128	Description	Grey floor covering
Room/Area	C016 Bathroom	Site Code/UPRN	10004843255

Last Inspection Date	- 13 Dec 2006	Certificate N^o	- C15751
Next Inspection Date	- N/A	Sample N^o	- B09
Survey Type	- Type 2	Photograph N^o	- 10

Position	- Internal (Occupied)	Damage Risk	- Low
Asbestos Type	- No Asbestos Detected	HSE Notifiable	- No
Product Type	- Vinyl

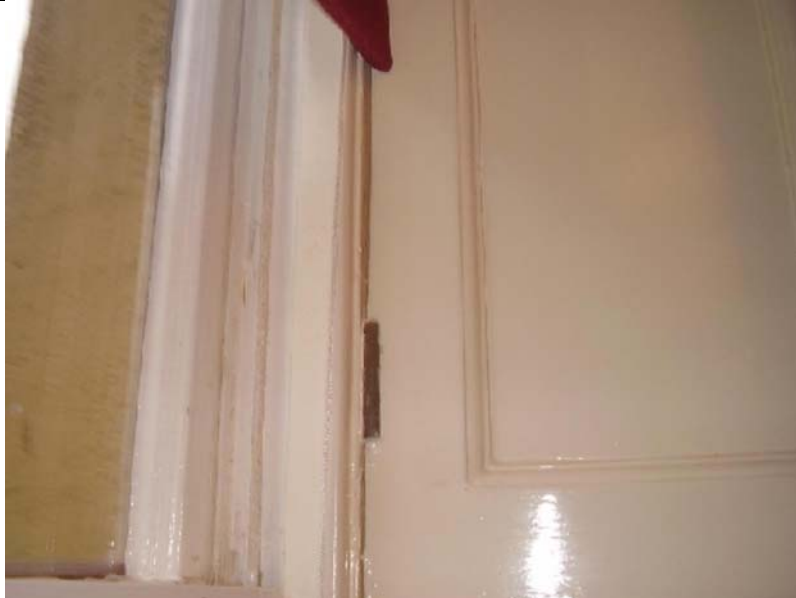
Swindon Borough Council			
Project Ref	J10943	Building	00 Main Building
Site	Lydiard House Lydiard Tregoze Swindon	Floor	01 First
Location	ENS0236	Description	Sash cord to windows
Room/Area	C020 Lounge	Site Code/UPRN	10004843255

Last Inspection Date	- 18 Dec 2006	Certificate N^o	- C15751
Next Inspection Date	- N/A	Sample N^o	- Ref B18
Survey Type	- Type 2	Photograph N^o	- 33

Position	- Internal (Occupied)	Damage Risk	- Low
Asbestos Type	- No Asbestos Detected	HSE Notifiable	- No
Product Type	- Rope

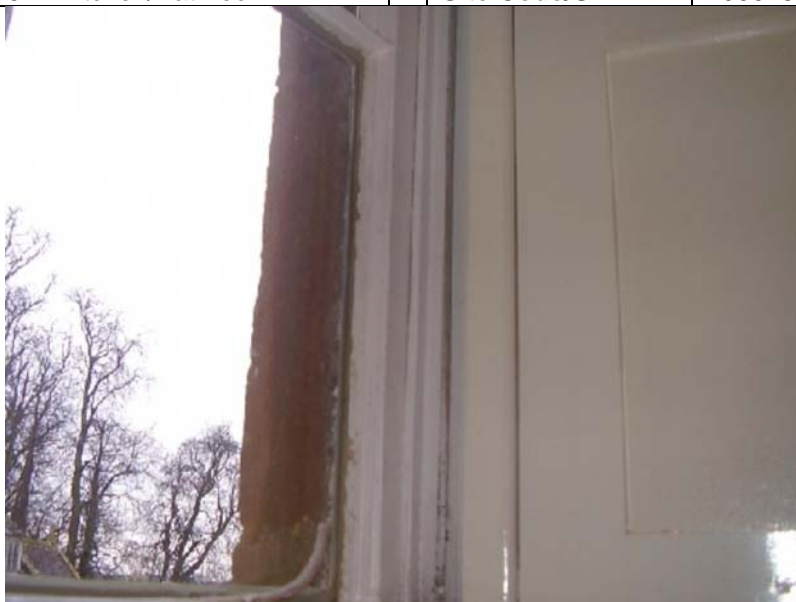
Swindon Borough Council			
Project Ref	J10943	Building	00 Main Building
Site	Lydiard House Lydiard Tregoze Swindon	Floor	01 First
Location	ENS0238	Description	Sash cord to windows
Room/Area	C021 Kitchen/Bathroom	Site Code/UPRN	10004843255

Last Inspection Date	- 18 Dec 2006	Certificate N^o	- C15751
Next Inspection Date	- N/A	Sample N^o	- Ref B18
Survey Type	- Type 2	Photograph N^o	- 34

Position	- Internal (Occupied)	Damage Risk	- Low
Asbestos Type	- No Asbestos Detected	HSE Notifiable	- No
Product Type	- Rope

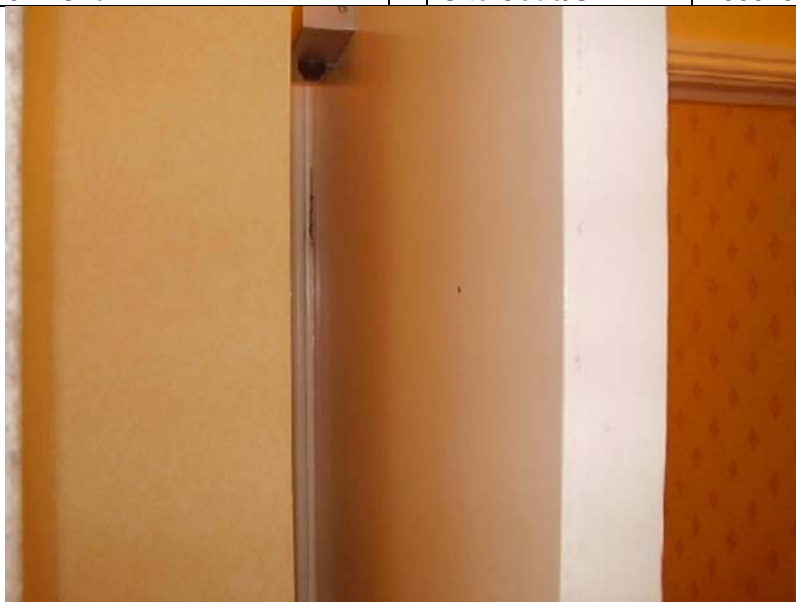
Swindon Borough Council			
Project Ref	J10943	Building	00 Main Building
Site	Lydiard House Lydiard Tregoze Swindon	Floor	01 First
Location	ENS0232	Description	Board panel to rear of door
Room/Area	C022 Circ	Site Code/UPRN	10004843255

Last Inspection Date	- 18 Dec 2006	Certificate N°	- C15751
Next Inspection Date	- N/A	Sample N°	- B22
Survey Type	- Type 2	Photograph N°	- 32

Position	- Internal (Occupied)	Damage Risk	- Low
Asbestos Type	- No Asbestos Detected	HSE Notifiable	- No
Product Type	- Insulating Board

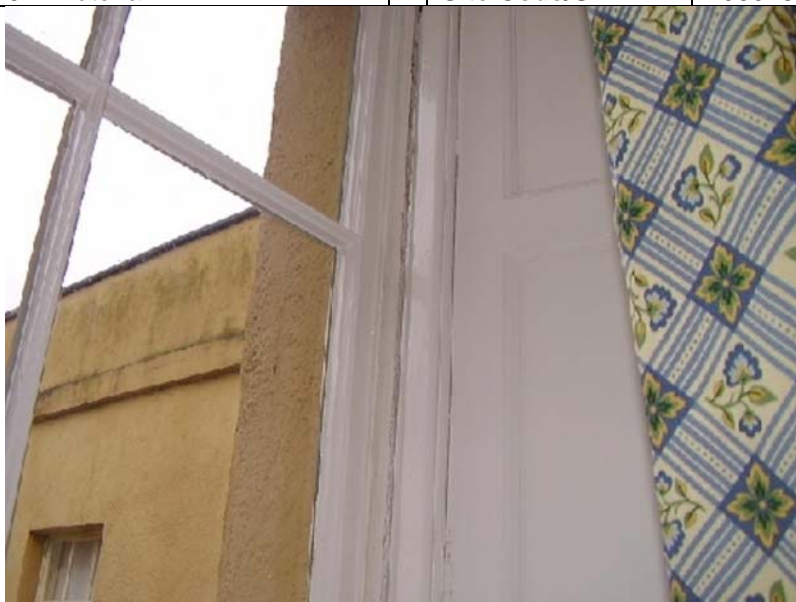
Swindon Borough Council			
Project Ref	J10943	Building	00 Main Building
Site	Lydiard House Lydiard Tregoze Swindon	Floor	01 First
Location	ENS0228	Description	Sash cord to windows
Room/Area	C024 Tutorial	Site Code/UPRN	10004843255

Last Inspection Date	- 18 Dec 2006	Certificate N°	- C15751
Next Inspection Date	- N/A	Sample N°	- Ref B18
Survey Type	- Type 2	Photograph N°	- 31

Position	- Internal (Occupied)	Damage Risk	- Low
Asbestos Type	- No Asbestos Detected	HSE Notifiable	- No
Product Type	- Rope

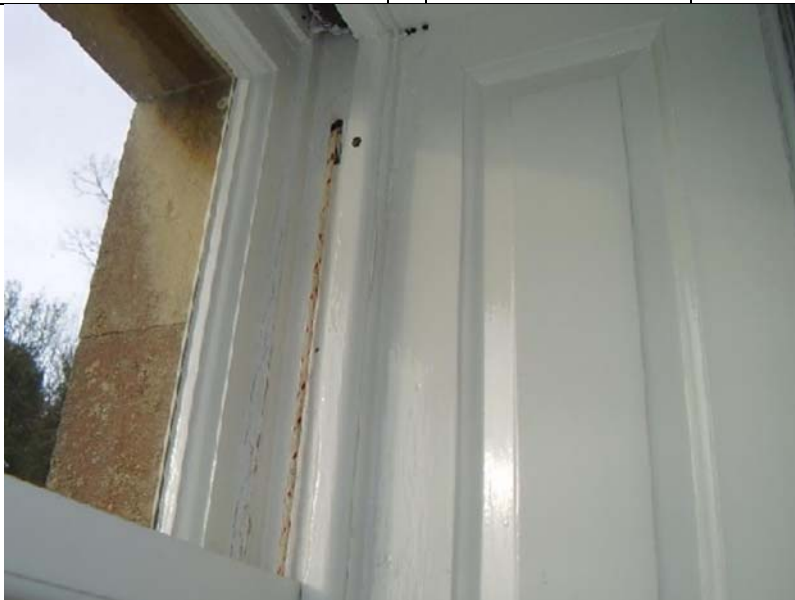
Swindon Borough Council			
Project Ref	J10943	Building	00 Main Building
Site	Lydiard House Lydiard Tregoze Swindon	Floor	01 First
Location	ENS0226	Description	Sash cord to windows
Room/Area	C025 Tutorial	Site Code/UPRN	10004843255

Last Inspection Date	- 18 Dec 2006	Certificate N^o	- C15751
Next Inspection Date	- N/A	Sample N^o	- Ref B18
Survey Type	- Type 2	Photograph N^o	- 30

Position	- Internal (Occupied)	Damage Risk	- Low
Asbestos Type	- No Asbestos Detected	HSE Notifiable	- No
Product Type	- Rope

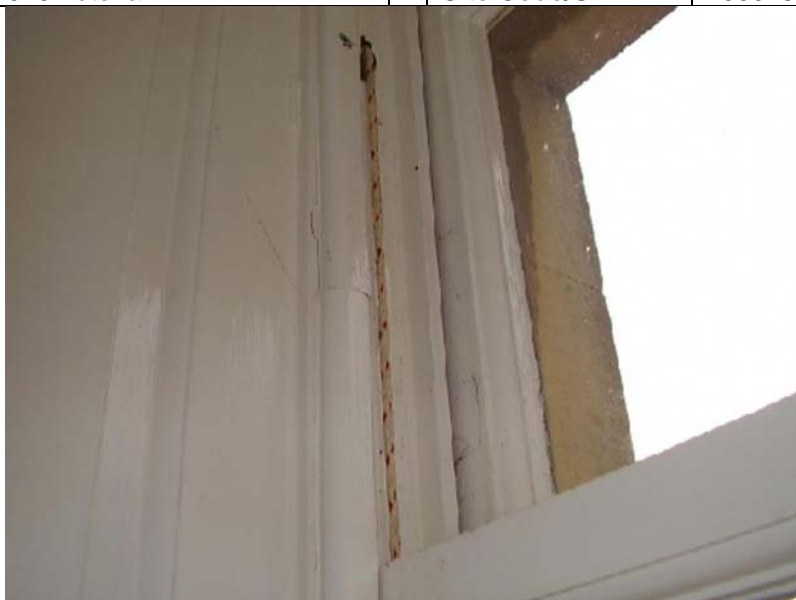
Swindon Borough Council			
Project Ref	J10943	Building	00 Main Building
Site	Lydiard House Lydiard Tregoze Swindon	Floor	01 First
Location	ENS0224	Description	Sash cord to windows
Room/Area	C026 Tutorial	Site Code/UPRN	10004843255

Last Inspection Date	- 18 Dec 2006	Certificate N°	- C15751
Next Inspection Date	- N/A	Sample N°	- Ref B18
Survey Type	- Type 2	Photograph N°	- 29

Position	- Internal (Occupied)	Damage Risk	- Low
Asbestos Type	- No Asbestos Detected	HSE Notifiable	- No
Product Type	- Rope

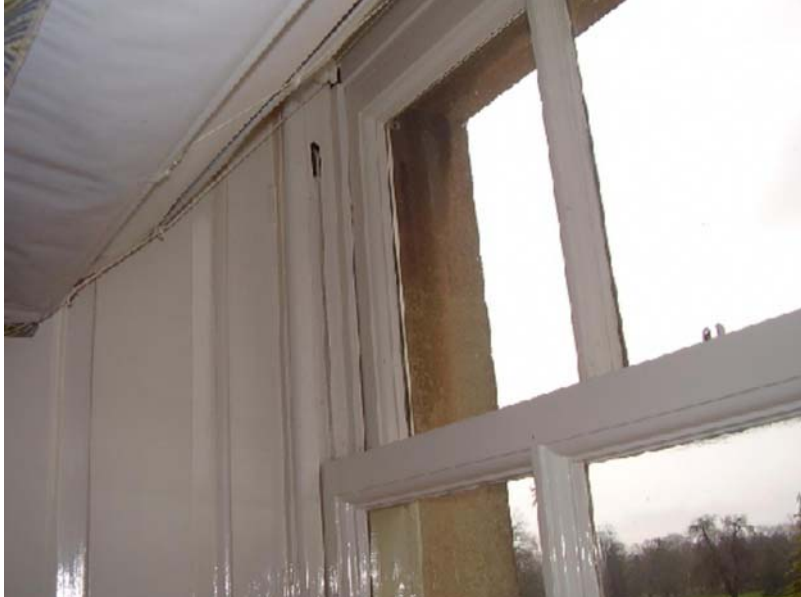
Swindon Borough Council			
Project Ref	J10943	Building	00 Main Building
Site	Lydiard House Lydiard Tregoze Swindon	Floor	01 First
Location	ENS0222	Description	Sash cord to windows
Room/Area	C027 Tutorial	Site Code/UPRN	10004843255

Last Inspection Date	- 18 Dec 2006	Certificate N°	- C15751
Next Inspection Date	- N/A	Sample N°	- Ref B18
Survey Type	- Type 2	Photograph N°	- 28

Position	- Internal (Occupied)	Damage Risk	- Low
Asbestos Type	- No Asbestos Detected	HSE Notifiable	- No
Product Type	- Rope

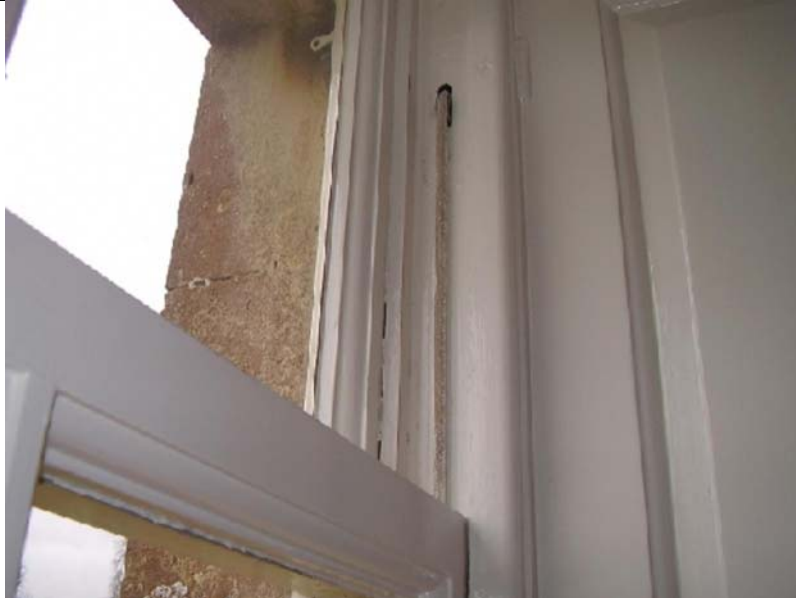
Swindon Borough Council			
Project Ref	J10943	Building	00 Main Building
Site	Lydiard House Lydiard Tregoze Swindon	Floor	01 First
Location	Loc0192	Description	Sash cord to windows
Room/Area	C028 Tutorial	Site Code/UPRN	10004843255

Last Inspection Date	- 18 Dec 2006	Certificate N^o.	- C15751
Next Inspection Date	- N/A	Sample N^o.	- Ref B18
Survey Type	- Type 2	Photograph N^o.	- 24

Position	- Internal (Occupied)	Damage Risk	- Low
Asbestos Type	- No Asbestos Detected	HSE Notifiable	- No
Product Type	- Rope

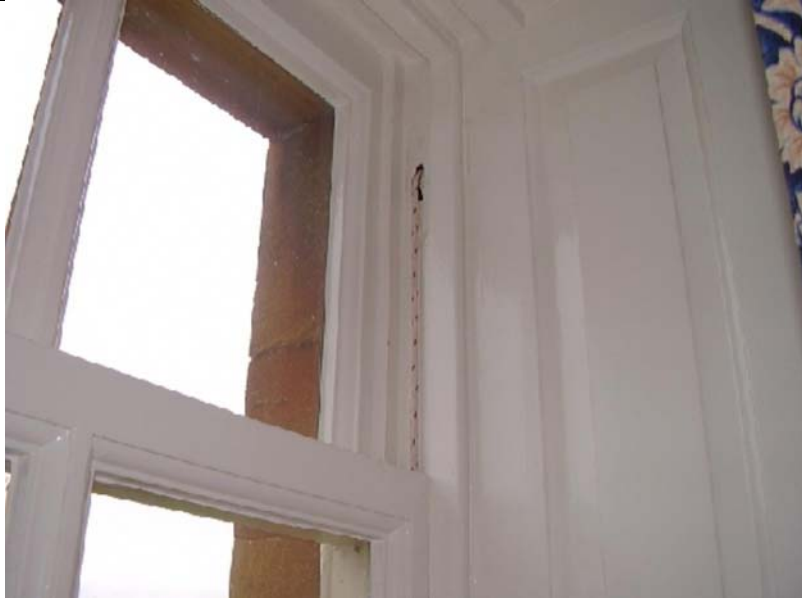
Swindon Borough Council			
Project Ref	J10943	Building	00 Main Building
Site	Lydiard House Lydiard Tregoze Swindon	Floor	01 First
Location	ENS0205	Description	Sash cord to windows
Room/Area	C029 Tutorial	Site Code/UPRN	10004843255

Last Inspection Date	- 18 Dec 2006	Certificate N^o	- C15751
Next Inspection Date	- N/A	Sample N^o	- B18
Survey Type	- Type 2	Photograph N^o	- 19

Position	- Internal (Occupied)	Damage Risk	- Low
Asbestos Type	- No Asbestos Detected	HSE Notifiable	- No
Product Type	- Rope
