Report of 'Type 2' Asbestos Survey
At
Lydiard House
Lydiard Tregoze
Swindon
For
Swindon Borough Council

On
Tuesday 12th December 2006
Project Ref: J10943
UPRN: 10004843255

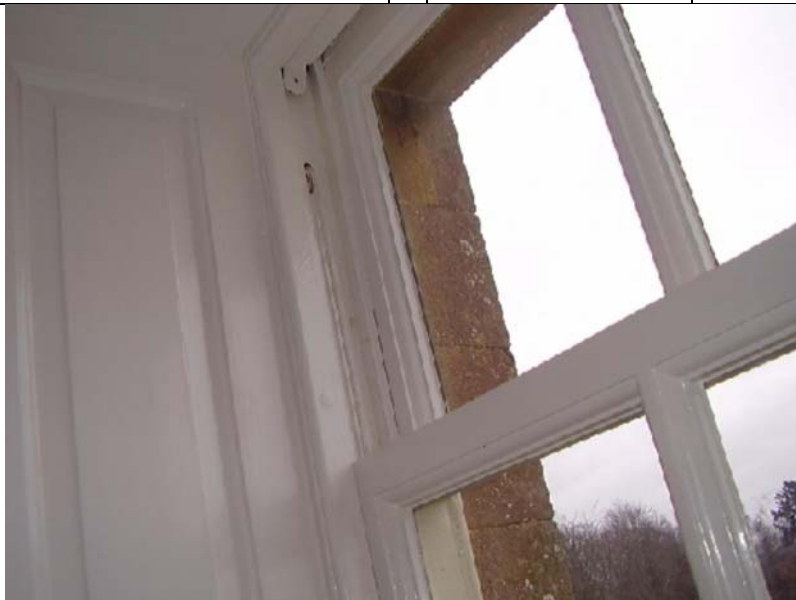
Swindon Borough Council			
Project Ref	J10943	Building	00 Main Building
Site	Lydiard House Lydiard Tregoze Swindon	Floor	01 First
Location	ENS0207	Description	Sash cord to windows
Room/Area	C030 Tutorial	Site Code/UPRN	10004843255

Last Inspection Date	- 18 Dec 2006	Certificate N°	- C15751
Next Inspection Date	- N/A	Sample N°	- Ref B18
Survey Type	- Type 2	Photograph N°	- 20

Position	- Internal (Occupied)	Damage Risk	- Low
Asbestos Type	- No Asbestos Detected	HSE Notifiable	- No
Product Type	- Rope

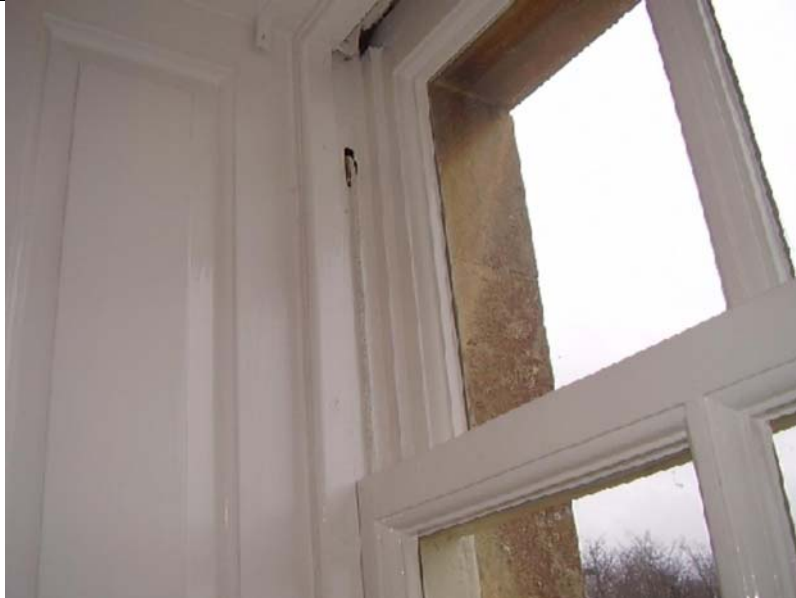
Swindon Borough Council			
Project Ref	J10943	Building	00 Main Building
Site	Lydiard House Lydiard Tregoze Swindon	Floor	01 First
Location	ENS0209	Description	Sash cord to windows
Room/Area	C031 Tutorial	Site Code/UPRN	10004843255

Last Inspection Date	- 18 Dec 2006	Certificate N°	- C15751
Next Inspection Date	- N/A	Sample N°	- Ref B18
Survey Type	- Type 2	Photograph N°	- 21

Position	- Internal (Occupied)	Damage Risk	- Low
Asbestos Type	- No Asbestos Detected	HSE Notifiable	- No
Product Type	- Rope

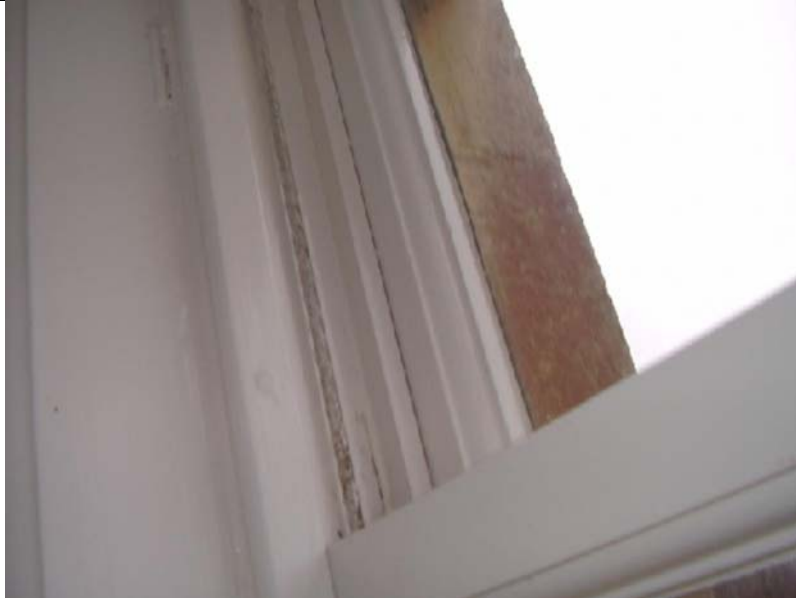
Swindon Borough Council			
Project Ref	J10943	Building	00 Main Building
Site	Lydiard House Lydiard Tregoze Swindon	Floor	01 First
Location	ENS0211	Description	Sash cord to windows
Room/Area	C032 Tutorial	Site Code/UPRN	10004843255

Last Inspection Date	- 18 Dec 2006	Certificate N°	- C15751
Next Inspection Date	- N/A	Sample N°	- Ref B18
Survey Type	- Type 2	Photograph N°	- 22

Position	- Internal (Occupied)	Damage Risk	- Low
Asbestos Type	- No Asbestos Detected	HSE Notifiable	- No
Product Type	- Rope

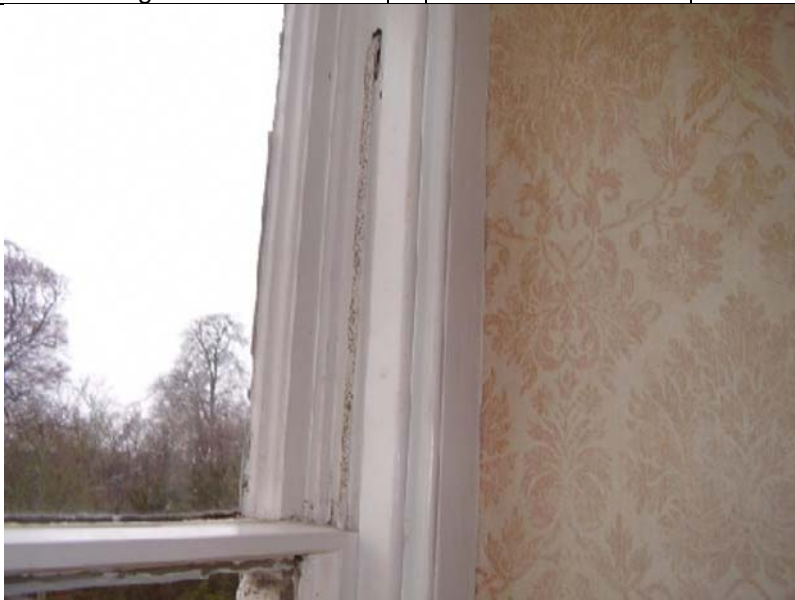
Swindon Borough Council			
Project Ref	J10943	Building	00 Main Building
Site	Lydiard House Lydiard Tregoze Swindon	Floor	01 First
Location	ENS0215	Description	Sash cord to windows
Room/Area	C035 Landing	Site Code/UPRN	10004843255

Last Inspection Date	- 18 Dec 2006	Certificate N^o.	- C15751
Next Inspection Date	- N/A	Sample N^o.	- Ref B18
Survey Type	- Type 2	Photograph N^o.	- 25

Position	- Internal (Occupied)	Damage Risk	- Low
Asbestos Type	- No Asbestos Detected	HSE Notifiable	- No
Product Type	- Rope

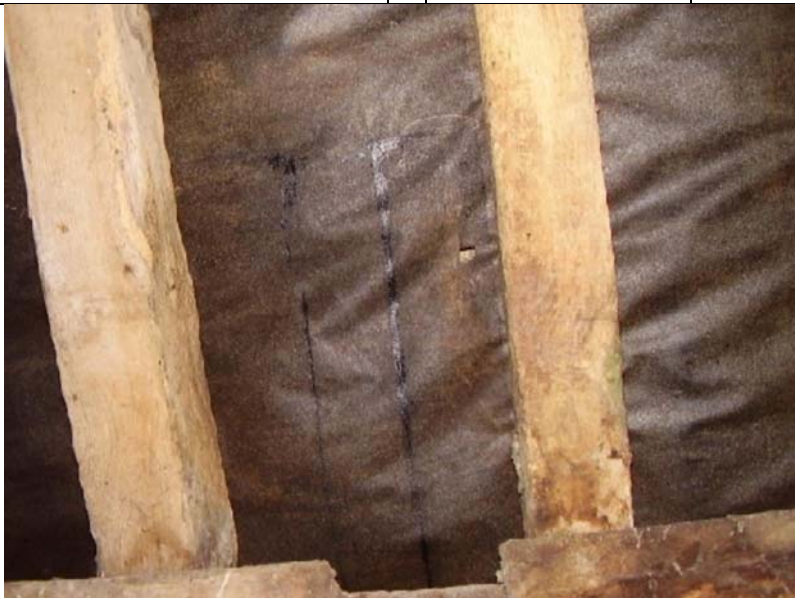
Swindon Borough Council			
Project Ref	J10943	Building	00 Main Building
Site	Lydiard House Lydiard Tregoze Swindon	Floor	01 First
Location	ENS0213	Description	Lining to roof in void
Room/Area	C036 Circ	Site Code/UPRN	10004843255

Last Inspection Date	- 18 Dec 2006	Certificate N°	- C15751
Next Inspection Date	- N/A	Sample N°	- B19
Survey Type	- Type 2	Photograph N°	- 23

Position	- Internal (Occupied)	Damage Risk	- Low
Asbestos Type	- No Asbestos Detected	HSE Notifiable	- No
Product Type	- Bitumen

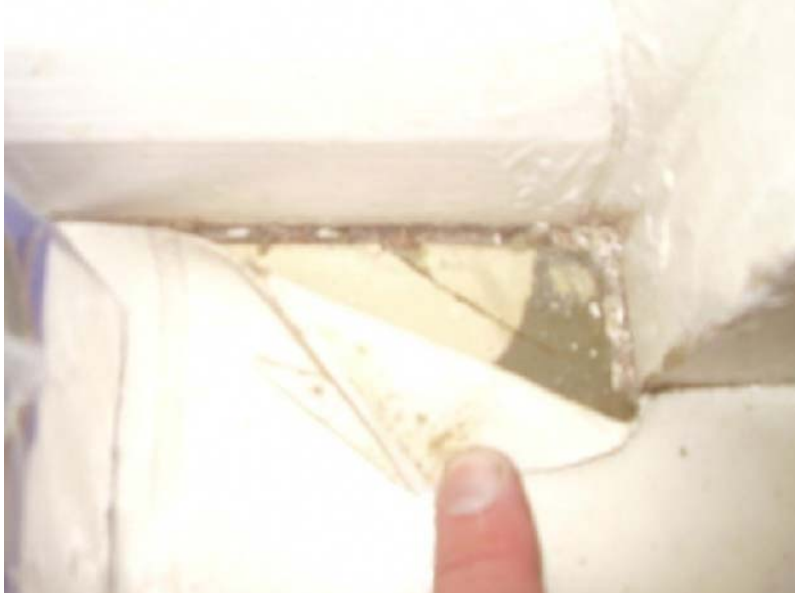
Swindon Borough Council			
Project Ref	J10943	Building	00 Main Building
Site	Lydiard House Lydiard Tregoze Swindon	Floor	01 First
Location	ENS0219	Description	Floor covering under linoluem floor to kitchen
Room/Area	C039 Kitchen	Site Code/UPRN	10004843255

Last Inspection Date	- 18 Dec 2006	Certificate N°	- C15751
Next Inspection Date	- 18 Dec 2007	Sample N°	- B20
Survey Type	- Type 2	Photograph N°	- 26

Position	- Internal (Occupied)	Damage Risk	- Low
Asbestos Type	- Chrysotile	HSE Notifiable	- No
Product Type	- Vinyl

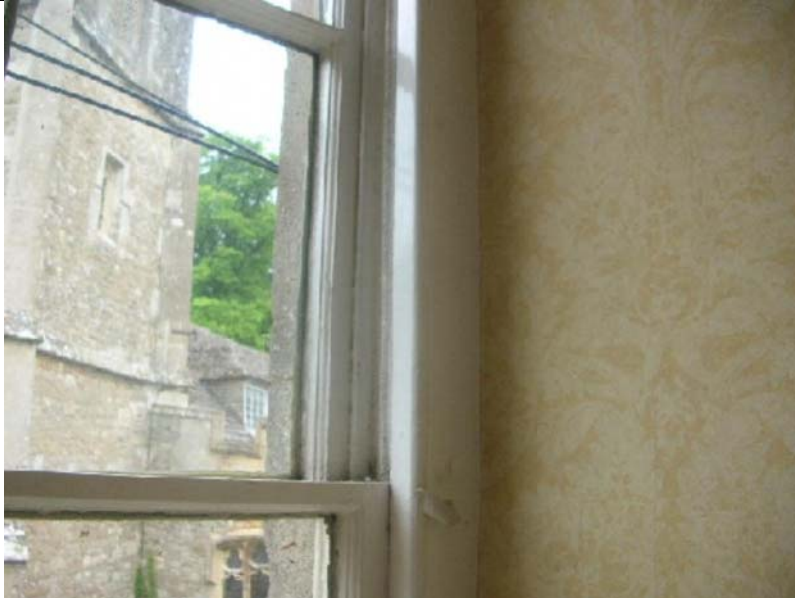
Swindon Borough Council			
Project Ref	J10943	Building	00 Main Building
Site	Lydiard House Lydiard Tregoze Swindon	Floor	01 First
Location	ENS1996	Description	Sash cord to stairs window
Room/Area	C043 Stairs	Site Code/UPRN	10004843255

Last Inspection Date	- 25 May 2007	Certificate N°	- C15751
Next Inspection Date	- N/A	Sample N°	- B53
Survey Type	- Type 2	Photograph N°	- 18

Position	- Internal (Occupied)	Damage Risk	- Low
Asbestos Type	- No Asbestos Detected	HSE Notifiable	- No
Product Type	- Rope

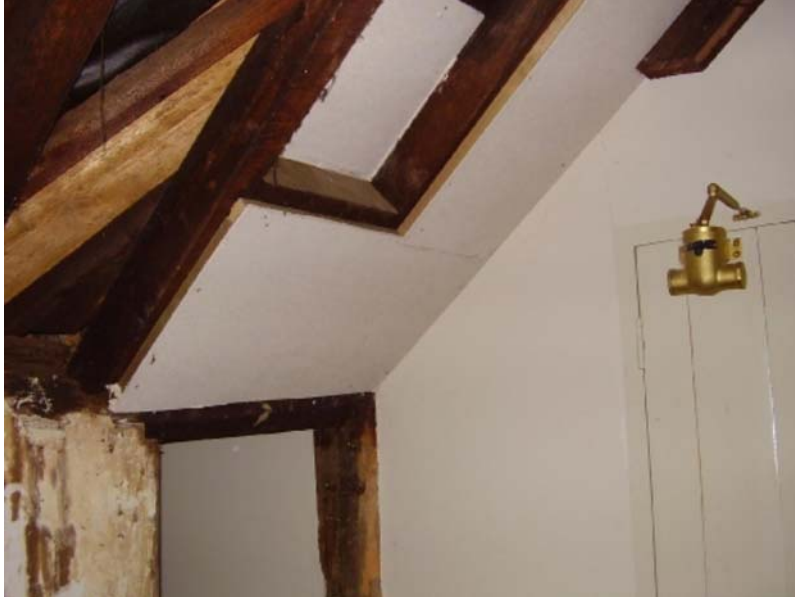
Swindon Borough Council			
Project Ref	J10943	Building	00 Main Building
Site	Lydiard House Lydiard Tregoze Swindon	Floor	03 Roof/Attic
Location	ENS107	Description	Paneling to roof
Room/Area	04 Circ	Site Code/UPRN	10004843255

Last Inspection Date	- 12 Dec 2006	Certificate N°	- C15751
Next Inspection Date	- N/A	Sample N°	- B01
Survey Type	- Type 2	Photograph N°	- 01

Position	- Internal (Occupied)	Damage Risk	- Low
Asbestos Type	- No Asbestos Detected	HSE Notifiable	- No
Product Type	- Insulating Board

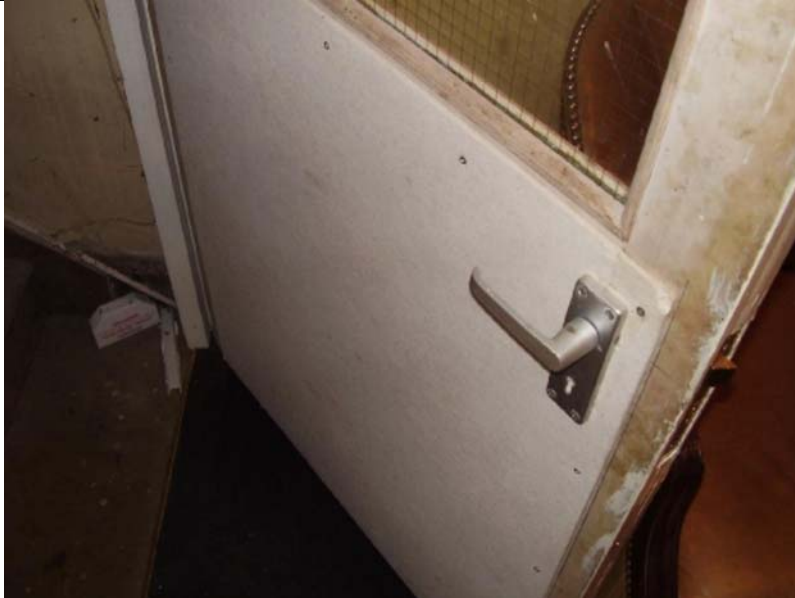
Swindon Borough Council			
Project Ref	J10943	Building	00 Main Building
Site	Lydiard House Lydiard Tregoze Swindon	Floor	03 Roof/Attic
Location	ENS117	Description	Panel to rear of door
Room/Area	04 Stairwell	Site Code/UPRN	10004843255

Last Inspection Date	- 12 Dec 2006	Certificate N°	- C15751
Next Inspection Date	- N/A	Sample N°	- B05
Survey Type	- Type 2	Photograph N°	- 06

Position	- Internal (Occupied)	Damage Risk	- Low
Asbestos Type	- No Asbestos Detected	HSE Notifiable	- No
Product Type	- Insulating Board

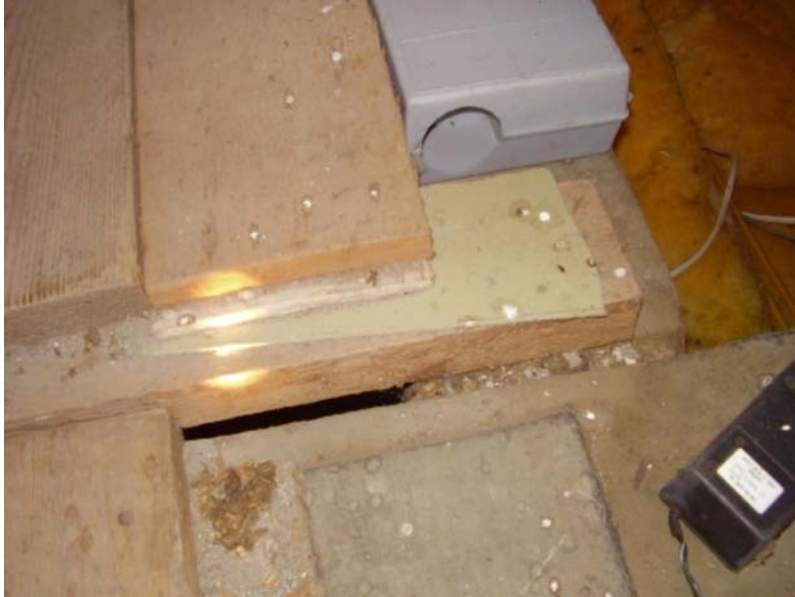
Swindon Borough Council			
Project Ref	J10943	Building	00 Main Building
Site	Lydiard House Lydiard Tregoze Swindon	Floor	03 Roof/Attic
Location	ENS114	Description	To panel behind old electrics
Room/Area	05 Loft	Site Code/UPRN	10004843255

Last Inspection Date	- 13 Dec 2006	Certificate N°	- C15751
Next Inspection Date	- N/A	Sample N°	- B03
Survey Type	- Type 2	Photograph N°	- 04

Position	- Internal (Occupied)	Damage Risk	- Low
Asbestos Type	- No Asbestos Detected	HSE Notifiable	- No
Product Type	- Bitumen

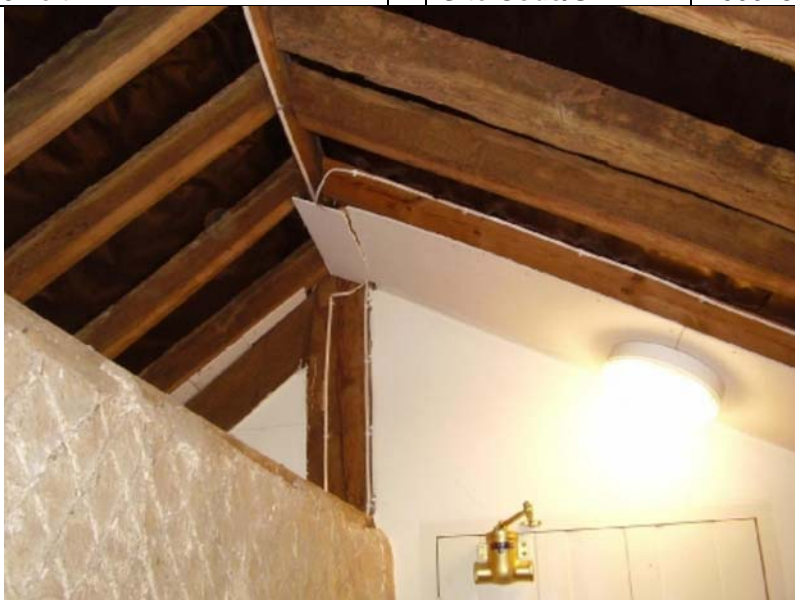
Swindon Borough Council			
Project Ref	J10943	Building	00 Main Building
Site	Lydiard House Lydiard Tregoze Swindon	Floor	03 Roof/Attic
Location	ENS111	Description	Panel above door to corridor
Room/Area	05 Loft	Site Code/UPRN	10004843255

Last Inspection Date	- 12 Dec 2006	Certificate N^o	- C15751
Next Inspection Date	- N/A	Sample N^o	- Ref B01
Survey Type	- Type 2	Photograph N^o	- 03

Position	- Internal (Occupied)	Damage Risk	- Low
Asbestos Type	- No Asbestos Detected	HSE Notifiable	- No
Product Type	- Insulating Board

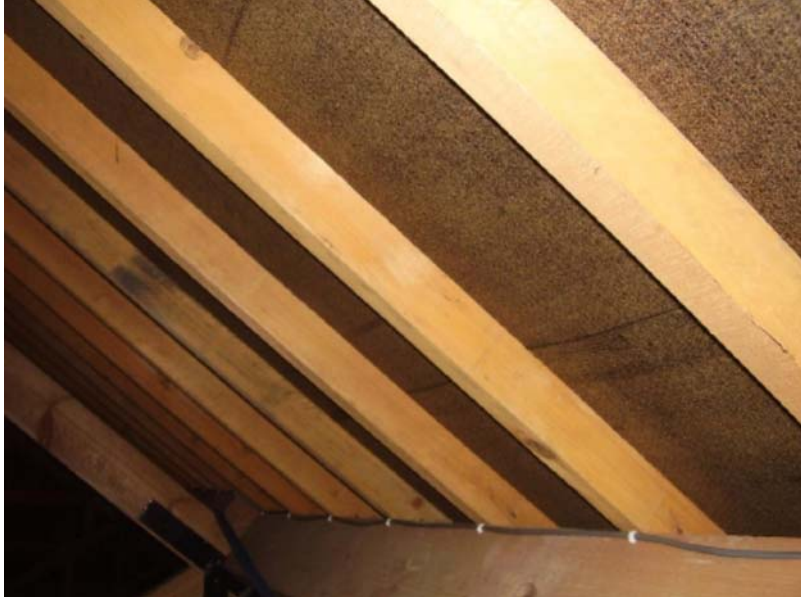
Swindon Borough Council			
Project Ref	J10943	Building	00 Main Building
Site	Lydiard House Lydiard Tregoze Swindon	Floor	03 Roof/Attic
Location	ENS192	Description	Lining to roof tiles
Room/Area	06 Loft	Site Code/UPRN	10004843255

Last Inspection Date	- 13 Dec 2006	Certificate N^o	- C15751
Next Inspection Date	- N/A	Sample N^o	- B17
Survey Type	- Type 2	Photograph N^o	- 18

Position	- Internal (Occupied)	Damage Risk	- Low
Asbestos Type	- No Asbestos Detected	HSE Notifiable	- No
Product Type	- Felt

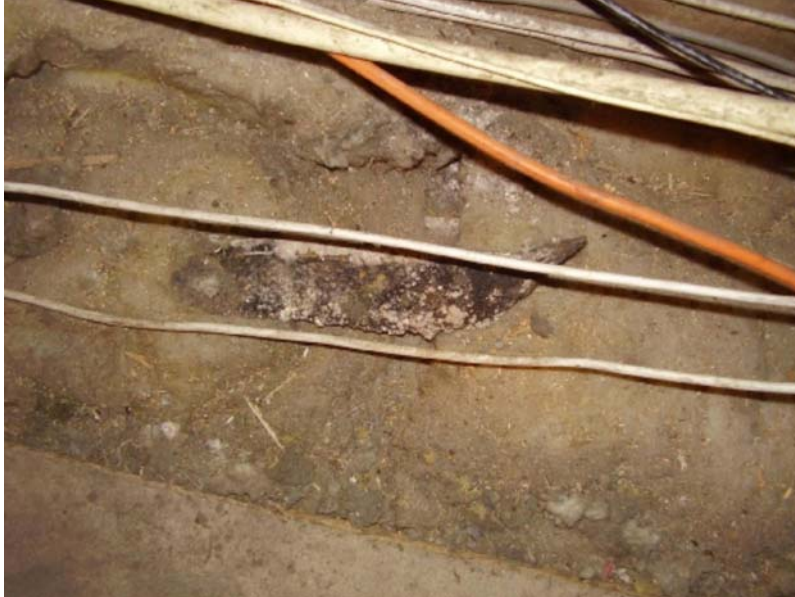
Swindon Borough Council			
Project Ref	J10943	Building	00 Main Building
Site	Lydiard House Lydiard Tregoze Swindon	Floor	03 Roof/Attic
Location	ENS191	Description	Loose tapes to floor of loft
Room/Area	06 Loft	Site Code/UPRN	10004843255

Last Inspection Date	- 15 Dec 2006	Certificate N^o	- C15751
Next Inspection Date	- 15 Dec 2007	Sample N^o	- B16
Survey Type	- Type 2	Photograph N^o	- 17

Position	- Internal (Occupied)	Damage Risk	- Medium
Asbestos Type	- Chrysotile	HSE Notifiable	- Yes
Product Type	- Woven Textiles

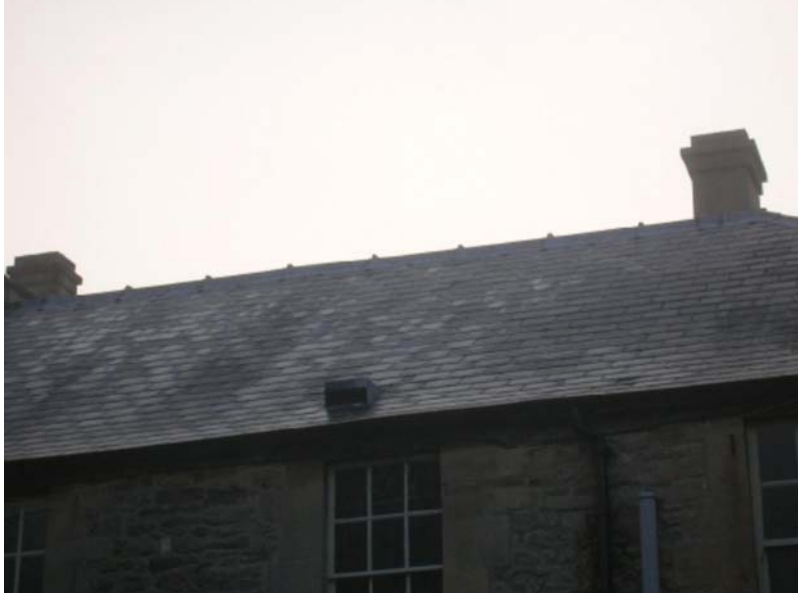
Swindon Borough Council			
Project Ref	J10943	Building	00 Main Building
Site	Lydiard House Lydiard Tregoze Swindon	Floor	External
Location	Loc0220	Description	Cement tiles to pitch roof
Room/Area	N/A	Site Code/UPRN	10004843255

Last Inspection Date	- 21 Dec 2006	Certificate N°	- C15751
Next Inspection Date	- 21 Dec 2007	Sample N°	- Ref B02
Survey Type	- Type 2	Photograph N°	- 53

Position	- External	Damage Risk	- Low
Asbestos Type	- Chrysotile	HSE Notifiable	- No
Product Type	- Cement

Amount	- 300 Sq M	Job Status	- Surveyed
Damage Extent	- Low Damage	Material Risk	- 4
Surface Treatment	- Unsealed Cement	Assessment	
Friability	- Low	Very Low Risk - Very low potential to release fibres

Comments:	- The material was unsampled in this location as a sample of identical material had been previously collected (Sample Reference B02).
Recommendations:	- If left undisturbed the asbestos containing cement does not require removal, however, must be managed accordingly. Although not a requirement it may be prudent to consider encapsulation/re-encapsulation and or labelling where practicable to do so.

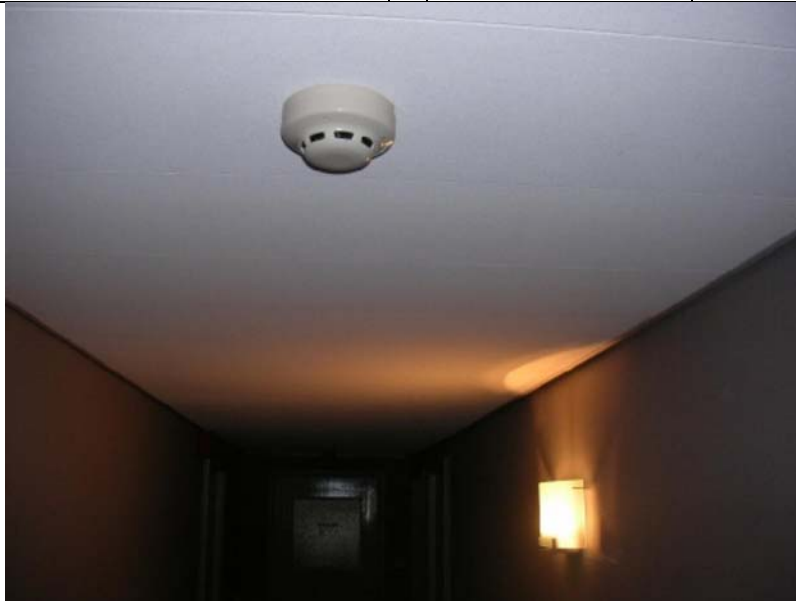
Swindon Borough Council			
Project Ref	J10943	Building	01 Accommodation Block
Site	Lydiard House Lydiard Tregoze Swindon	Floor	00 Ground
Location	Ens0370	Description	MMMf suspended tiles throughout
Room/Area	B032 Corridor	Site Code/UPRN	10004843255

Last Inspection Date	- 19 Dec 2006	Certificate N°	- C15751
Next Inspection Date	- N/A	Sample N°	- B28
Survey Type	- Type 2	Photograph N°	- 40

Position	- Internal (Occupied)	Damage Risk	- Low
Asbestos Type	- No Asbestos Detected	HSE Notifiable	- No
Product Type	- Compressed Fibre Board

Amount	- 11 Sq M	Job Status	- Surveyed
Damage Extent	- Low Damage	Material Risk	- 0
Surface Treatment	- Unsealed Board	Assessment	
Friability	- Medium	NO ASBESTOS DETECTED

Comments:	- Please refer to the recommendation below
Recommendations:	- No asbestos fibre was detected within the sample collected. As such the client is not required to take any further action.

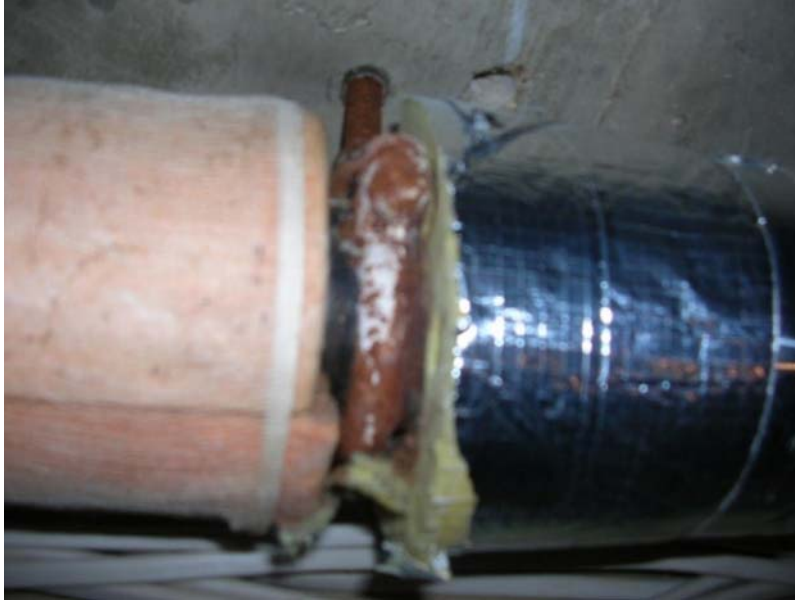
Swindon Borough Council			
Project Ref	J10943	Building	01 Accommodation Block
Site	Lydiard House Lydiard Tregoze Swindon	Floor	00 Ground
Location	Ens0369	Description	Debris to pipe hanger within ceiling void
Room/Area	B032 Corridor	Site Code/UPRN	10004843255

Last Inspection Date	- 19 Dec 2006	Certificate N°	- C15751
Next Inspection Date	- N/A	Sample N°	- B27
Survey Type	- Type 2	Photograph N°	- 39

Position	- Internal (Occupied)	Damage Risk	- Low
Asbestos Type	- No Asbestos Detected	HSE Notifiable	- No
Product Type	- Insulation

Amount	- < 1 Sq M	Job Status	- Surveyed
Damage Extent	- High Damage	Material Risk	- 0
Surface Treatment	- Unsealed Insulation	Assessment	
Friability	- High	NO ASBESTOS DETECTED

Comments:	- Please refer to the recommendation below
Recommendations:	- No asbestos fibre was detected within the sample collected. As such the client is not required to take any further action.

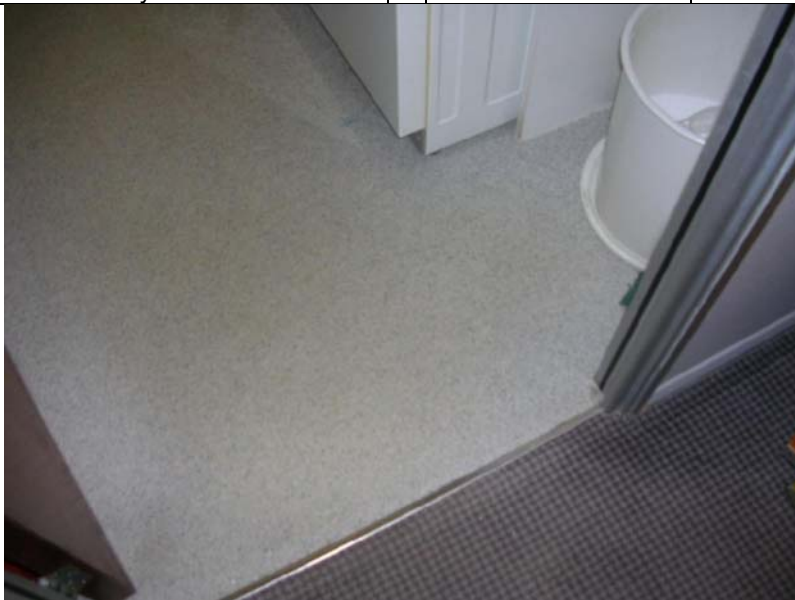
Swindon Borough Council			
Project Ref	J10943	Building	01 Accommodation Block
Site	Lydiard House Lydiard Tregoze Swindon	Floor	00 Ground
Location	Ens0342	Description	Modern vinyl floor covering
Room/Area	B048 Laundry	Site Code/UPRN	10004843255

Last Inspection Date	- 19 Dec 2006	Certificate N°	- C15751
Next Inspection Date	- N/A	Sample N°	- B26
Survey Type	- Type 2	Photograph N°	- 38

Position	- Internal (Occupied)	Damage Risk	- Low
Asbestos Type	- No Asbestos Detected	HSE Notifiable	- No
Product Type	- Vinyl

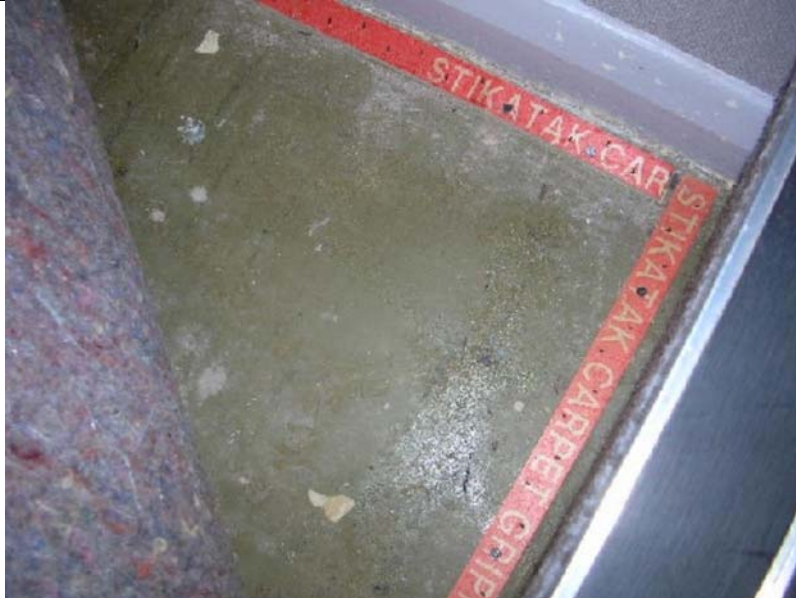
Swindon Borough Council			
Project Ref	J10943	Building	01 Accommodation Block
Site	Lydiard House Lydiard Tregoze Swindon	Floor	01 First floor
Location	ENS1997	Description	Floor covering under carpet
Room/Area	D018 Circ	Site Code/UPRN	10004843255

Last Inspection Date	- 25 May 2007	Certificate N°	- C15751
Next Inspection Date	- 25 May 2008	Sample N°	- B54
Survey Type	- Type 2	Photograph N°	- 19

Position	- Internal (Occupied)	Damage Risk	- Low
Asbestos Type	- Chrysotile	HSE Notifiable	- No
Product Type	- Vinyl

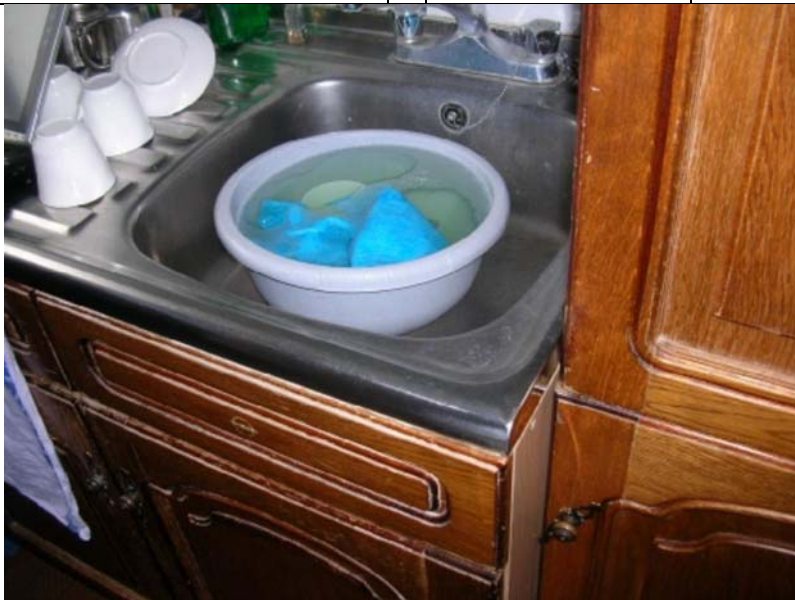
Swindon Borough Council			
Project Ref	J10943	Building	01 Accommodation Block
Site	Lydiard House Lydiard Tregoze Swindon	Floor	01 First floor
Location	Loc0198	Description	Mastic pad to underside of sink
Room/Area	D028 Kitchen	Site Code/UPRN	10004843255

Last Inspection Date	- 21 Dec 2006	Certificate N°	- C15751
Next Inspection Date	- N/A	Sample N°	- B38
Survey Type	- Type 2	Photograph N°	- 55

Position	- Internal (Occupied)	Damage Risk	- Low
Asbestos Type	- No Asbestos Detected	HSE Notifiable	- No
Product Type	- Mastic

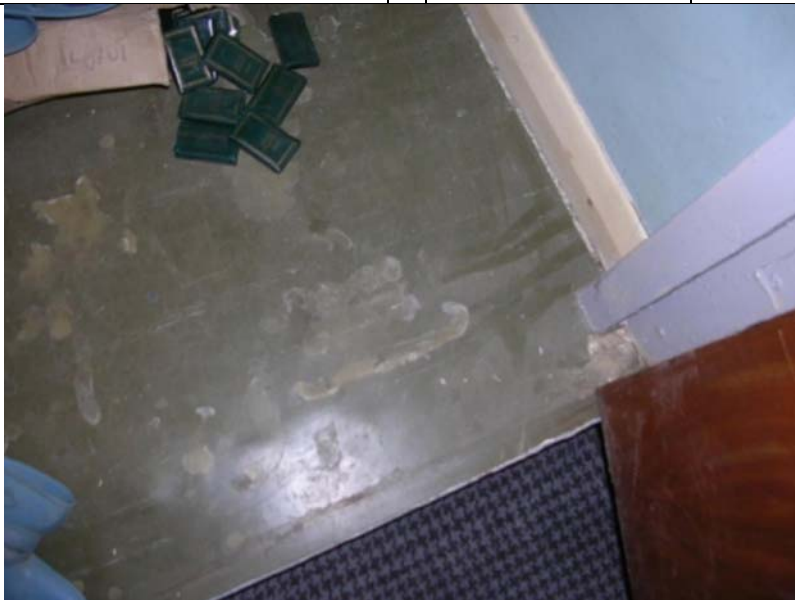
Swindon Borough Council			
Project Ref	J10943	Building	01 Accommodation Block
Site	Lydiard House Lydiard Tregoze Swindon	Floor	01 First floor
Location	Loc0203	Description	Green vinyl floor covering
Room/Area	D029 Store	Site Code/UPRN	10004843255

Last Inspection Date	- 21 Dec 2006	Certificate N°	- C15751
Next Inspection Date	- 21 Dec 2007	Sample N°	- B39
Survey Type	- Type 2	Photograph N°	- 56

Position	- Internal (Occupied)	Damage Risk	- Low
Asbestos Type	- Chrysotile	HSE Notifiable	- No
Product Type	- Vinyl

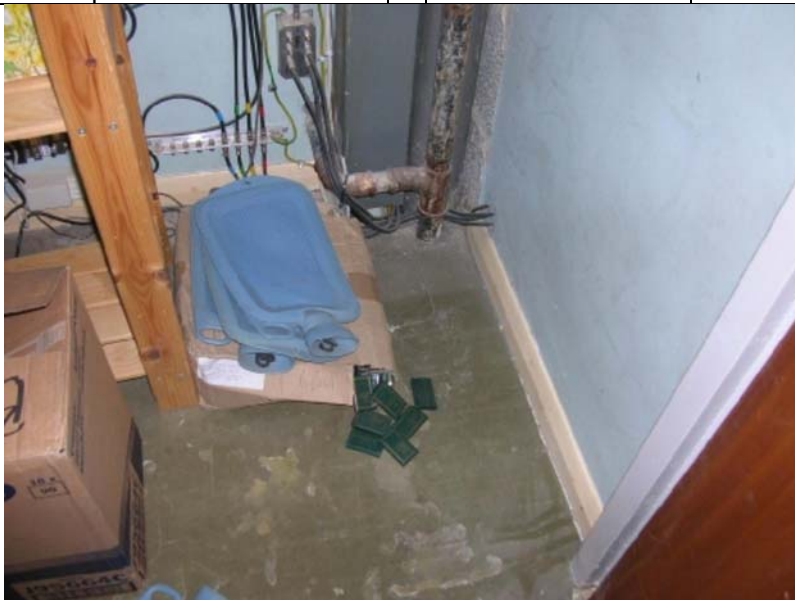
Swindon Borough Council			
Project Ref	J10943	Building	01 Accommodation Block
Site	Lydiard House Lydiard Tregoze Swindon	Floor	01 First floor
Location	Loc0205	Description	Green vinyl floor covering
Room/Area	D030 Cupboard	Site Code/UPRN	10004843255

Last Inspection Date	- 21 Dec 2006	Certificate N°	- C15751
Next Inspection Date	- 21 Dec 2007	Sample N°	- Ref B39
Survey Type	- Type 2	Photograph N°	- 57

Position	- Internal (Occupied)	Damage Risk	- Low
Asbestos Type	- Chrysotile	HSE Notifiable	- No
Product Type	- Vinyl

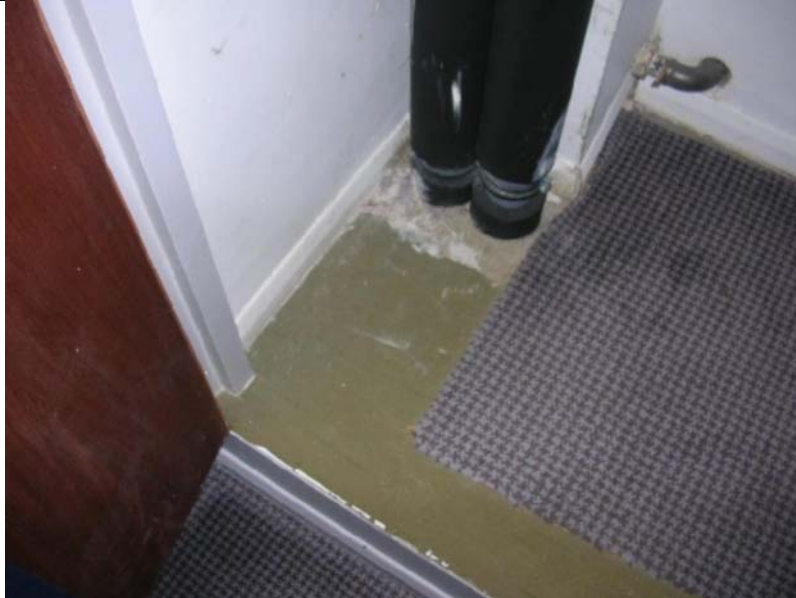
Swindon Borough Council			
Project Ref	J10943	Building	01 Accommodation Block
Site	Lydiard House Lydiard Tregoze Swindon	Floor	01 First floor
Location	Loc0211	Description	Green vinyl floor covering
Room/Area	D032 Cupboard	Site Code/UPRN	10004843255

Last Inspection Date	- 21 Dec 2006	Certificate N^o	- C15751
Next Inspection Date	- 21 Dec 2007	Sample N^o	- Ref B39
Survey Type	- Type 2	Photograph N^o	- 58

Position	- Internal (Occupied)	Damage Risk	- Low
Asbestos Type	- Chrysotile	HSE Notifiable	- No
Product Type	- Vinyl

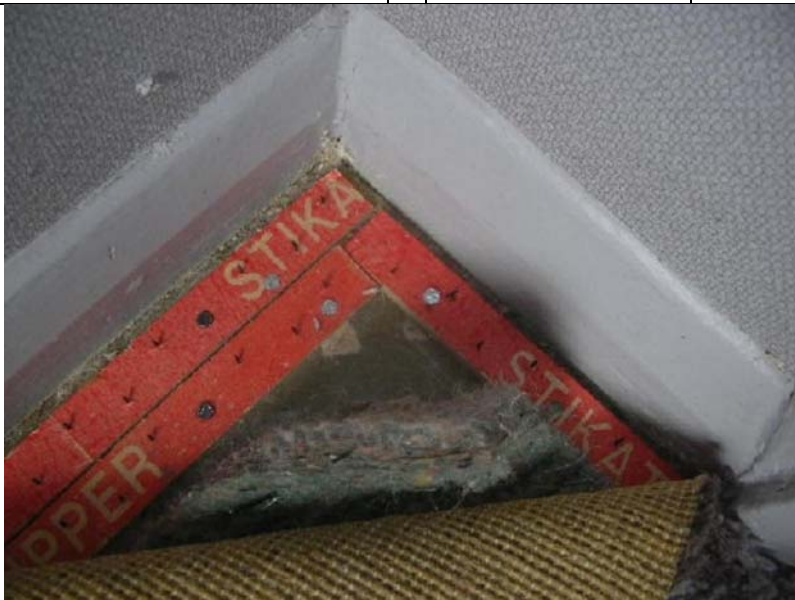
Swindon Borough Council			
Project Ref	J10943	Building	01 Accommodation Block
Site	Lydiard House Lydiard Tregoze Swindon	Floor	02 Second floor
Location	ENS2039	Description	Floor covering under carpet
Room/Area	E001 Circ	Site Code/UPRN	10004843255

Last Inspection Date	- 25 May 2007	Certificate N°	- C15751
Next Inspection Date	- 25 May 2008	Sample N°	- Ref B59
Survey Type	- Type 2	Photograph N°	- 33

Position	- Internal (Occupied)	Damage Risk	- Low
Asbestos Type	- Chrysotile	HSE Notifiable	- No
Product Type	- Vinyl

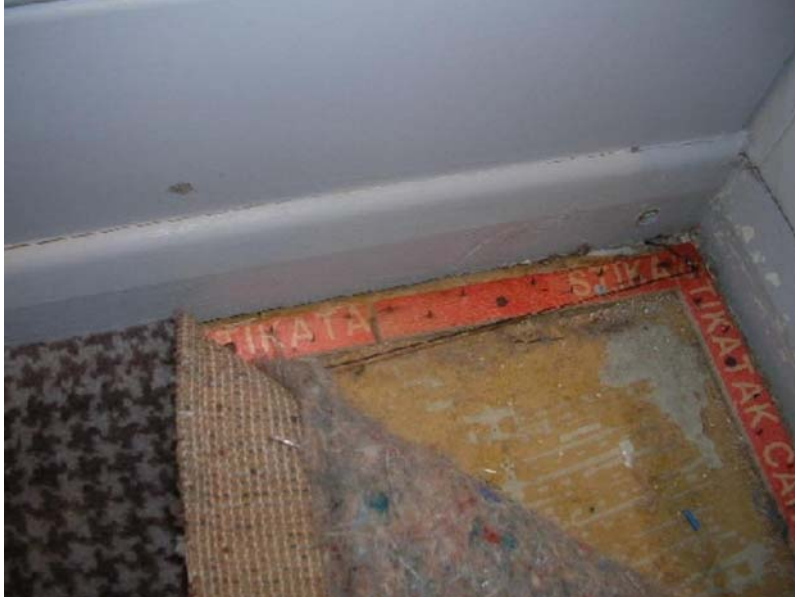
Swindon Borough Council			
Project Ref	J10943	Building	01 Accommodation Block
Site	Lydiard House Lydiard Tregoze Swindon	Floor	02 Second floor
Location	ENS2037	Description	Floor covering under carpet
Room/Area	E003 Bathroom	Site Code/UPRN	10004843255

Last Inspection Date	- 25 May 2007	Certificate N°	- C15751
Next Inspection Date	- 25 May 2008	Sample N°	- Ref B58
Survey Type	- Type 2	Photograph N°	- 31

Position	- Internal (Occupied)	Damage Risk	- Low
Asbestos Type	- Chrysotile	HSE Notifiable	- No
Product Type	- Vinyl

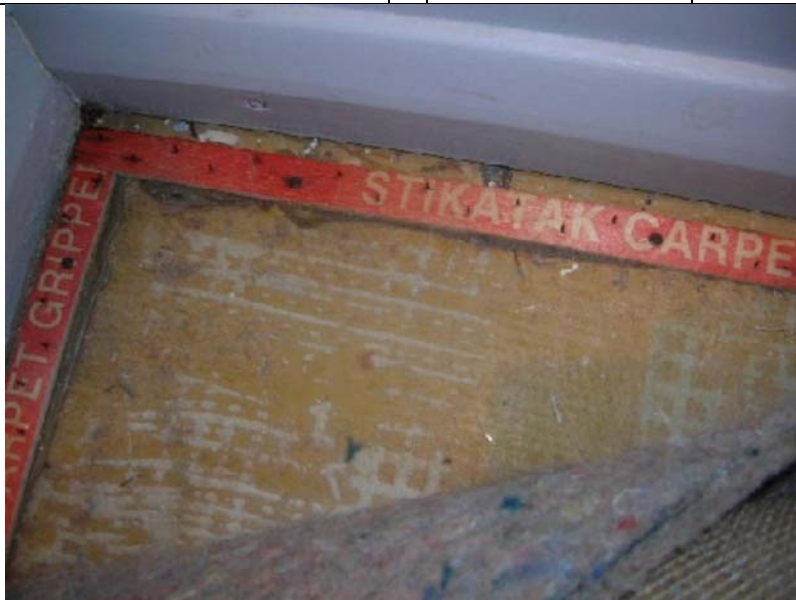
Swindon Borough Council			
Project Ref	J10943	Building	01 Accommodation Block
Site	Lydiard House Lydiard Tregoze Swindon	Floor	02 Second floor
Location	ENS2030	Description	Floor covering under carpet
Room/Area	E006 Bed 4	Site Code/UPRN	10004843255

Last Inspection Date	- 25 May 2007	Certificate N°	- C15751
Next Inspection Date	- 25 May 2008	Sample N°	- Ref B57
Survey Type	- Type 2	Photograph N°	- 26

Position	- Internal (Occupied)	Damage Risk	- Low
Asbestos Type	- Chrysotile	HSE Notifiable	- No
Product Type	- Vinyl

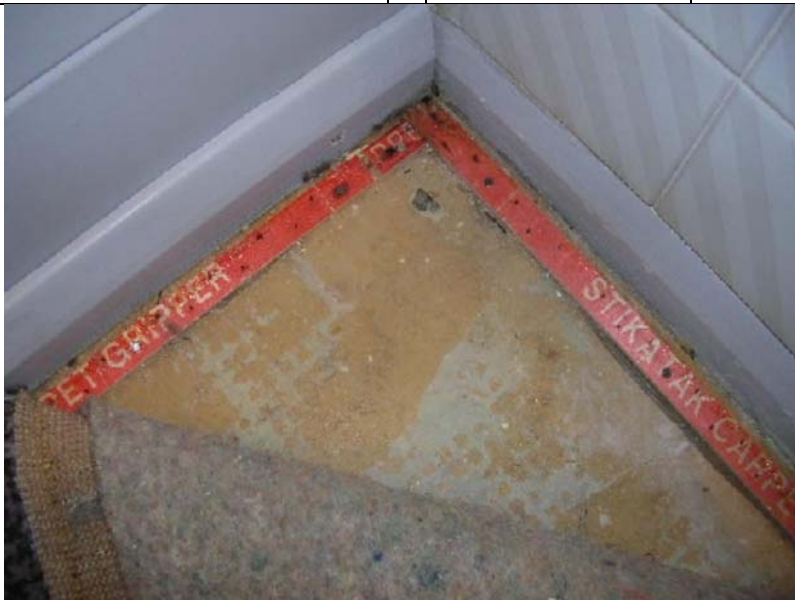
Swindon Borough Council			
Project Ref	J10943	Building	01 Accommodation Block
Site	Lydiard House Lydiard Tregoze Swindon	Floor	02 Second floor
Location	ENS2027	Description	Floor covering under carpet
Room/Area	E009 Bathroom	Site Code/UPRN	10004843255

Last Inspection Date	- 25 May 2007	Certificate N°	- C15751
Next Inspection Date	- 25 May 2008	Sample N°	- B57
Survey Type	- Type 2	Photograph N°	- 23

Position	- Internal (Occupied)	Damage Risk	- Low
Asbestos Type	- Chrysotile	HSE Notifiable	- No
Product Type	- Vinyl

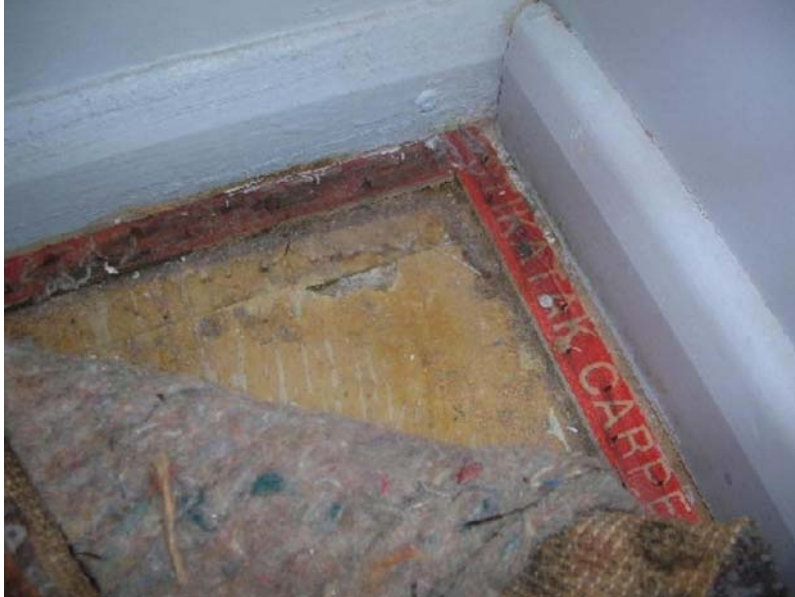
Swindon Borough Council			
Project Ref	J10943	Building	01 Accommodation Block
Site	Lydiard House Lydiard Tregoze Swindon	Floor	02 Second floor
Location	ENS2025	Description	Floor tiles under carpet
Room/Area	E013 Bathroom	Site Code/UPRN	10004843255

Last Inspection Date	- 25 May 2007	Certificate N^o	- C15751
Next Inspection Date	- 25 May 2008	Sample N^o	- B56
Survey Type	- Type 2	Photograph N^o	- 21

Position	- Internal (Occupied)	Damage Risk	- Low
Asbestos Type	- Chrysotile	HSE Notifiable	- No
Product Type	- Vinyl

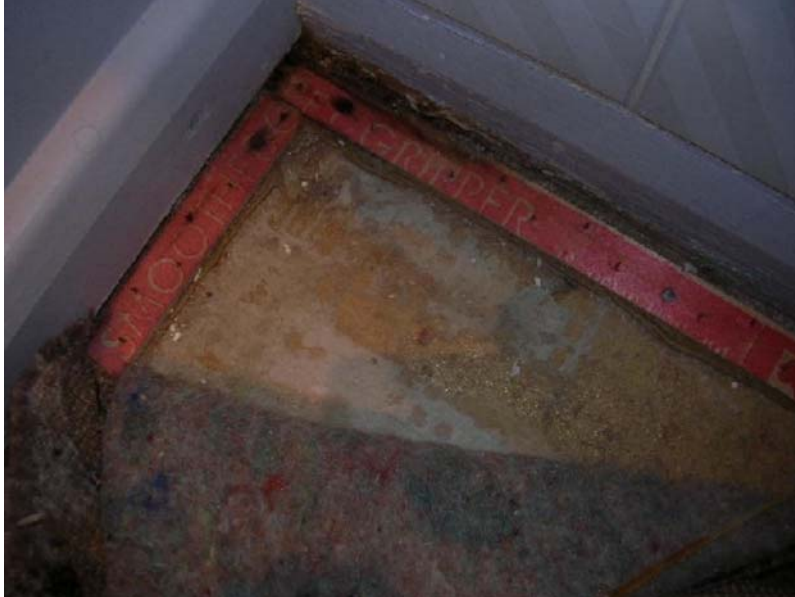
Swindon Borough Council			
Project Ref	J10943	Building	01 Accommodation Block
Site	Lydiard House Lydiard Tregoze Swindon	Floor	02 Second floor
Location	ENS2026	Description	Floor covering under carpet
Room/Area	E015 Bathroom	Site Code/UPRN	10004843255

Last Inspection Date	- 25 May 2007	Certificate N°	- C15751
Next Inspection Date	- 25 May 2008	Sample N°	- Ref B56
Survey Type	- Type 2	Photograph N°	- 22

Position	- Internal (Occupied)	Damage Risk	- Low
Asbestos Type	- Chrysotile	HSE Notifiable	- No
Product Type	- Vinyl

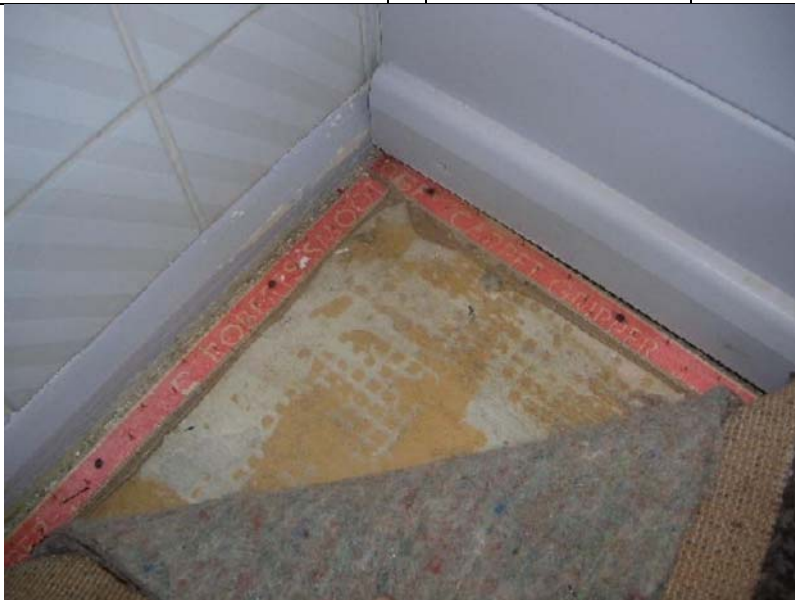
Swindon Borough Council			
Project Ref	J10943	Building	01 Accommodation Block
Site	Lydiard House Lydiard Tregoze Swindon	Floor	02 Second floor
Location	ENS2028	Description	Floor covering under carpet
Room/Area	E017 Bathroom	Site Code/UPRN	10004843255

Last Inspection Date	- 25 May 2007	Certificate N°	- C15751
Next Inspection Date	- 25 May 2008	Sample N°	- Ref B57
Survey Type	- Type 2	Photograph N°	- 24

Position	- Internal (Occupied)	Damage Risk	- Low
Asbestos Type	- Chrysotile	HSE Notifiable	- No
Product Type	- Vinyl

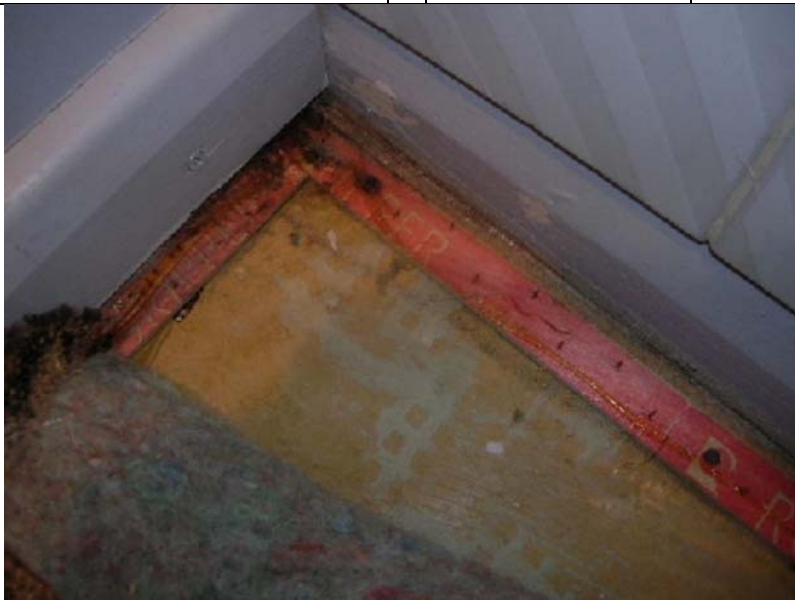
Swindon Borough Council			
Project Ref	J10943	Building	01 Accommodation Block
Site	Lydiard House Lydiard Tregoze Swindon	Floor	02 Second floor
Location	ENS2029	Description	Floor covering under carpet
Room/Area	E019 Bathroom	Site Code/UPRN	10004843255

Last Inspection Date	- 25 May 2007	Certificate N^o	- C15751
Next Inspection Date	- 25 May 2008	Sample N^o	- Ref B57
Survey Type	- Type 2	Photograph N^o	- 25

Position	- Internal (Occupied)	Damage Risk	- Low
Asbestos Type	- Chrysotile	HSE Notifiable	- No
Product Type	- Vinyl

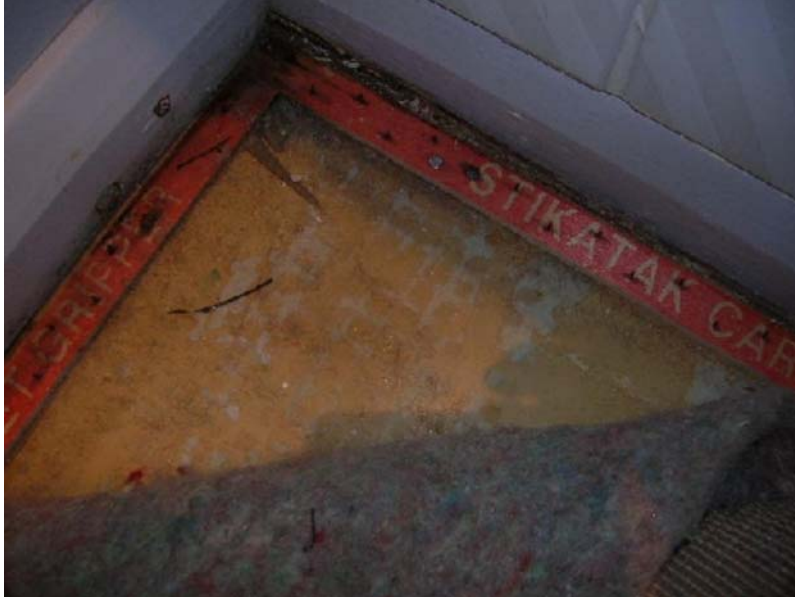
Swindon Borough Council			
Project Ref	J10943	Building	01 Accommodation Block
Site	Lydiard House Lydiard Tregoze Swindon	Floor	02 Second floor
Location	ENS2034	Description	Floor covering under carpet
Room/Area	E021 Bathroom	Site Code/UPRN	10004843255

Last Inspection Date	- 25 May 2007	Certificate N°	- C15751
Next Inspection Date	- 25 May 2008	Sample N°	- Ref B57
Survey Type	- Type 2	Photograph N°	- 28

Position	- Internal (Occupied)	Damage Risk	- Low
Asbestos Type	- Chrysotile	HSE Notifiable	- No
Product Type	- Vinyl

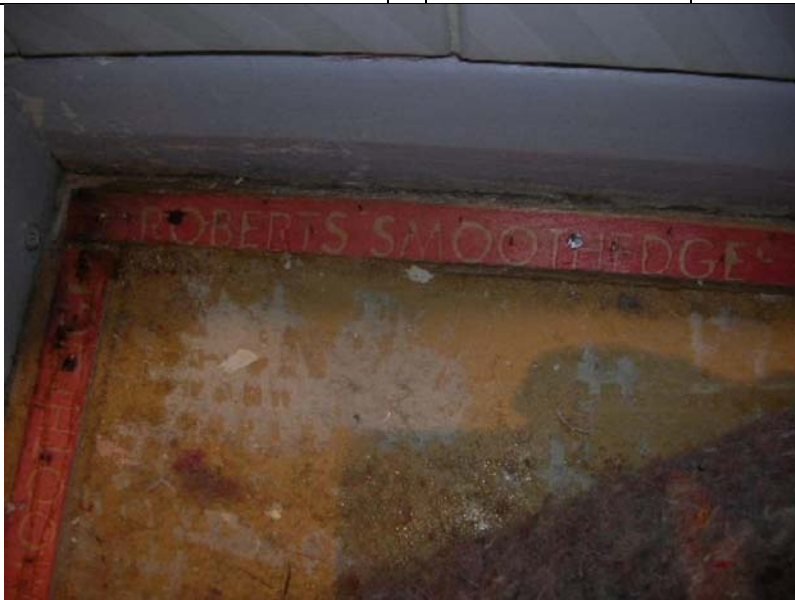
Swindon Borough Council			
Project Ref	J10943	Building	01 Accommodation Block
Site	Lydiard House Lydiard Tregoze Swindon	Floor	02 Second floor
Location	ENS2035	Description	Floor covering under carpet
Room/Area	E023 Bathroom	Site Code/UPRN	10004843255

Last Inspection Date	- 25 May 2007	Certificate N°	- C15751
Next Inspection Date	- 25 May 2008	Sample N°	- B58
Survey Type	- Type 2	Photograph N°	- 29

Position	- Internal (Occupied)	Damage Risk	- Low
Asbestos Type	- Chrysotile	HSE Notifiable	- No
Product Type	- Vinyl

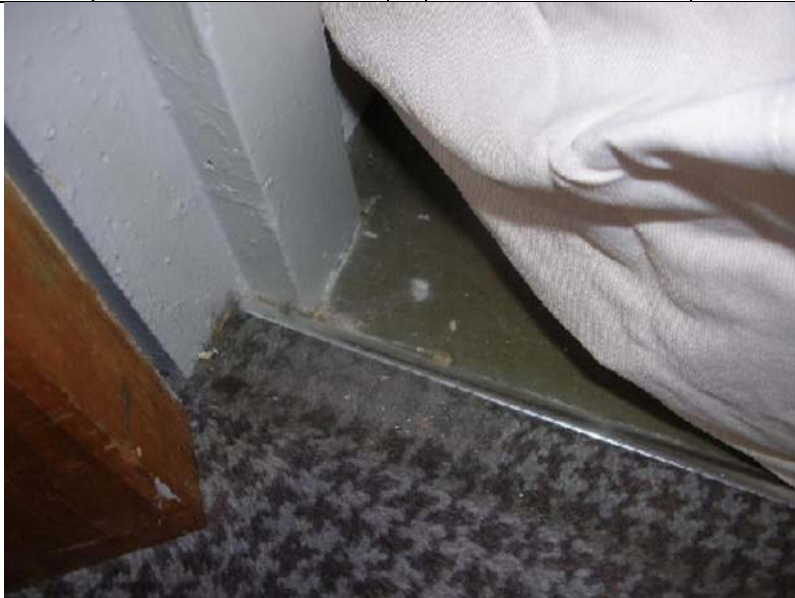
Swindon Borough Council			
Project Ref	J10943	Building	01 Accommodation Block
Site	Lydiard House Lydiard Tregoze Swindon	Floor	02 Second floor
Location	ENS2038	Description	Floor covering to cupboard
Room/Area	E025 Cupboard	Site Code/UPRN	10004843255

Last Inspection Date	- 25 May 2007	Certificate N^o.	- C15751
Next Inspection Date	- 25 May 2008	Sample N^o.	- B59
Survey Type	- Type 2	Photograph N^o.	- 32

Position	- Internal (Occupied)	Damage Risk	- Low
Asbestos Type	- Chrysotile	HSE Notifiable	- No
Product Type	- Vinyl

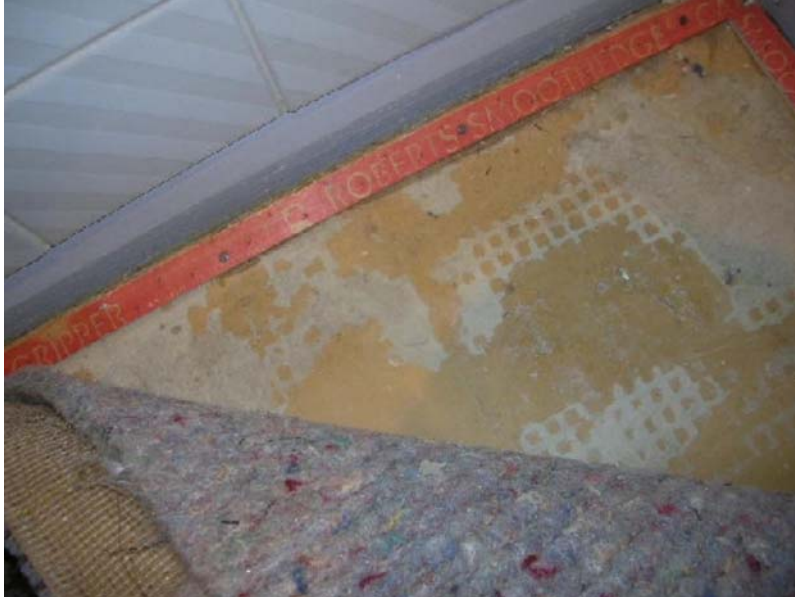
Swindon Borough Council			
Project Ref	J10943	Building	01 Accommodation Block
Site	Lydiard House Lydiard Tregoze Swindon	Floor	02 Second floor
Location	ENS2032	Description	Floor covering under carpet
Room/Area	E028 Bathroom	Site Code/UPRN	10004843255

Last Inspection Date	- 25 May 2007	Certificate N°	- C15751
Next Inspection Date	- 25 May 2008	Sample N°	- Ref B57
Survey Type	- Type 2	Photograph N°	- 27

Position	- Internal (Occupied)	Damage Risk	- Low
Asbestos Type	- Chrysotile	HSE Notifiable	- No
Product Type	- Vinyl

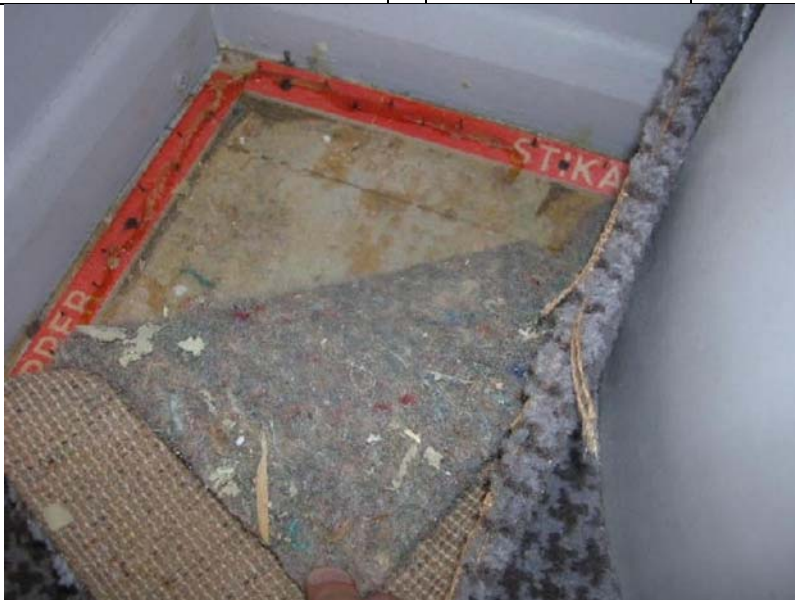
Swindon Borough Council			
Project Ref	J10943	Building	01 Accommodation Block
Site	Lydiard House Lydiard Tregoze Swindon	Floor	02 Second floor
Location	ENS2036	Description	Floor covering under carpet
Room/Area	E029 Bathroom	Site Code/UPRN	10004843255

Last Inspection Date	- 25 May 2007	Certificate N°	- C15751
Next Inspection Date	- 25 May 2008	Sample N°	- Ref B58
Survey Type	- Type 2	Photograph N°	- 30

Position	- Internal (Occupied)	Damage Risk	- Low
Asbestos Type	- Chrysotile	HSE Notifiable	- No
Product Type	- Vinyl

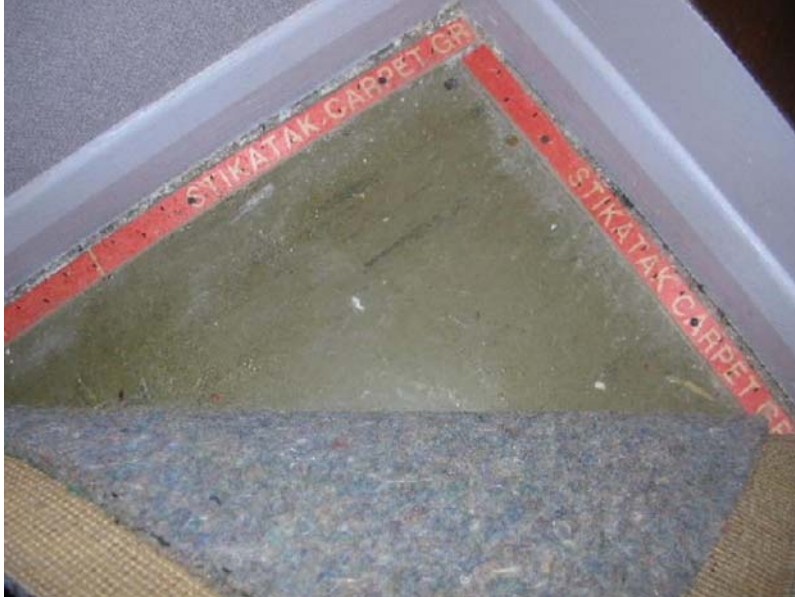
Swindon Borough Council			
Project Ref	J10943	Building	01 Accommodation Block
Site	Lydiard House Lydiard Tregoze Swindon	Floor	02 Second floor
Location	ENS2024	Description	Floor covering under carpet
Room/Area	E030 Circ	Site Code/UPRN	10004843255

Last Inspection Date	- 25 May 2007	Certificate N°	- C15751
Next Inspection Date	- 25 May 2008	Sample N°	- B55
Survey Type	- Type 2	Photograph N°	- 20

Position	- Internal (Occupied)	Damage Risk	- Low
Asbestos Type	- Chrysotile	HSE Notifiable	- No
Product Type	- Vinyl
