Report of 'Type 2' Asbestos Survey
At
Lydiard House
Lydiard Tregoze
Swindon
For
Swindon Borough Council

On
Tuesday 12th December 2006
Project Ref: J10943
UPRN: 10004843255

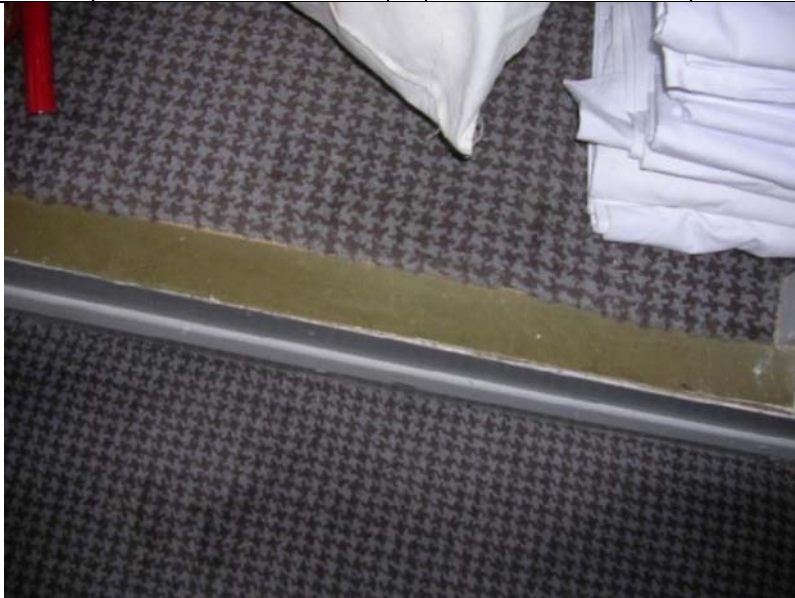
Swindon Borough Council			
Project Ref	J10943	Building	01 Accommodation Block
Site	Lydiard House Lydiard Tregoze Swindon	Floor	02 Second floor
Location	Loc0216	Description	Green vinyl floor covering
Room/Area	E032 Cupboard	Site Code/UPRN	10004843255

Last Inspection Date	- 21 Dec 2006	Certificate N°	- C15751
Next Inspection Date	- 21 Dec 2007	Sample N°	- Ref B39
Survey Type	- Type 2	Photograph N°	- 59

Position	- Internal (Occupied)	Damage Risk	- Low
Asbestos Type	- Chrysotile	HSE Notifiable	- No
Product Type	- Vinyl

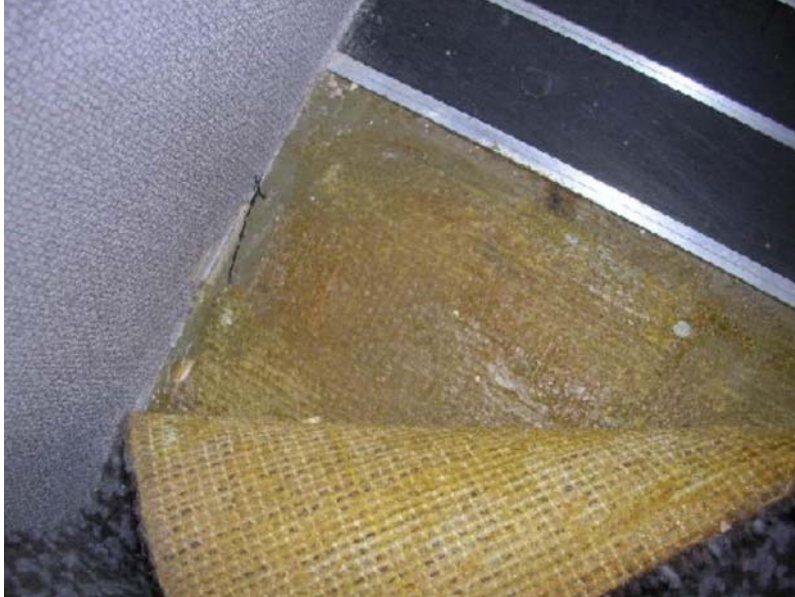
Swindon Borough Council			
Project Ref	J10943	Building	01 Accommodation Block
Site	Lydiard House Lydiard Tregoze Swindon	Floor	02 Second floor
Location	ENS2040	Description	Floor covering under carpet
Room/Area	E033 Stairs	Site Code/UPRN	10004843255

Last Inspection Date	- 25 May 2007	Certificate N°	- C15751
Next Inspection Date	- 25 May 2008	Sample N°	- Ref B59
Survey Type	- Type 2	Photograph N°	- 34

Position	- Internal (Occupied)	Damage Risk	- Low
Asbestos Type	- Chrysotile	HSE Notifiable	- No
Product Type	- Vinyl

Amount	- 5 Sq M	Job Status	- Surveyed
Damage Extent	- Low Damage	Material Risk	- 3
Surface Treatment	- Composite (Self Sealed)	Assessment	
Friability	- Low	Very Low Risk - Very low potential to release fibres

Comments:	- The material was unsampled in this location as a sample of identical material had been previously collected (Sample Reference B59).
Recommendations:	- The asbestos containing composite product does not require removal or encapsulation, however, must be managed accordingly. It may be prudent to consider labelling where practicable to do so.

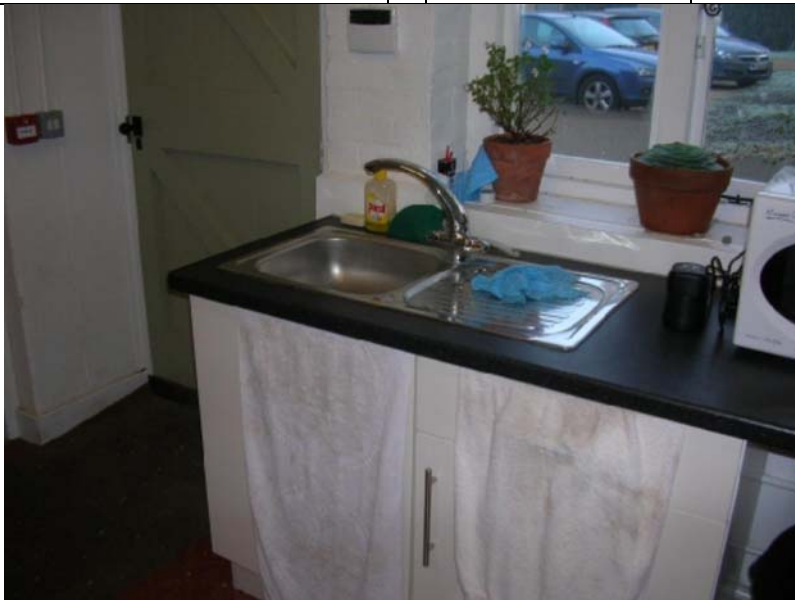
Swindon Borough Council			
Project Ref	J10943	Building	02 Stables
Site	Lydiard House Lydiard Tregoze Swindon	Floor	00 Ground
Location	Loc0149	Description	Mastic pad to underside of sink
Room/Area	SB01 Staff Room	Site Code/UPRN	10004843255

Last Inspection Date	- 20 Dec 2006	Certificate N°	- C15751
Next Inspection Date	- N/A	Sample N°	- B37
Survey Type	- Type 2	Photograph N°	- 54

Position	- Internal (Occupied)	Damage Risk	- Low
Asbestos Type	- No Asbestos Detected	HSE Notifiable	- No
Product Type	- Mastic

Amount	- 2 Units	Job Status	- Surveyed
Damage Extent	- Low Damage	Material Risk	- 0
Surface Treatment	- Composite (Self Sealed)	Assessment	
Friability	- Low	NO ASBESTOS DETECTED

Comments:	- Please refer to the recommendation below
Recommendations:	- No asbestos fibre was detected within the sample collected. As such the client is not required to take any further action.

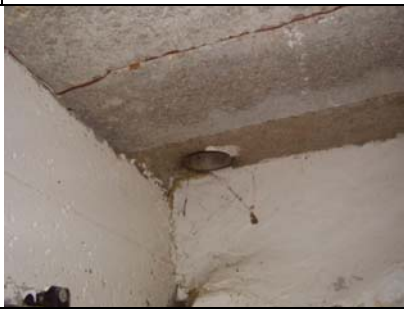
Swindon Borough Council			
UPRN	10004843255	Building	00 Main Building
Site	Lydiard House, Lydiard Tregoze, Swindon, SN5 3PA	Floor	-00 Basement
Location	ENS120	Room/Area	A001
Sample No	B06	Description	Flue to concrete ceiling

Material Risk (MA)			
Product Type	Cement	Surface Treatment	Unsealed Cement
Asbestos Type	Chrysotile	Damage Extent	Low Damage

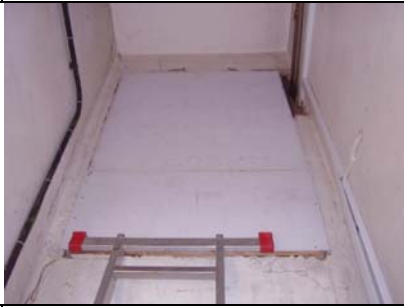
Swindon Borough Council			
UPRN	10004843255	Building	00 Main Building
Site	Lydiard House, Lydiard Tregoze, Swindon, SN5 3PA	Floor	-00 Basement
Location	ENS129	Room/Area	A001
Sample No	B08	Description	Panels above stairs leading down to basement

Material Risk (MA)			
Product Type	Insulating Board	Surface Treatment	Unsealed Board
Asbestos Type	Amosite & Chrysotile	Damage Extent	Medium Damage

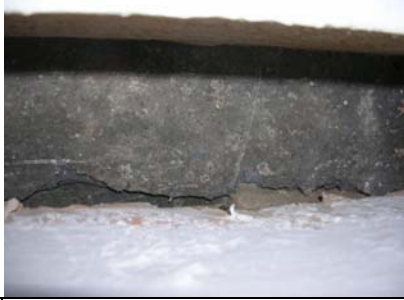
Swindon Borough Council			
UPRN	10004843255	Building	00 Main Building
Site	Lydiard House, Lydiard Tregoze, Swindon, SN5 3PA	Floor	00 Ground
Location	Ens0375	Room/Area	B008 Corridor
Sample No	B29	Description	Cement panel to underside of cupboard

Material Risk (MA)			
Product Type	Cement	Surface Treatment	Unsealed Cement
Asbestos Type	Chrysotile	Damage Extent	Medium Damage

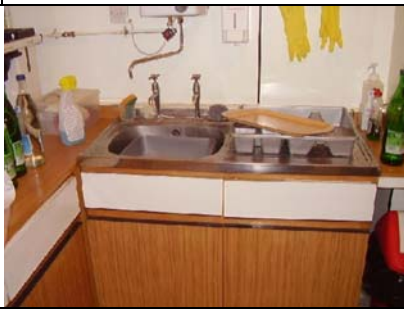
Swindon Borough Council			
UPRN	10004843255	Building	00 Main Building
Site	Lydiard House, Lydiard Tregoze, Swindon, SN5 3PA	Floor	01 First
Location	ENS0220	Room/Area	C039 Kitchen
Sample No	B21	Description	Pad to sink in kitchen

Material Risk (MA)			
Product Type	Mastic	Surface Treatment	Composite (Self Sealed)
Asbestos Type	Chrysotile	Damage Extent	Low Damage

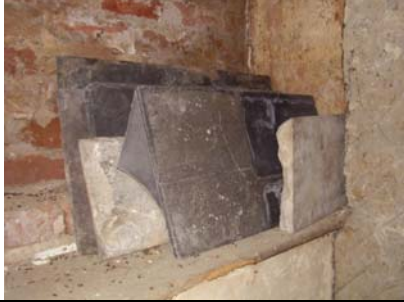
Swindon Borough Council			
UPRN	10004843255	Building	00 Main Building
Site	Lydiard House, Lydiard Tregoze, Swindon, SN5 3PA	Floor	03 Roof/Attic
Location	ENS109	Room/Area	04 Circ
Sample No	B02	Description	Loose roof tiles

Material Risk (MA)			
Product Type	Slate (Cement)	Surface Treatment	Unsealed Cement
Asbestos Type	Chrysotile	Damage Extent	Medium Damage

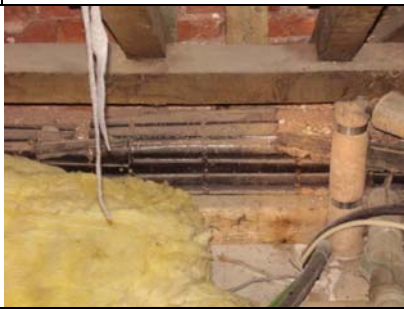
Swindon Borough Council			
UPRN	10004843255	Building	00 Main Building
Site	Lydiard House, Lydiard Tregoze, Swindon, SN5 3PA	Floor	03 Roof/Attic
Location	ENS115	Room/Area	05 Loft
Sample No	B04	Description	Packer below floor of walkway

Material Risk (MA)			
Product Type	Cement	Surface Treatment	Part Sealed Cement
Asbestos Type	Chrysotile	Damage Extent	Medium Damage

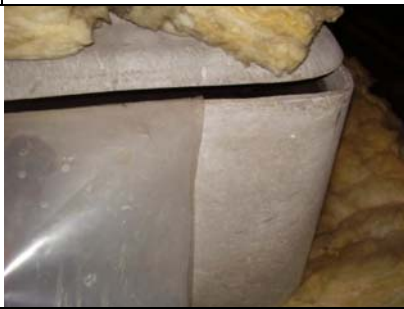
Swindon Borough Council			
UPRN	10004843255	Building	00 Main Building
Site	Lydiard House, Lydiard Tregoze, Swindon, SN5 3PA	Floor	03 Roof/Attic
Location	ENS190	Room/Area	06 Loft
Sample No	B15	Description	Water tanks to platform in loft

Material Risk (MA)			
Product Type	Cement	Surface Treatment	Unsealed Cement
Asbestos Type	Chrysotile & Crocidolite	Damage Extent	Low Damage

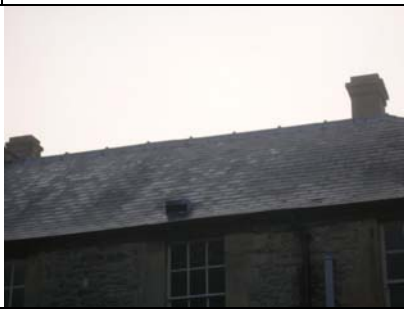
Swindon Borough Council			
UPRN	10004843255	Building	00 Main Building
Site	Lydiard House, Lydiard Tregoze, Swindon, SN5 3PA	Floor	External
Location	Loc0220	Room/Area	N/A
Sample No	Ref B02	Description	Cement tiles to pitch roof

Material Risk (MA)			
Product Type	Cement	Surface Treatment	Unsealed Cement
Asbestos Type	Chrysotile	Damage Extent	Low Damage

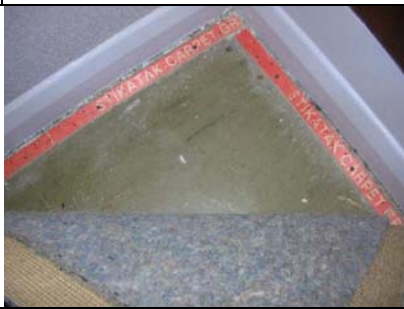
Swindon Borough Council			
UPRN	10004843255	Building	01 Accommodation Block
Site	Lydiard House, Lydiard Tregoze, Swindon, SN5 3PA	Floor	02 Second floor
Location	ENS2024	Room/Area	E030 Circ
Sample No	B55	Description	Floor covering under carpet

Material Risk (MA)			
Product Type	Vinyl	Surface Treatment	Composite (Self Sealed)
Asbestos Type	Chrysotile	Damage Extent	Low Damage

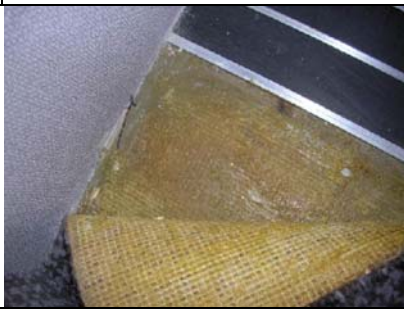
Swindon Borough Council			
UPRN	10004843255	Building	01 Accommodation Block
Site	Lydiard House, Lydiard Tregoze, Swindon, SN5 3PA	Floor	02 Second floor
Location	ENS2040	Room/Area	E033 Stairs
Sample No	Ref B59	Description	Floor covering under carpet

Material Risk (MA)			
Product Type	Vinyl	Surface Treatment	Composite (Self Sealed)
Asbestos Type	Chrysotile	Damage Extent	Low Damage
