Architectural Services

Asbestos Management

Elms Bank Specialist Arts College – Asbestos Management Plan Review

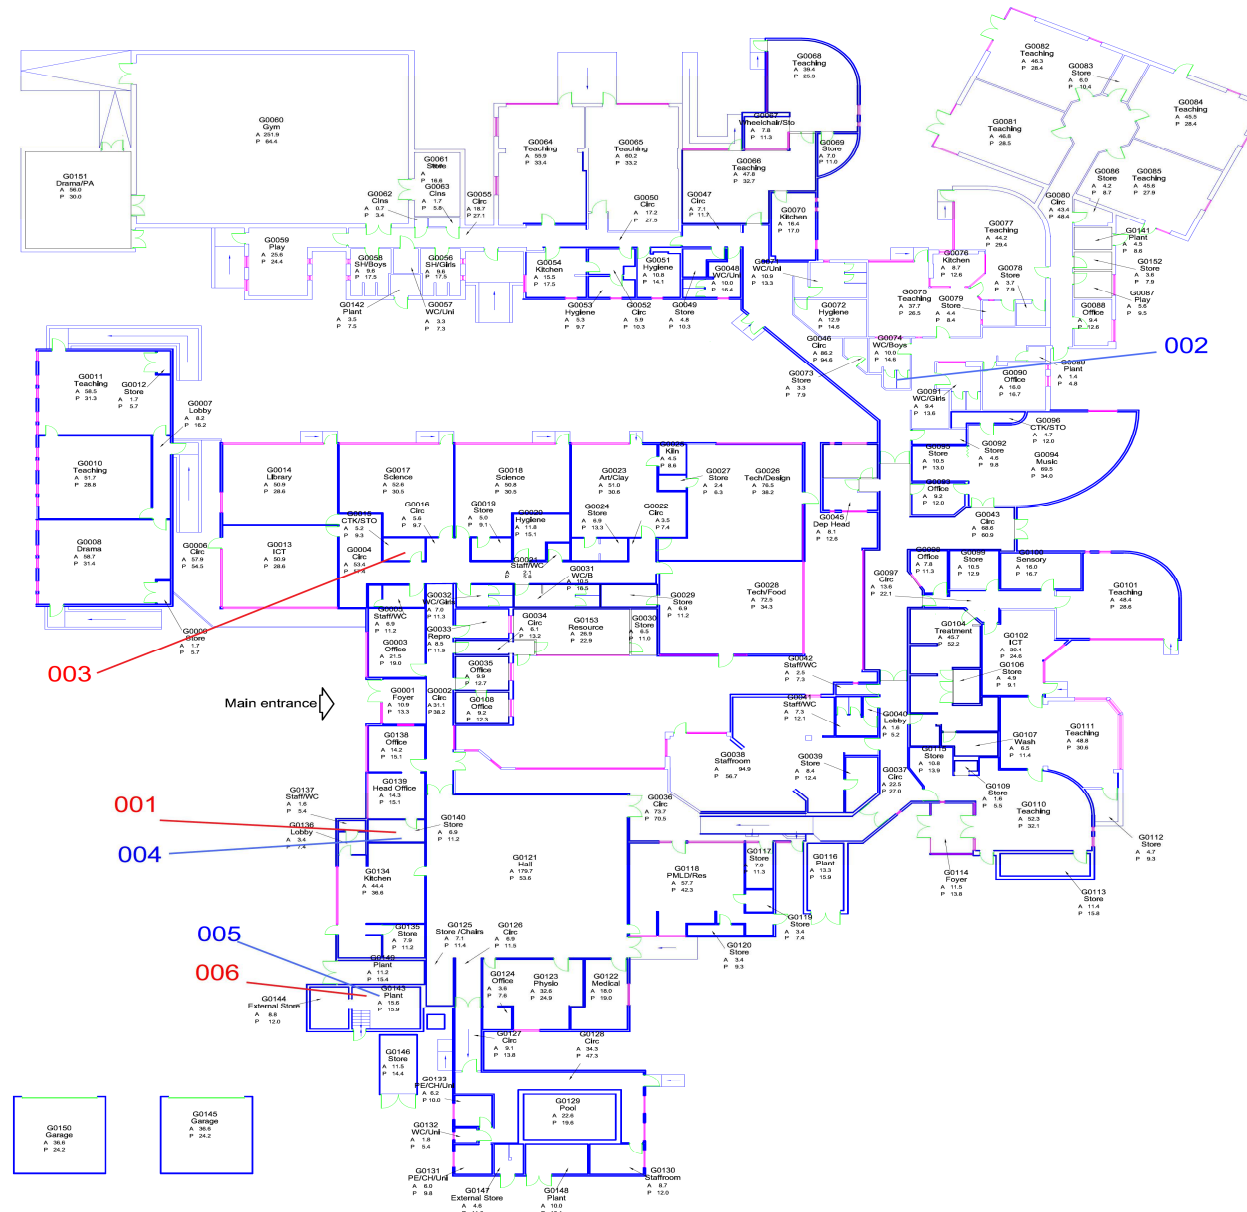
Site Plan

Key:	
■	Asbestos Containing Material
■	Removed Asbestos Containing Material
Site Name: Elms Bank Specialist Arts College	
Building: Main Building	
Floor: Ground Floor	
Drawn By: A. Skinner	
Date: 24/11/2017
