Project address:      Museum of Oxford  
Oxford Town Hall  
St Aldgates  
Oxford OX1 1BX

## Pre Construction Information

| Date | 10 November 2018 |

**Works to Museum of Oxford**

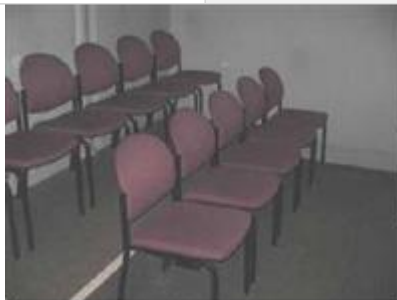
| <b>Location ID</b> | 2F D8 15 F3 | <b>Room / Area</b> | Auditorium |

| <b>Building</b> | Museum | <b>Description</b> | No suspect materials observed within area / room |

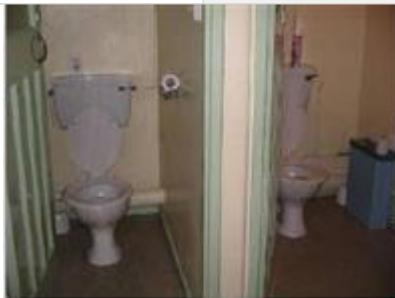
| <b>Location ID</b> | F7 7E 31 9A | <b>Room / Area</b> | Ladies WC |

| <b>Building</b> | Museum | <b>Description</b> | No suspect materials observed within area / room |

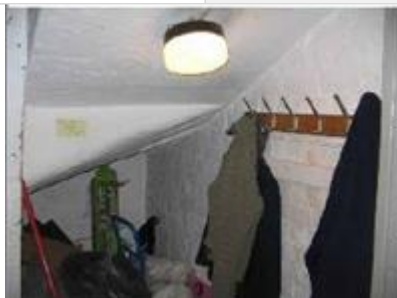
| <b>Location ID</b> | 29 9D BE 34 | <b>Room / Area</b> | Lockers & Storage |

| <b>Building</b> | Museum | <b>Description</b> | No suspect materials observed within area / room |

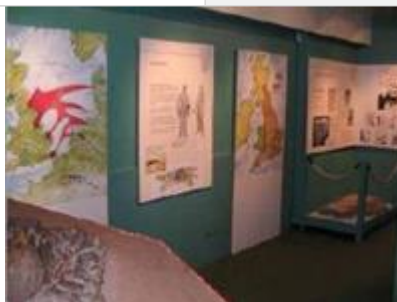
| <b>Location ID</b> | 1F A6 52 29 | <b>Room / Area</b> | Lower Gallery Area 1 |

| <b>Building</b> | Museum | <b>Description</b> | No suspect materials observed within area / room |

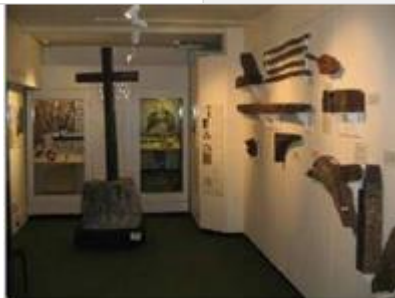
| <b>Location ID</b> | 76 A0 1D 66 | <b>Room / Area</b> | Lower Gallery Area 2 |

| <b>Building</b> | Museum | <b>Description</b> | No suspect materials observed within area / room |

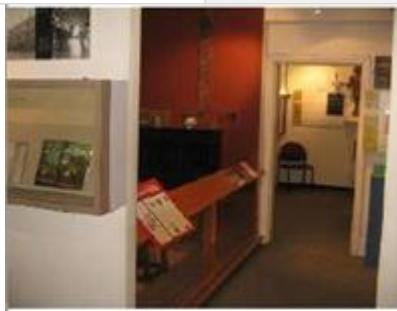
| <b>Location ID</b> | 3E D9 08 A2 | <b>Room / Area</b> | Lower Gallery Area 3 |

| <b>Building</b> | Museum | <b>Description</b> | No suspect materials observed within area / room |

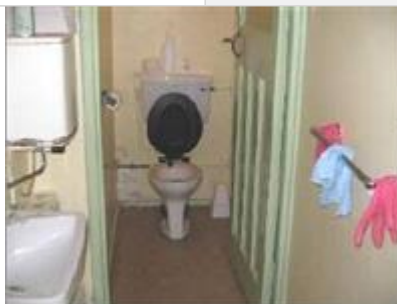
| <b>Location ID</b> | 88 49 F7 6C | <b>Room / Area</b> | Male WC |

| <b>Building</b> | Museum | <b>Description</b> | No suspect materials observed within area / room |

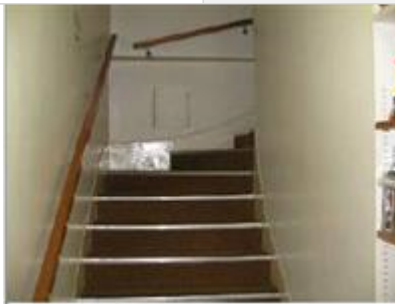
| <b>Location ID</b> | F8 BE CD 08 | <b>Room / Area</b> | Stairs & Corridor |

| <b>Building</b> | Museum | <b>Description</b> | No suspect materials observed within area / room |

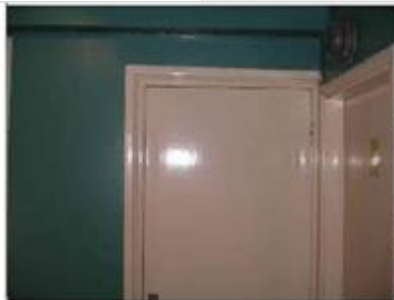
| <b>Location ID</b> | C7 A2 0D C6 | <b>Room / Area</b> | Stairs Lobby Area |

| <b>Building</b> | Museum | <b>Description</b> | Area Accessed - No Asbestos Found |

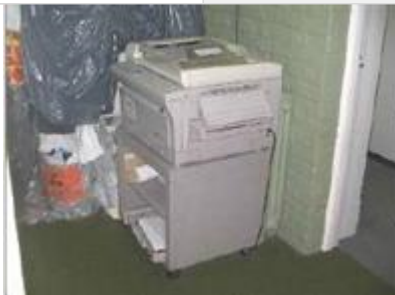
| <b>Location ID</b> | D2 B0 B2 52 | <b>Room / Area</b> | Store Room |

| <b>Building</b> | Museum | <b>Description</b> | No suspect materials observed within area / room |

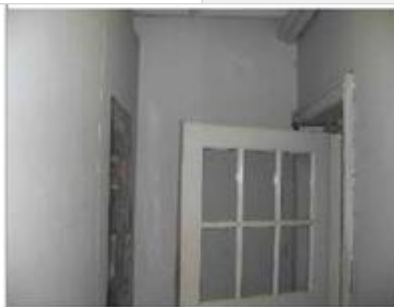
| <b>Location ID</b> | 02 3D 58 31 | <b>Room / Area</b> | Toilet Corridor |

| <b>Building</b> | Museum | <b>Description</b> | No suspect materials observed within area / room |

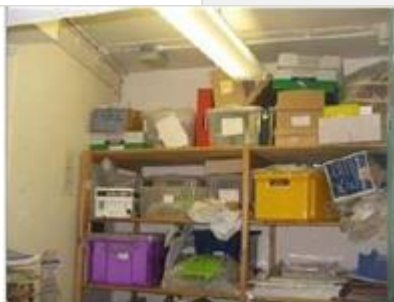
| <b>Location ID</b> | DA 31 94 88 | <b>Room / Area</b> | Work Room Store |

| <b>Building</b> | Museum | <b>Description</b> | No suspect materials observed within area / room |

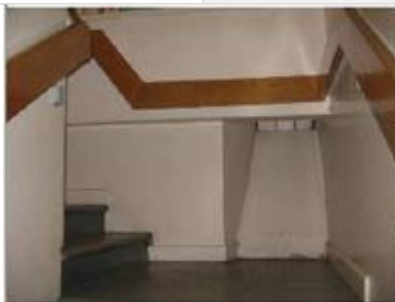
| <b>Location ID</b> | 9A 06 10 A8 | <b>Room / Area</b> | Stairs & Lobby |

| <b>Building</b> | Museum | <b>Description</b> | No suspect materials observed within area / room |

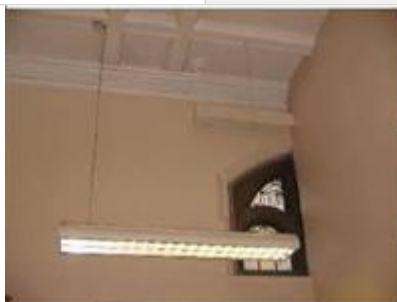
| <b>Location ID</b> | D4 BB 62 3B | <b>Room / Area</b> | All Rooms |

| <b>Building</b> | Museum | <b>Description</b> | No Asbestos Detected |

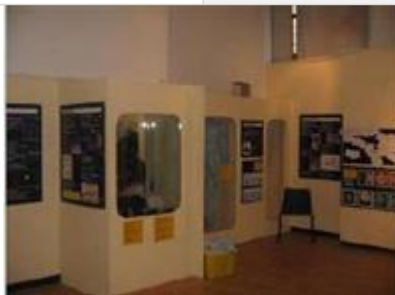
| <b>Location ID</b> | E5 E5 67 D9 | <b>Room / Area</b> | Exhibition Gallery 1 |

| <b>Building</b> | Museum | <b>Description</b> | No suspect materials observed within area / room including cupboards |

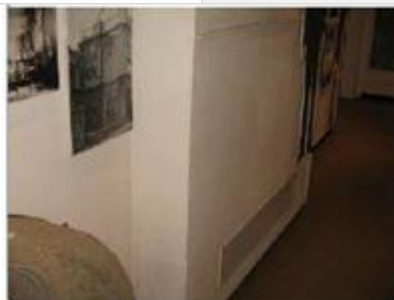
| <b>Location ID</b> | 2C 15 AF 75 | <b>Room / Area</b> | Exhibition Gallery 2 |

| <b>Building</b> | Museum | <b>Description</b> | No suspect materials observed within area / room |

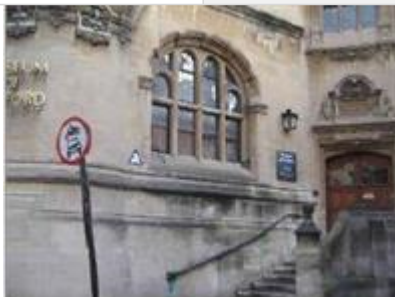
| <b>Location ID</b> | B0 C3 54 E0 | <b>Room / Area</b> | External Elevations |

| <b>Building</b> | Museum | <b>Description</b> | No suspect materials observed within area up to 2.5m |

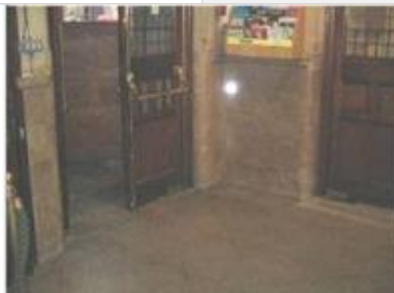
| <b>Location ID</b> | 15 31 C5 75 | <b>Room / Area</b> | Main Entrance & Foyer |

| <b>Building</b> | Museum | <b>Description</b> | No suspect materials observed below ceiling |

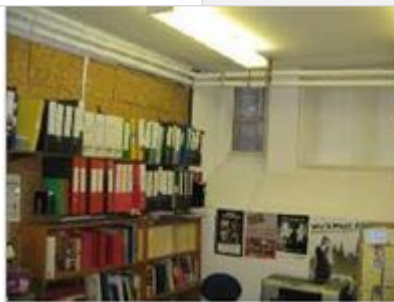
| <b>Location ID</b> | 88 C1 69 C3 | <b>Room / Area</b> | Museum Office |

| <b>Building</b> | Museum | <b>Description</b> | No suspect materials observed within area / room |

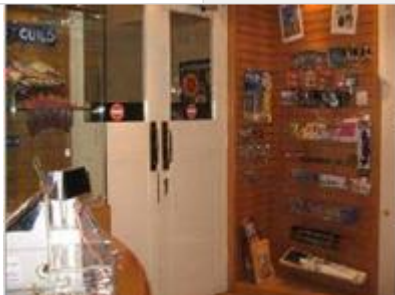
| <b>Location ID</b> | C4 0D D6 A7 | <b>Room / Area</b> | Museum Shop |

| <b>Building</b> | Museum | <b>Description</b> | No suspect materials observed below ceiling |
