Long Lane Pavilion

Feasibility Options

Elevations

As Proposed

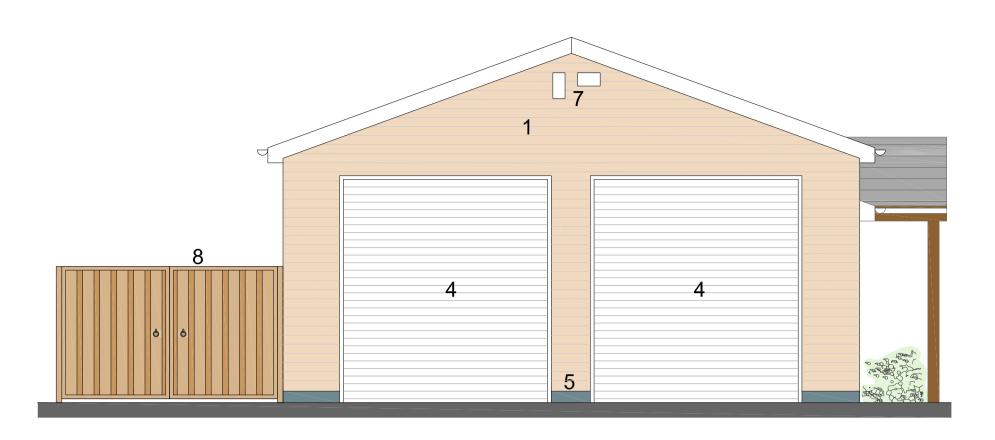
NORTH WEST ELEVATION

- 1 Composite timber effect cladding
- 2 Rendered external walls
- 3 Tile effect insulated metal roof coverings to reflect existing design and for durability
- 4 Metal shutter doors
- 5 Brick plinth
- 6 Low level planting to act as deterrent to vandalism
- 7 Bat/swallow boxes. Indicative size & positions
- 8 Timber fencing
- 9 Potential future PV provision
- 10 Signage. Design TBC
